NATIONAL TRANSPORT RESEARCH CENTRE

ACCIDENT BLACK SPOTS STUDY

NATIONAL HIGHWAY (N-5)

HASANABDAL - ATTOCK

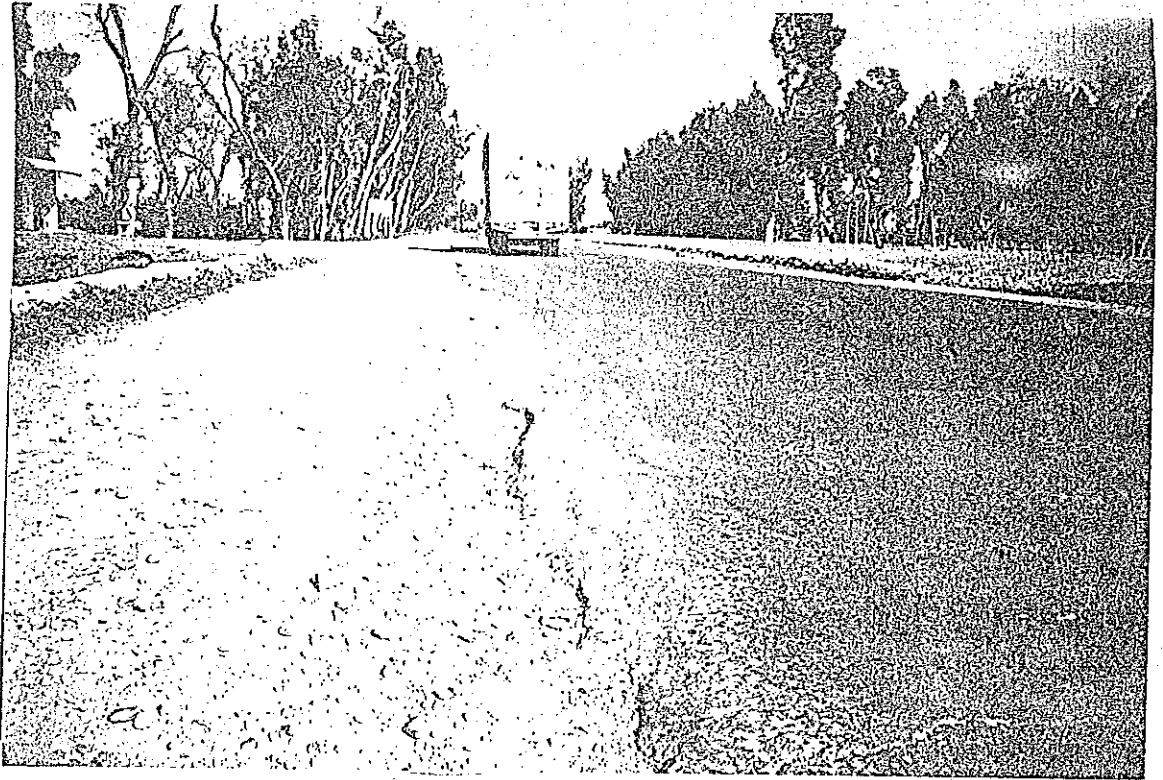
(Photograph - 1)

1. Poor Shoulder Condition

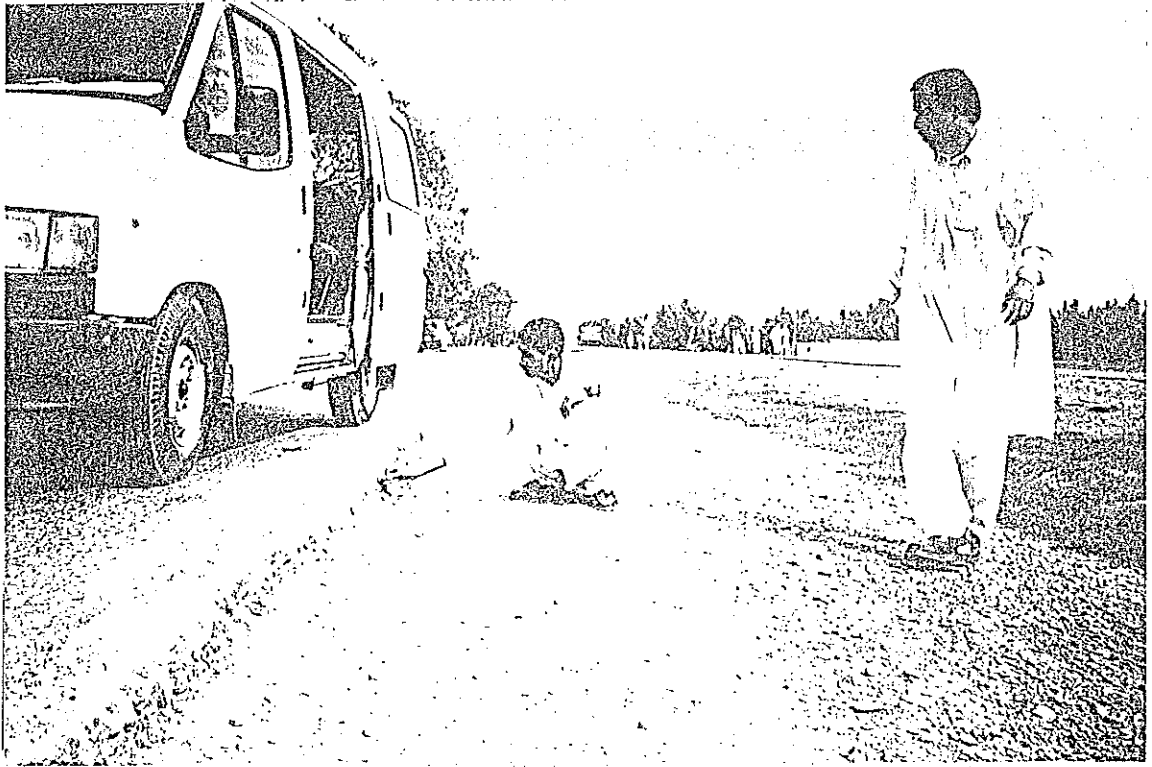
(Photograph - 2)

1. Shoulder surface is uncompacted and 6" - 8" below the pavement surface.
2. Hazardous for overtaking as no vehicle would like to give way to the other vehicle by retiring to shoulder.
3. Heavy goods vehicles would not use such shoulders so to avoid its axles from being damaged/breakage.

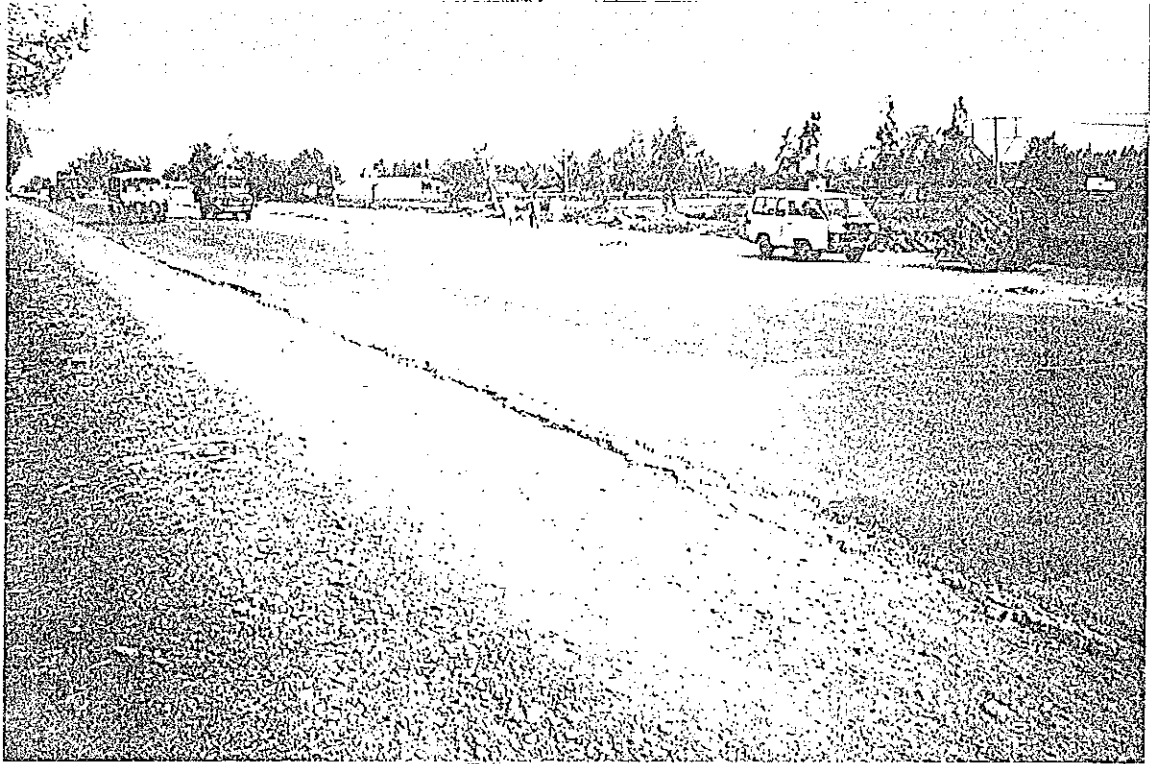
(Photograph - 3)

1. Vehicle parked on shoulder.
2. Overspeeding commuter Van (115 KPH).
3. Poor Condition of the shoulder.

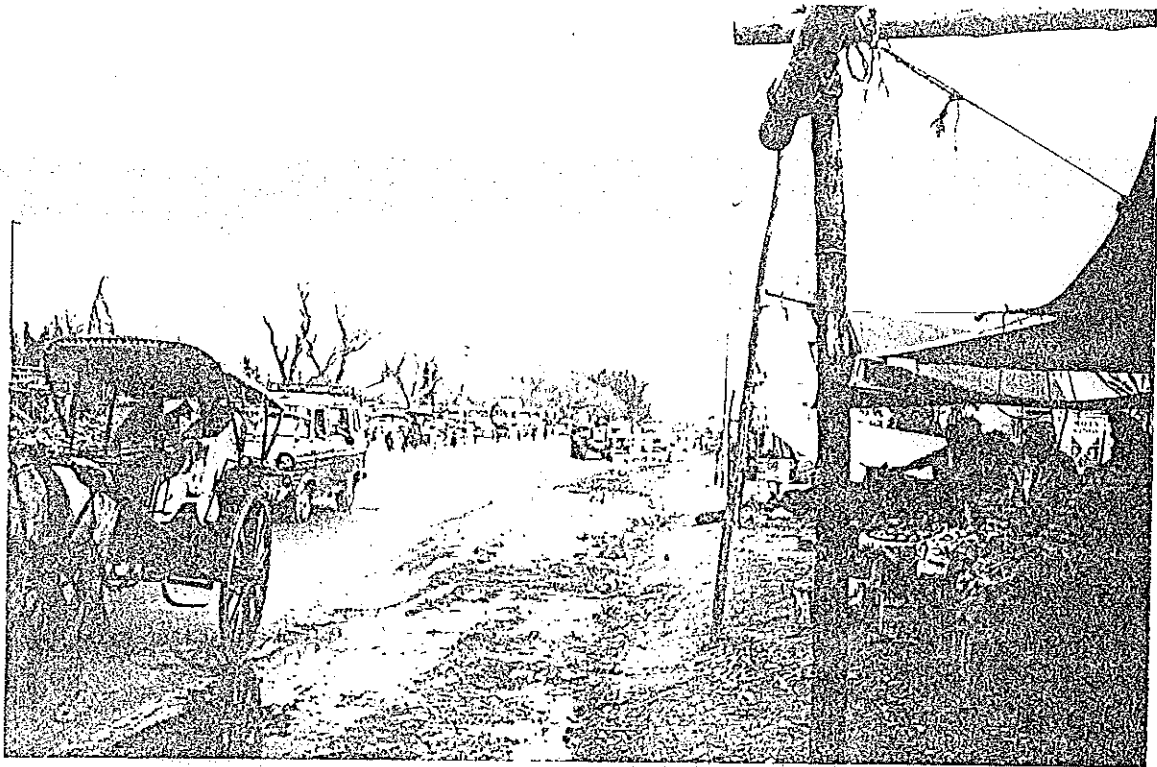
(Photograph - 4)

1. Reduced right of way.
2. Water standing on the road and shoulder.
3. Inadequate drainage system.
4. Animal Drawn vehicles on the road.

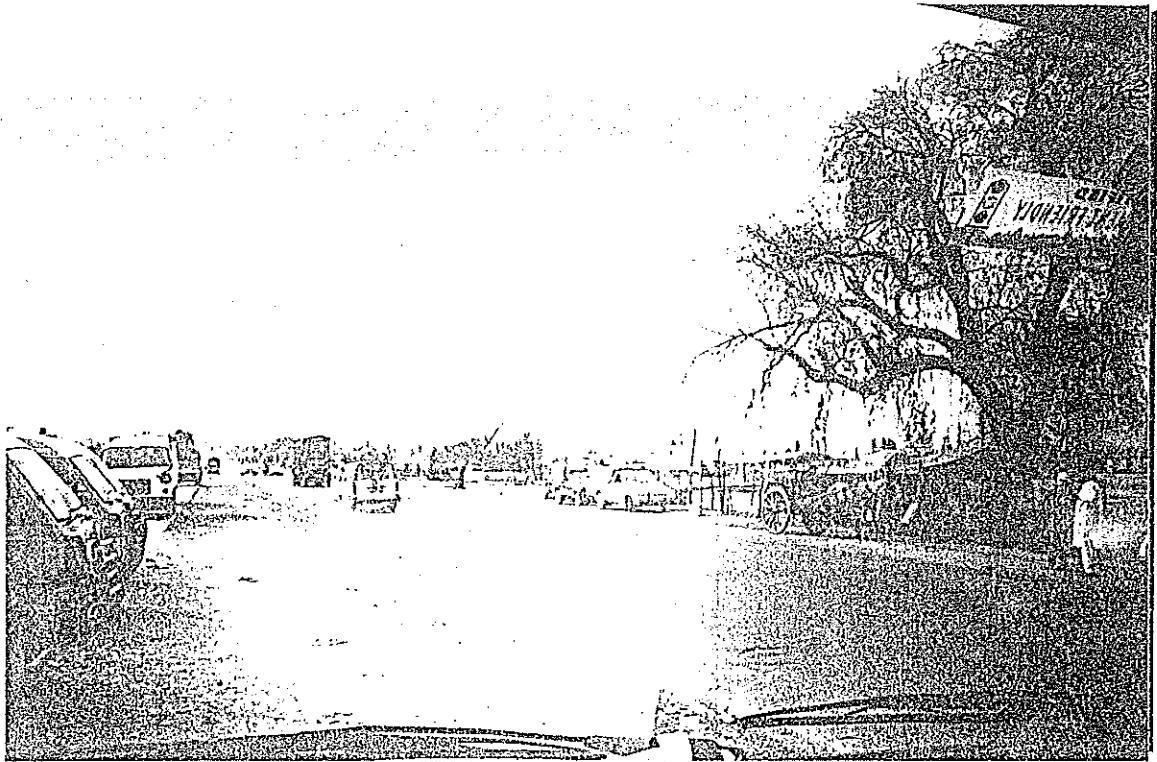
(Photograph - 5)

1. Typical example of rash overtaking. Negligent behaviour of wagon and bus drivers is quite visible.
2. Although safe passing distance was not available but overtaking maneveaour was carried out.

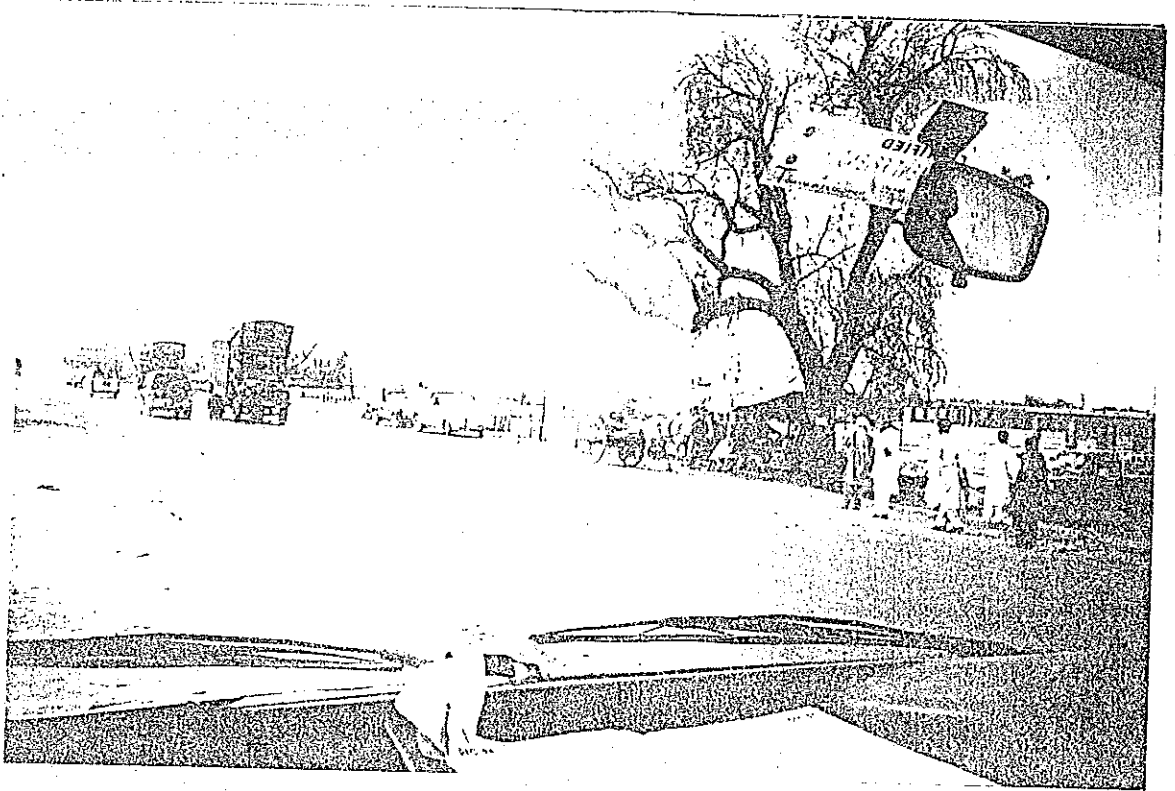
(Photograph - 6)

1. Although the safe passing distance was not available but the bus driver tried to overtake the truck resulting in narrow escape from head on collision between bus and wagon.

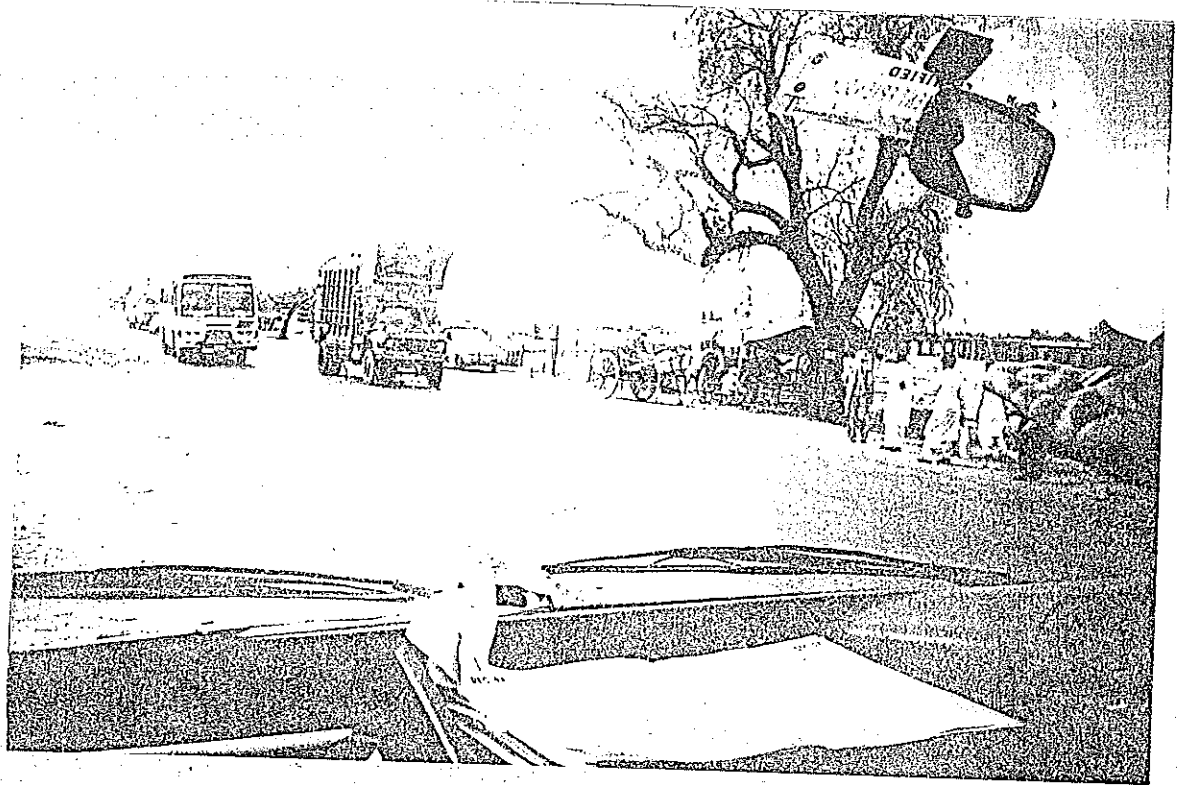
(Photograph - 7)

1. Bus passing through Urban Area and making hazardous overtaking manoeuver.

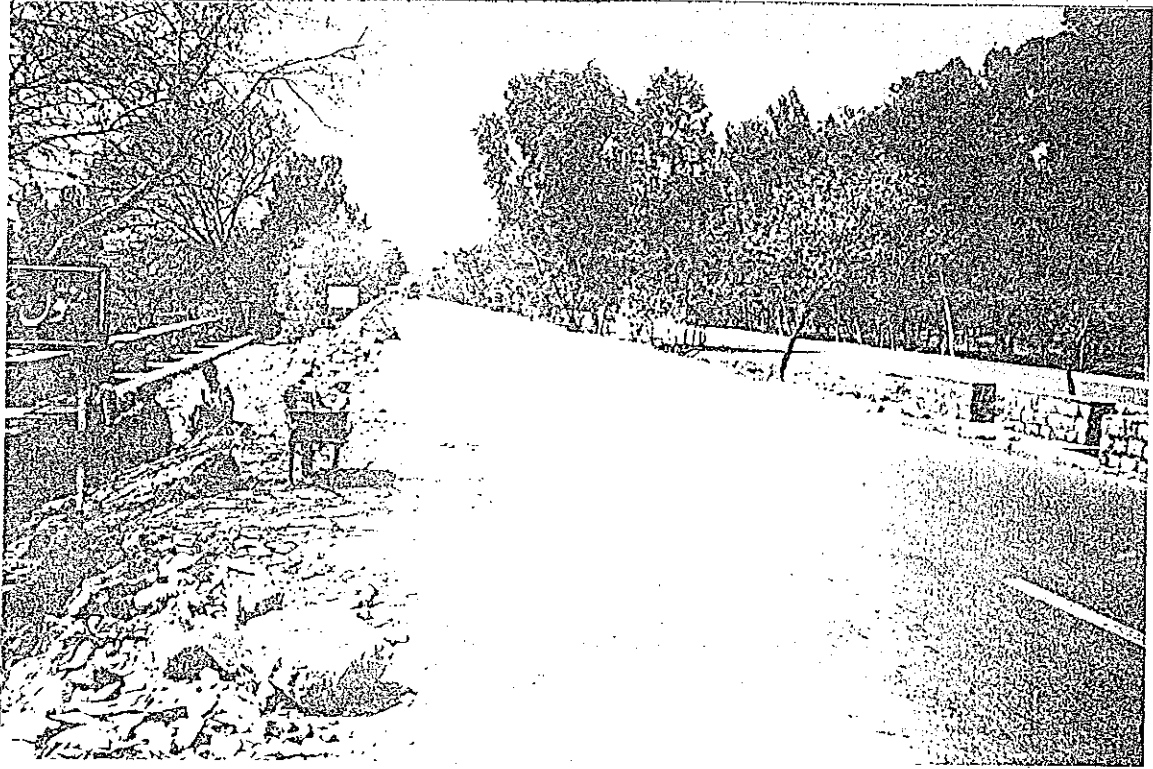
(Photograph 2.2)

1. Construction material dumped on the road thereby reducing right of way and causing traffic hazard.

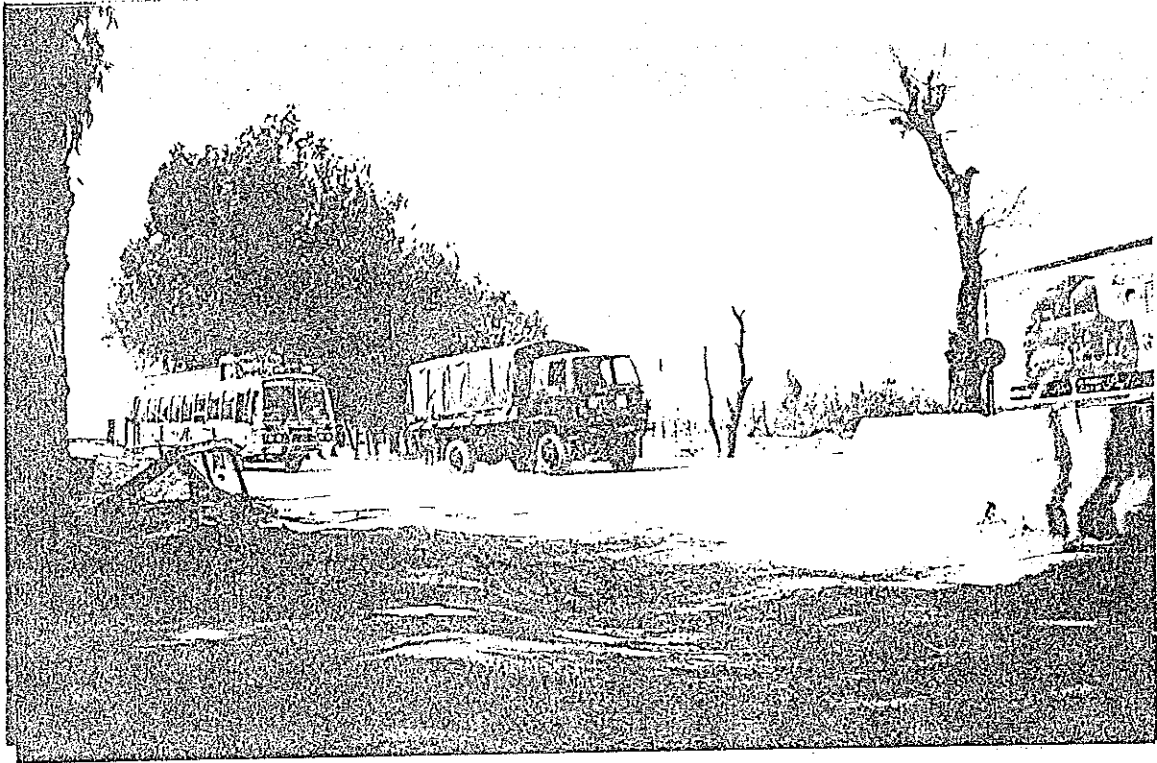
(Photograph 2.3.1.a)

1. This is the worst section of the road. The road is completely broken and during rainy season it becomes slushy. Therefore, creating complete traffic jam.

- It is recommended that road should be constructed and shoulders of proper width should be added so that the traffic can pass smoothly. The under construction 4 lane overhead bridge would be completed in the near future, therefore, it is expected that the congestion would be eliminated and smooth flow would be quite possible.
- The M/s. CPECC may be asked to assist traffic Police in case of traffic emergencies as they are equipped with heavy cranes.
- Drainage must be improved by providing proper side drains.
- Strict enforcement of traffic rules is necessary.
- Drivers must be penalised for parallel parking of vehicles when the crossing closes.

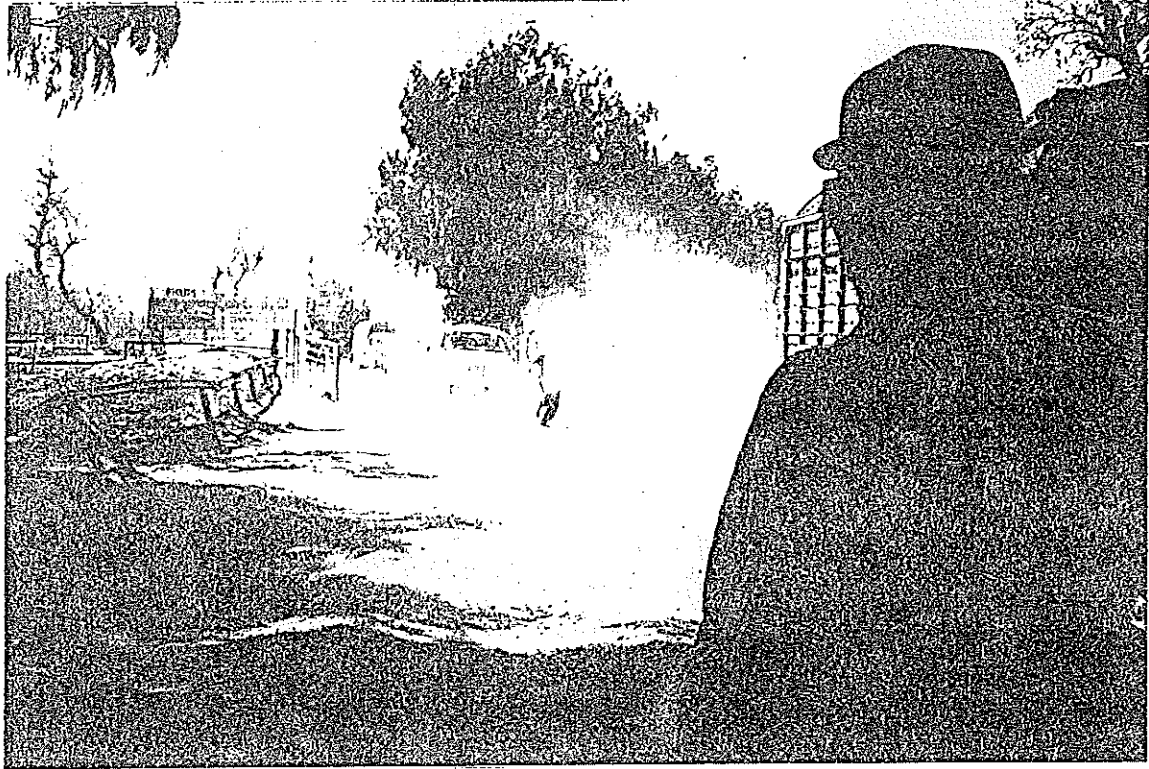
(Photograph 2.3.1.b)

1. The dilapidated condition of the road is clearly visible. Due to bumpy condition, the vehicles take too much time to cross this section.

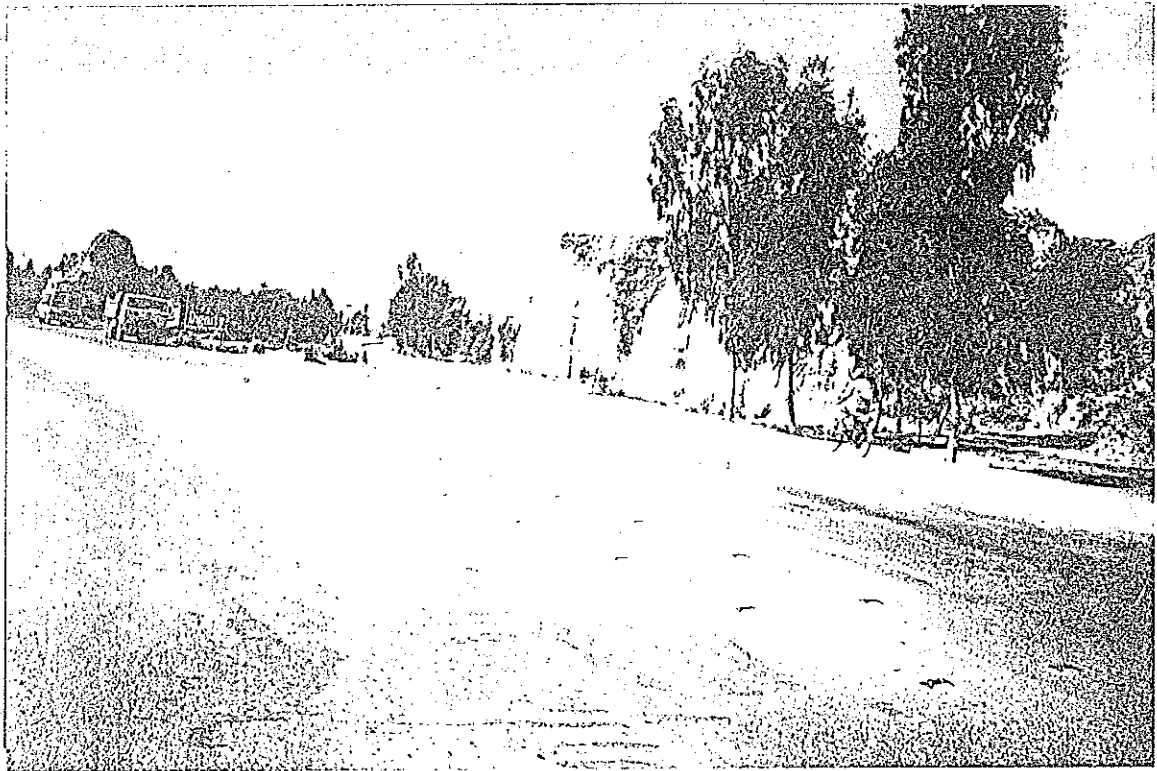
(Photograph 2.5.1)

1. No traffic sign or barrier to guide the drivers onto the new bridge.
2. Similarly, no sign warning drivers not to use old road.

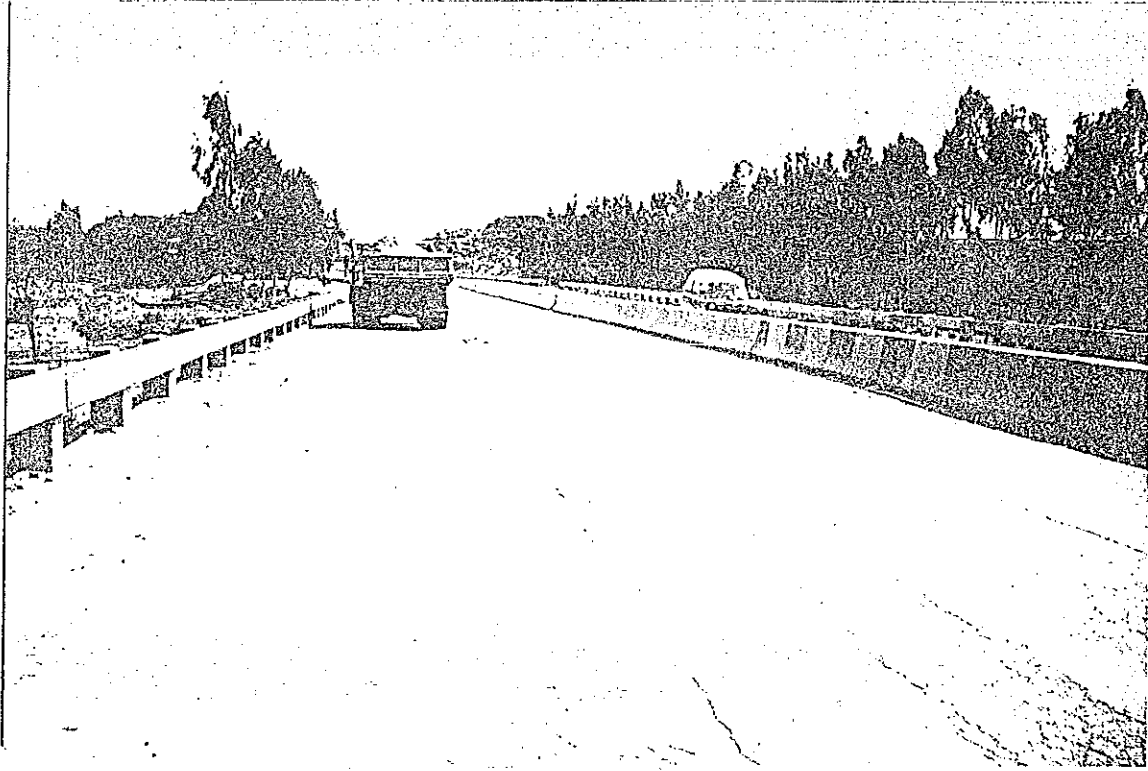
(Photograph - 2.5.2)

1. A broken vehicle is parked on the road without any warning sign.

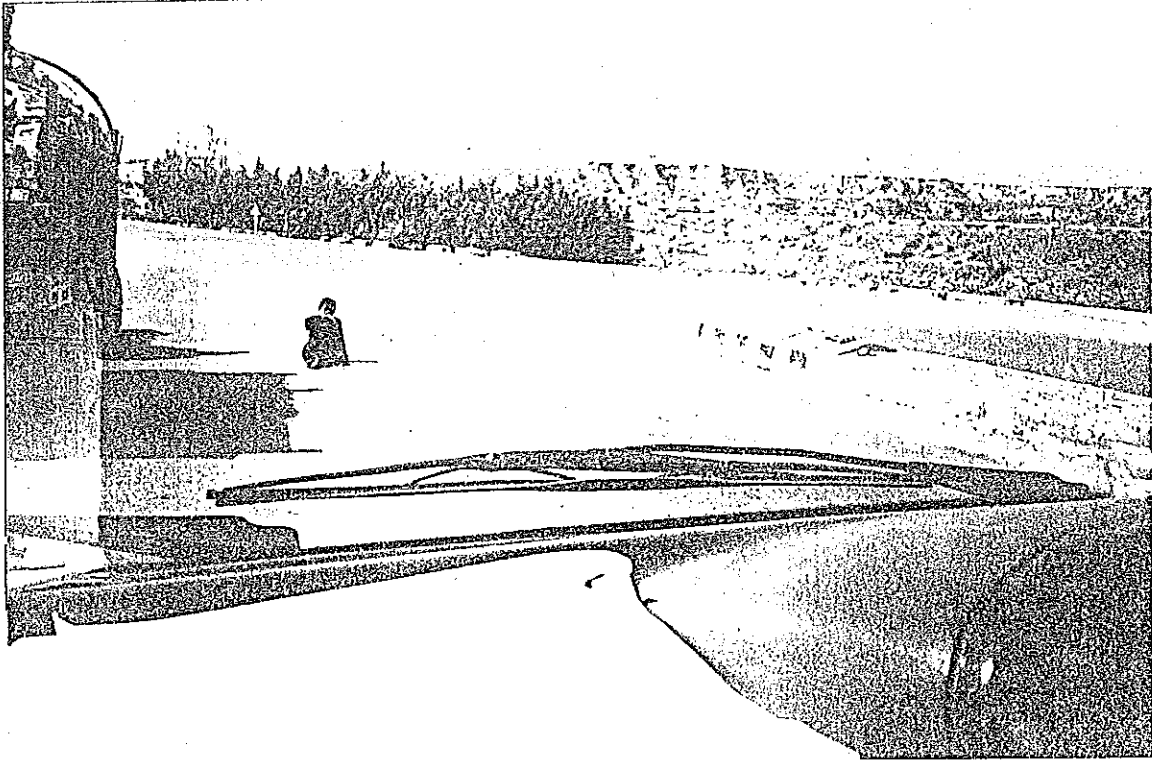
(Photograph 2.5.3)

1. A disabled boy begging in the middle of the road..

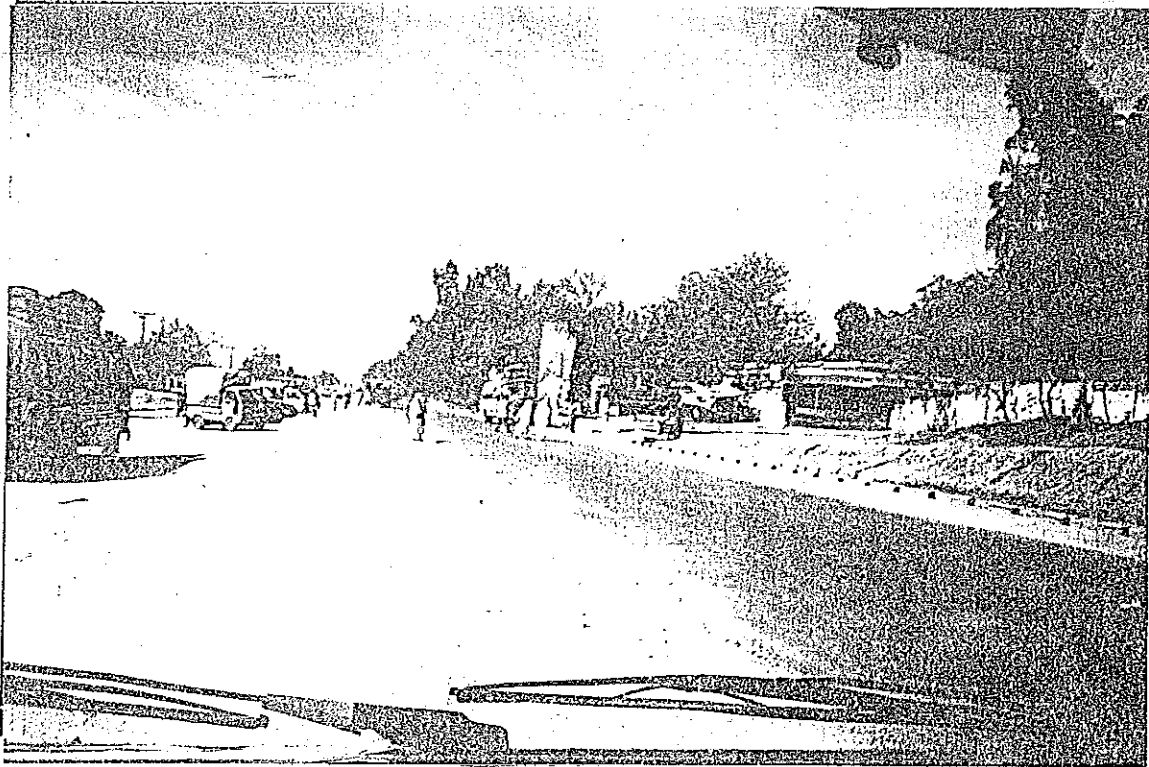
(Photograph 2.6)

1. On road Suzuki Stand.
2. No proper bus bays and on road embarking and disembarking of passengers.
3. No proper pedestrian crossing.
4. Not properly designed intersection.

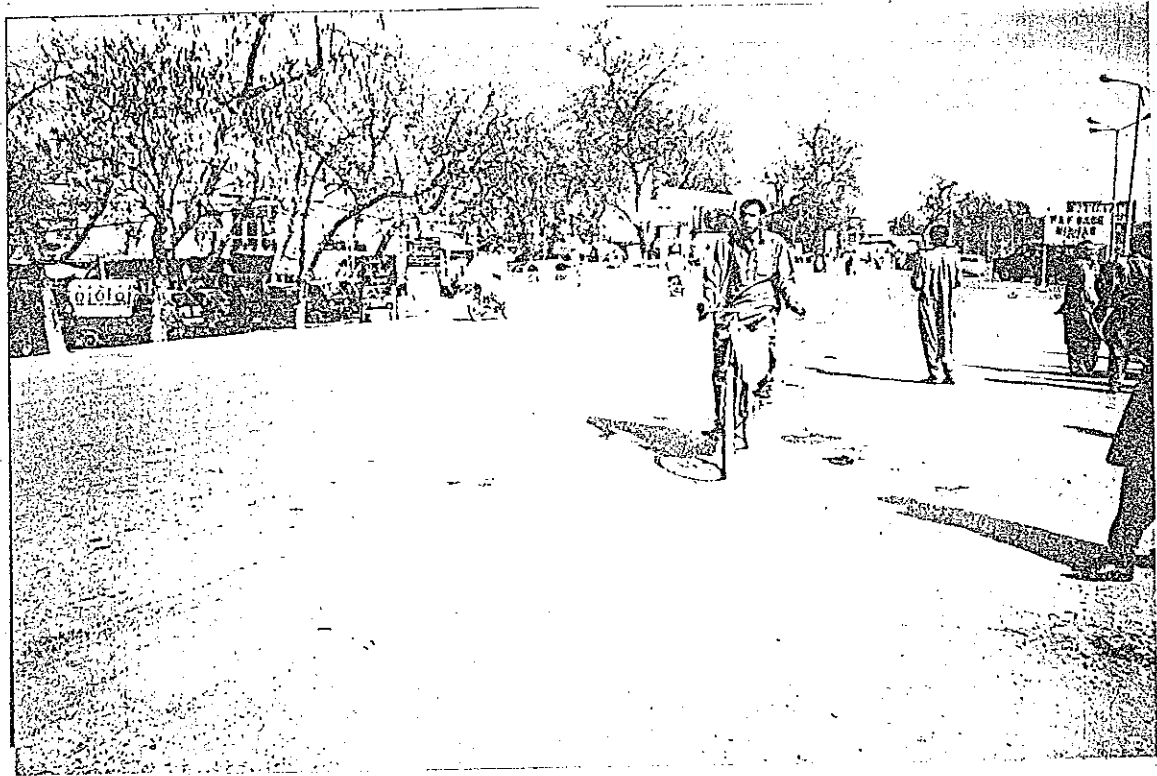
(Photograph 2.8.1)

1. Suzuki stand just adjacent to the main road.
2. Main highway being used by residents as city road.
3. *Poorly designed interactions.*

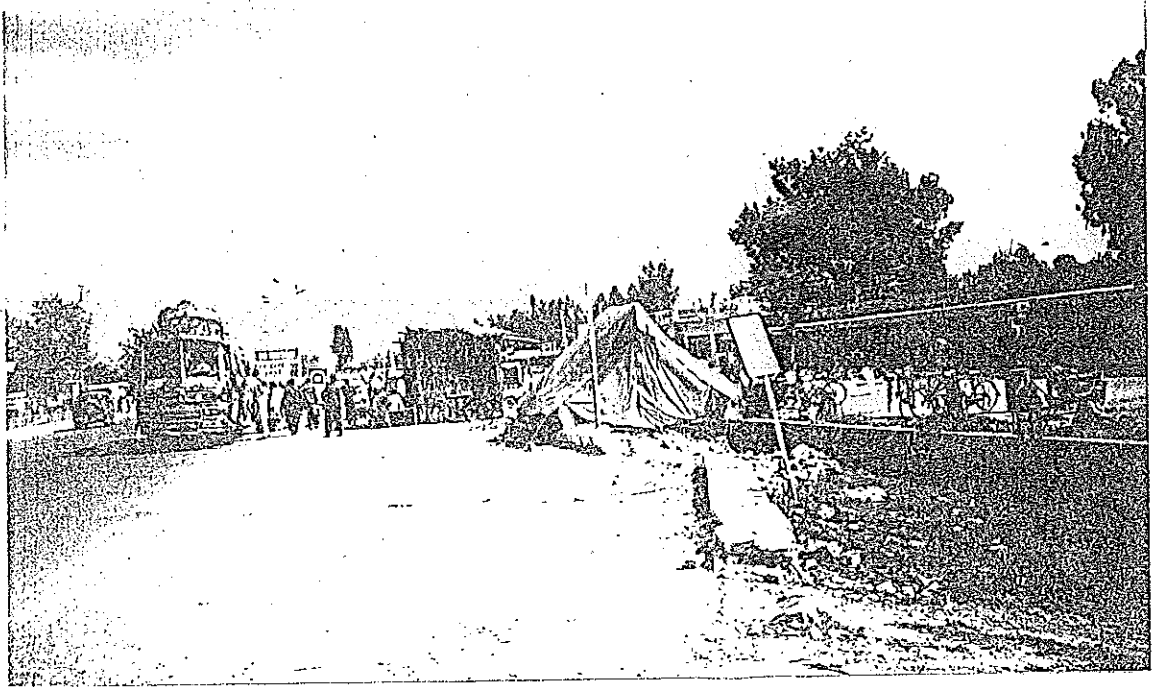
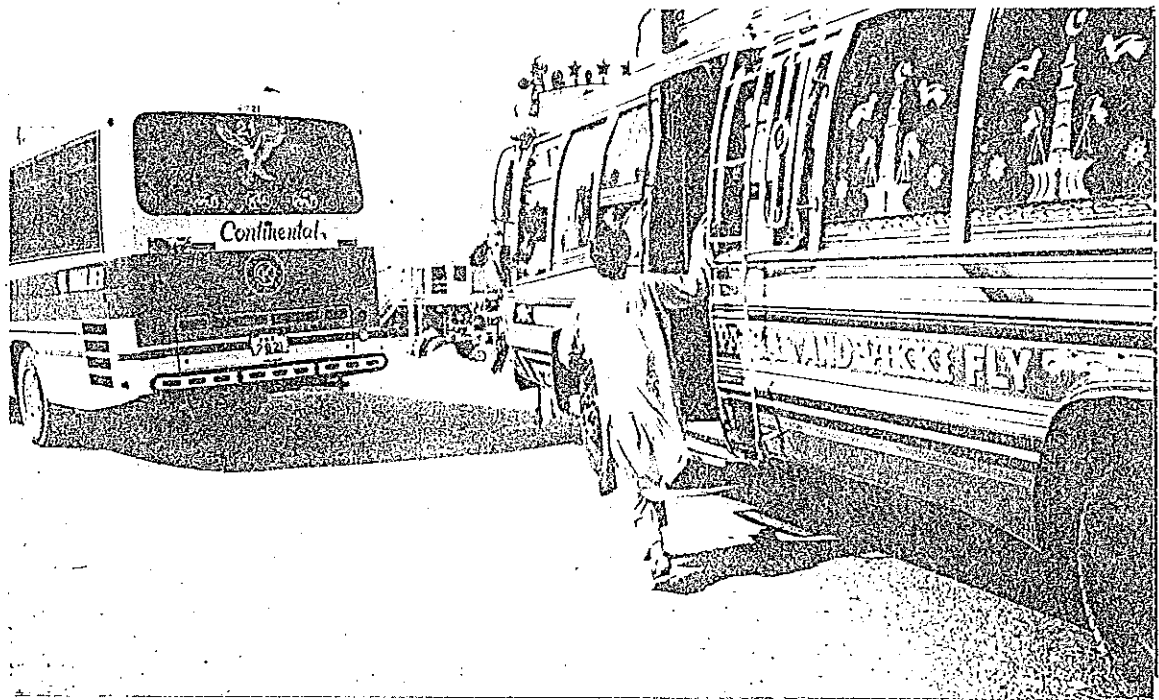
(Photograph 2.8.2)

1. No use of bus bay facility. On road embarking and disembarking of passengers.

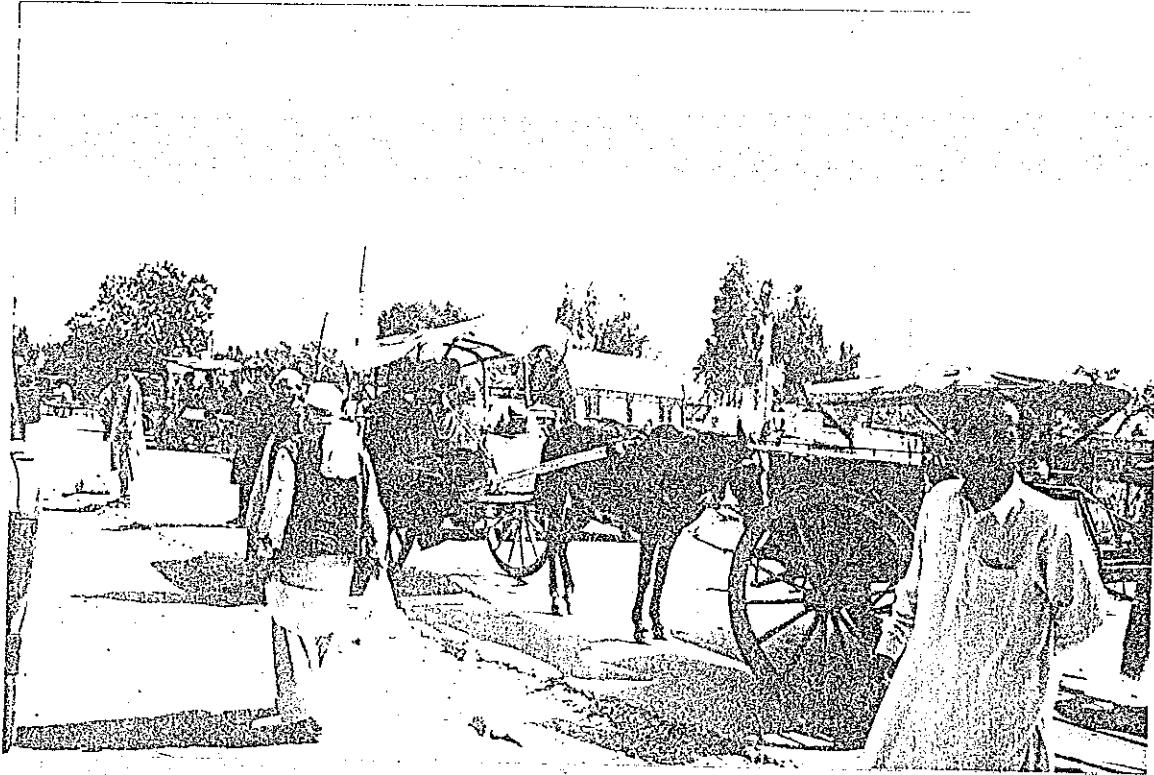
(Photograph 2.11.1)

1. On road tonga stand.

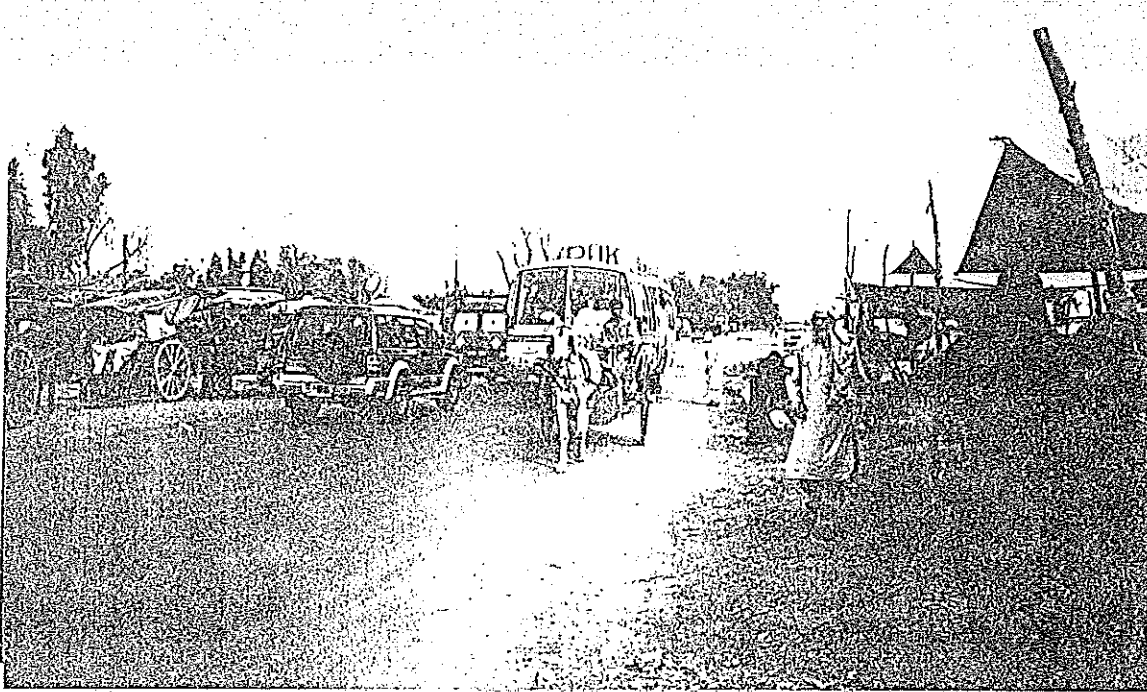
(Photograph 2.11.2)

1. Reduced width of right of way.
2. Mixed traffic on main road.
3. Highway being used as city road.

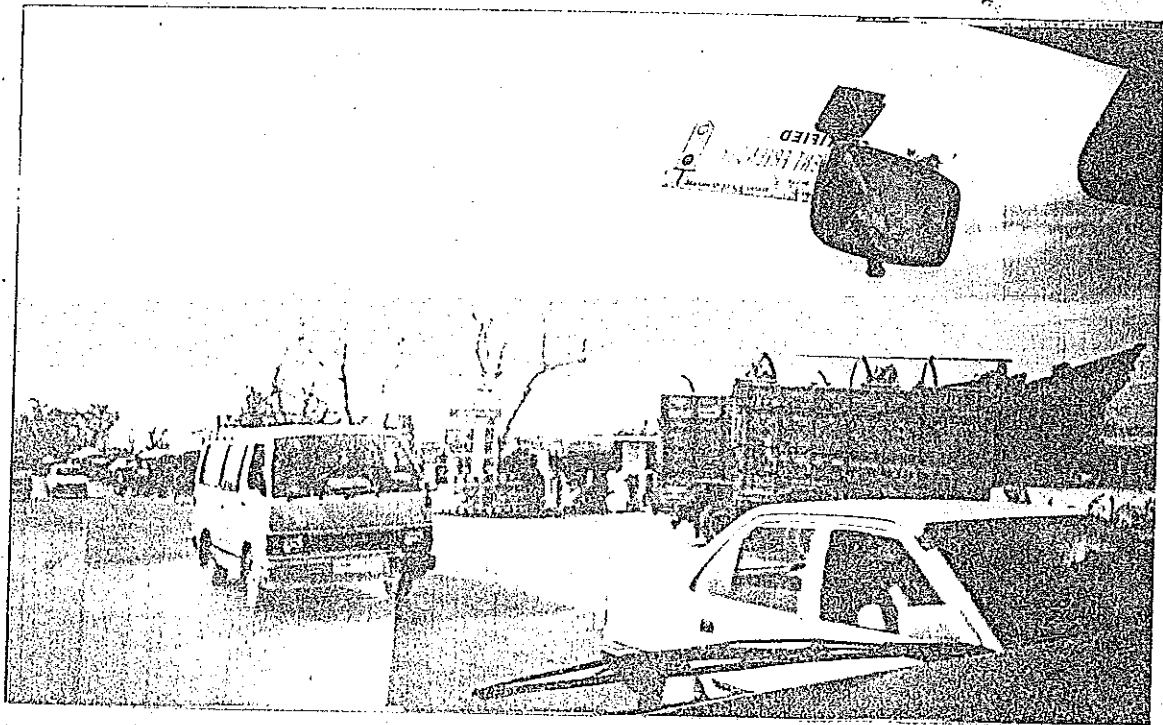
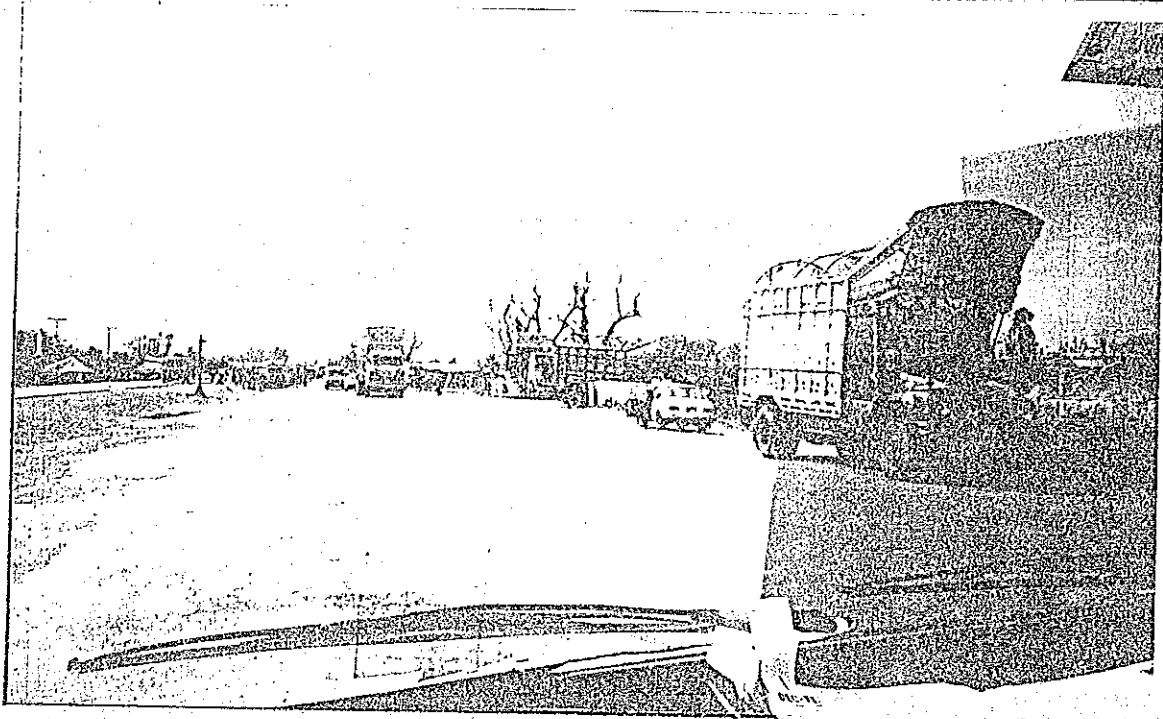
(Photograph 2.11.3)

1. Vehicles parked along with the main road.

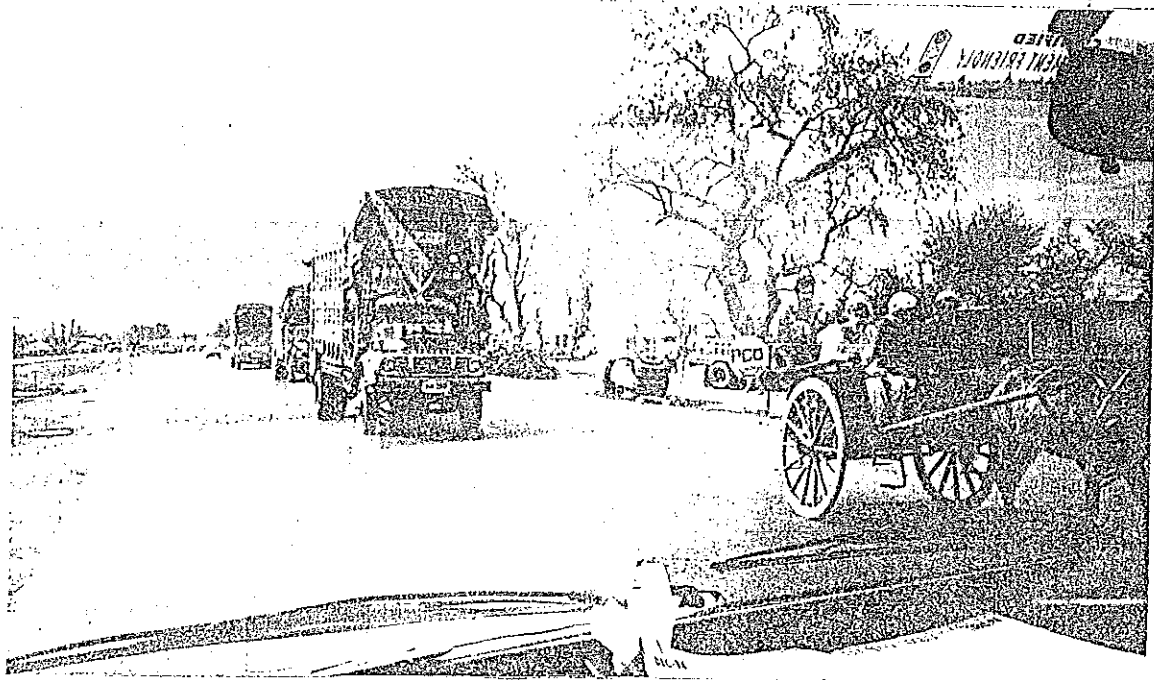
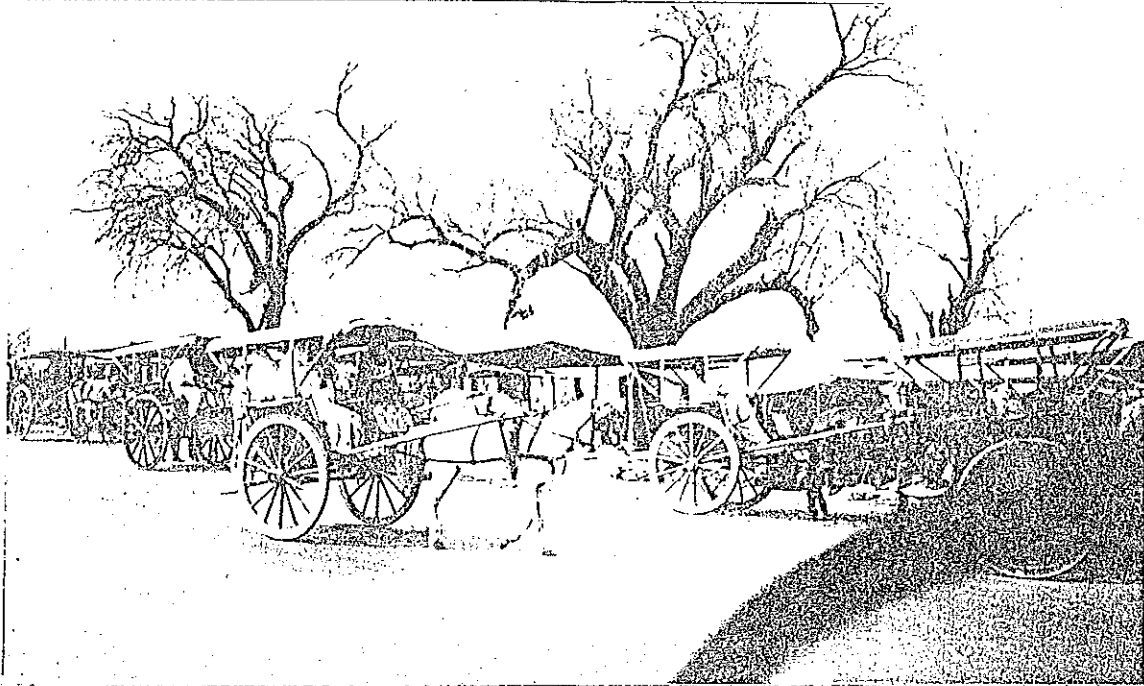
(Photograph 2.11.4)

1. Traffic hazard due to tongas.

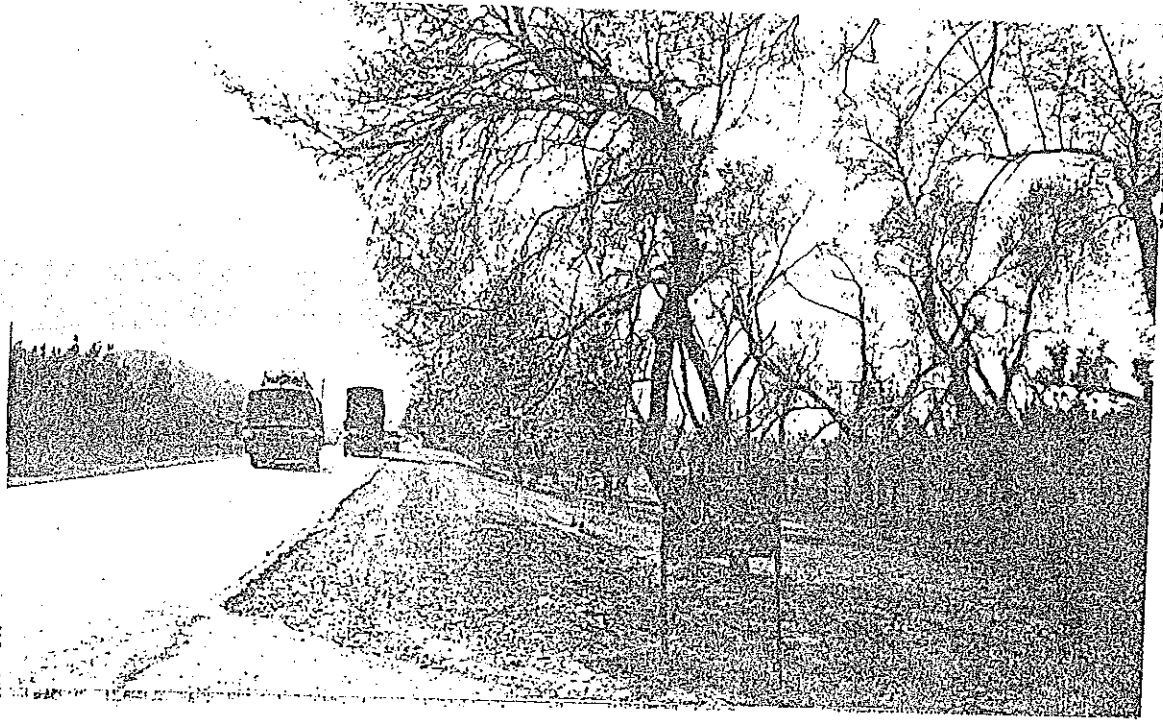
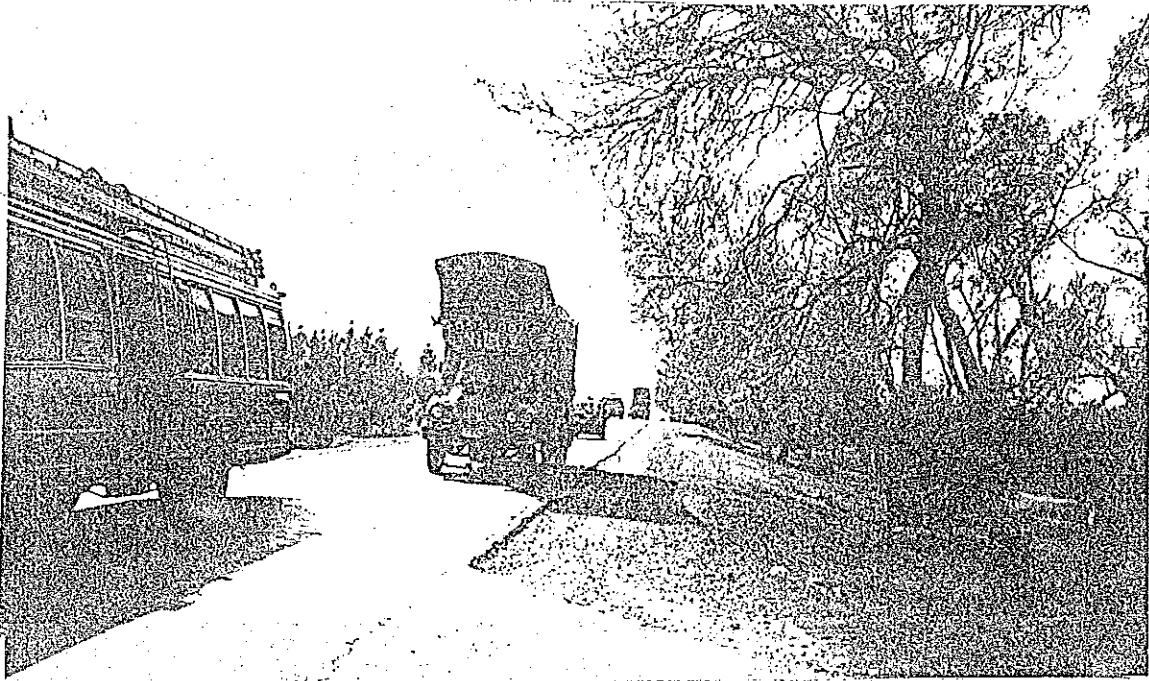
(Photograph 2.12)

1. No road sign indicating T-Junction.
2. Poor condition of the shoulders.

- The intersection must be properly designed and signalised and warning signs must be fixed at appropriate location.
- It is expected that this section will be dualized in the near future and the accident ratio would be considerably reduced.
- Routine traffic monitoring is very important to check the traffic violations e.g. over speeding, negligent driving, etc. Missing/necessary traffic signs must be installed.
- Shoulders must be levelled and properly sloped.
- Drainage must be improved by providing proper side drains.
- Proper pedestrian crossings must be provided.
- Strict enforcement of traffic rules is most important, as wrong overtaking and high speeds are very common on such "Open" sections.
