NATIONAL TRANSPORT RESEARCH CENTRE

ACCIDENT BLACK SPOTS STUDY

NATIONAL HIGHWAY (N-5)

HASANABDAL - ATTOCK

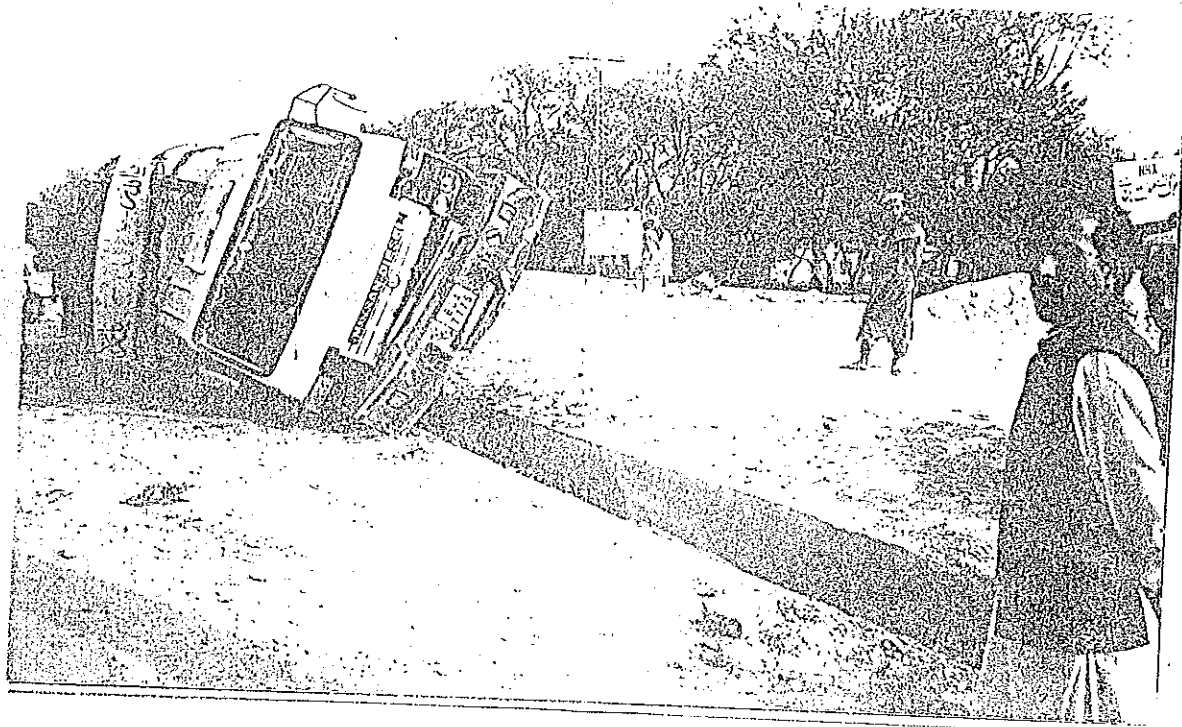
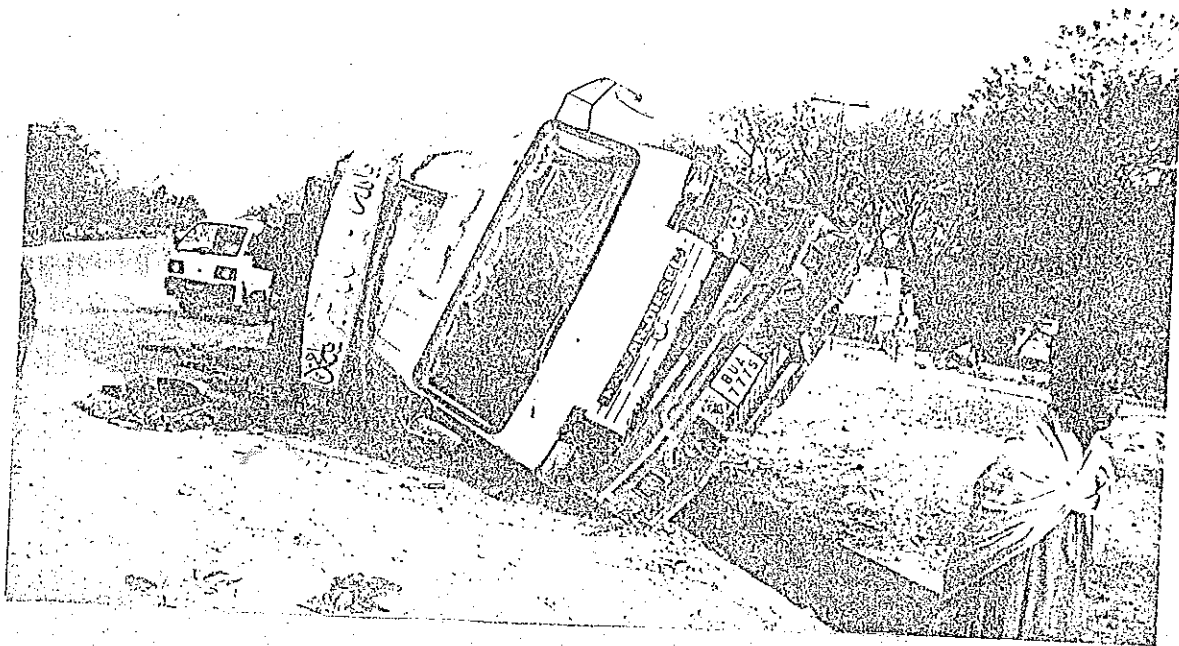
(Photograph 3.2)

Due to dualisation of highway, a diversion was provided on the highway section but the warning sign was fixed at the start of the diversion. The truck going from the one direction took a long turn and strayed into the opposite lane and to avoid collision took a sharp turn and skided into the ditch and overturned but a major loss of life was averted. Observers at the scene described the driver as "sleepy" and blamed the driver for negligent driving, therefore, diversions must be properly designed and constructed rather than simply cleared off shrubs and be opened to traffic. Traffic at such diversions must be separated to a certain distance to avoid head on collisions, as shown in the sketch.

1. A view of the overturned oil tanker.
