NATIONAL TRANSPORT RESEARCH CENTRE

CONDITION SURVEY
OF
ISLAMABAD RUNWAY PAVEMENT

NTRC-230

December, 2000

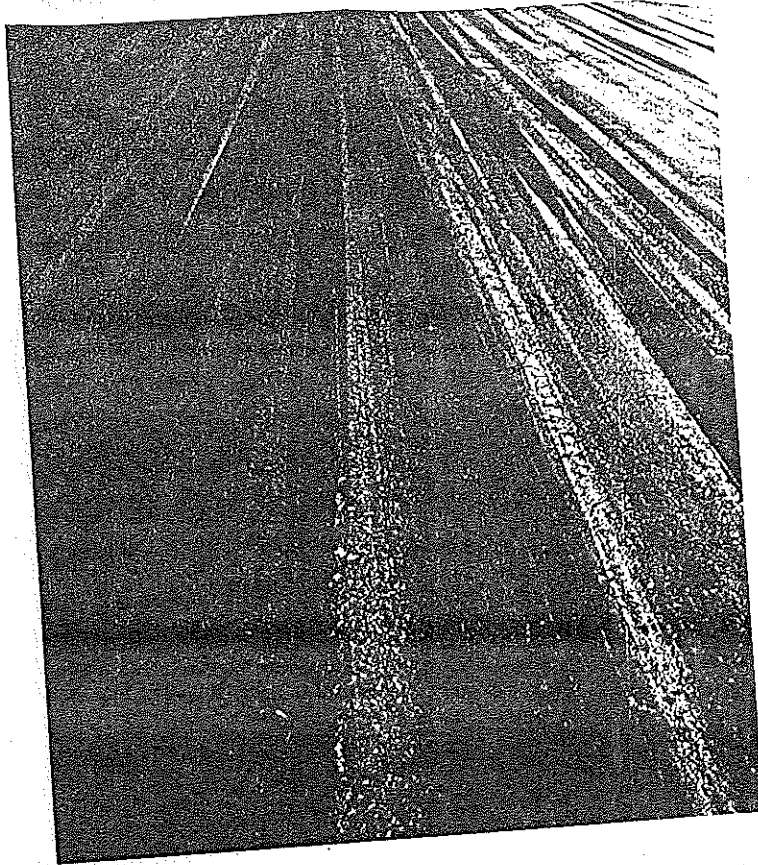
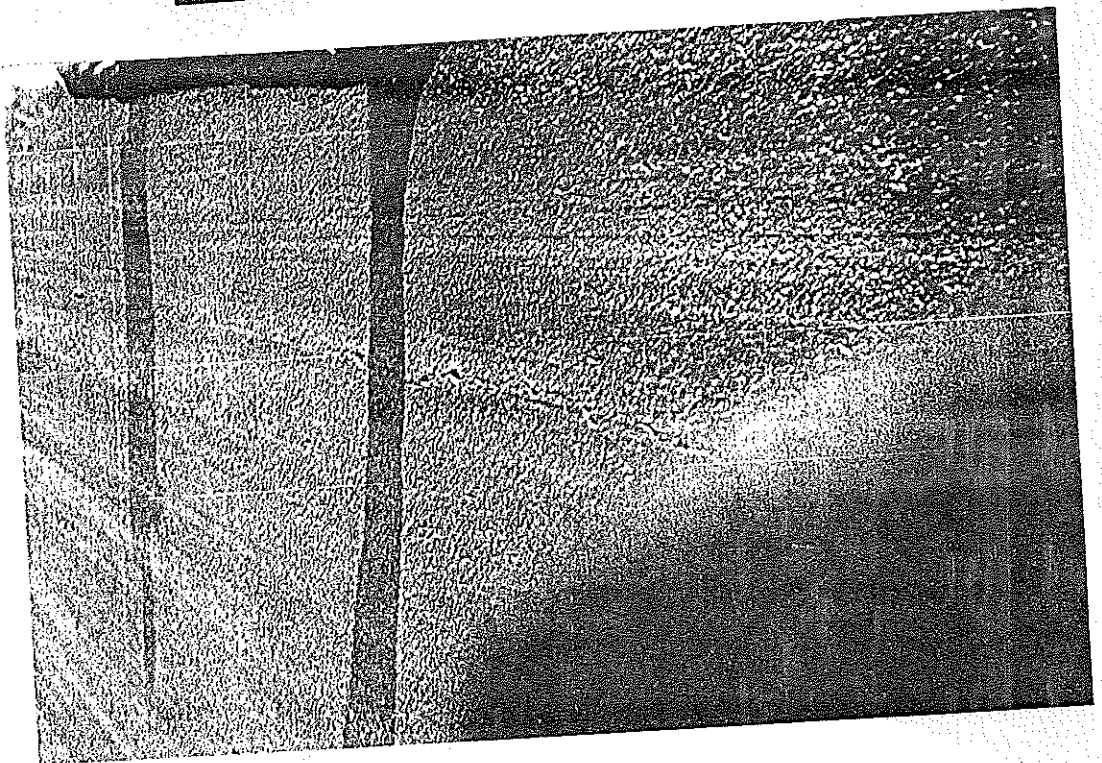
- a) Longitudinal cracks of high severity were found in 2000 feet of the main runway length whereas 3400 feet falls in the medium severity and 3500 feet were rated as low severity distress.

Photo 1 - 2 : Longitudinal Cracks in the Pavement

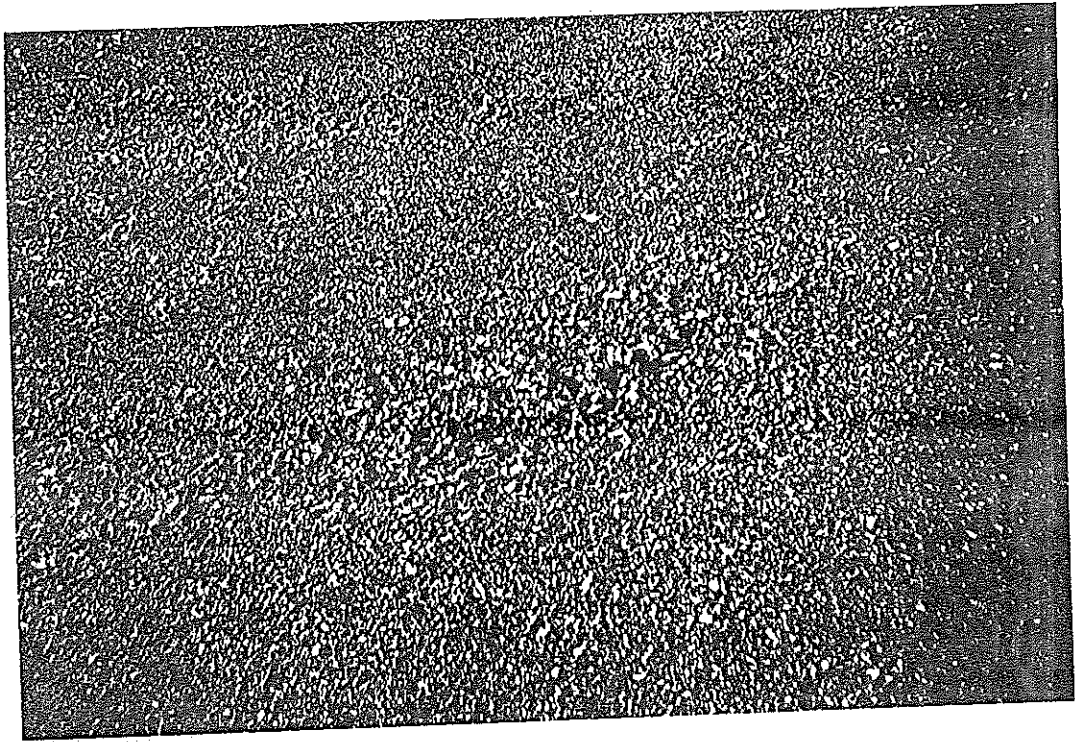
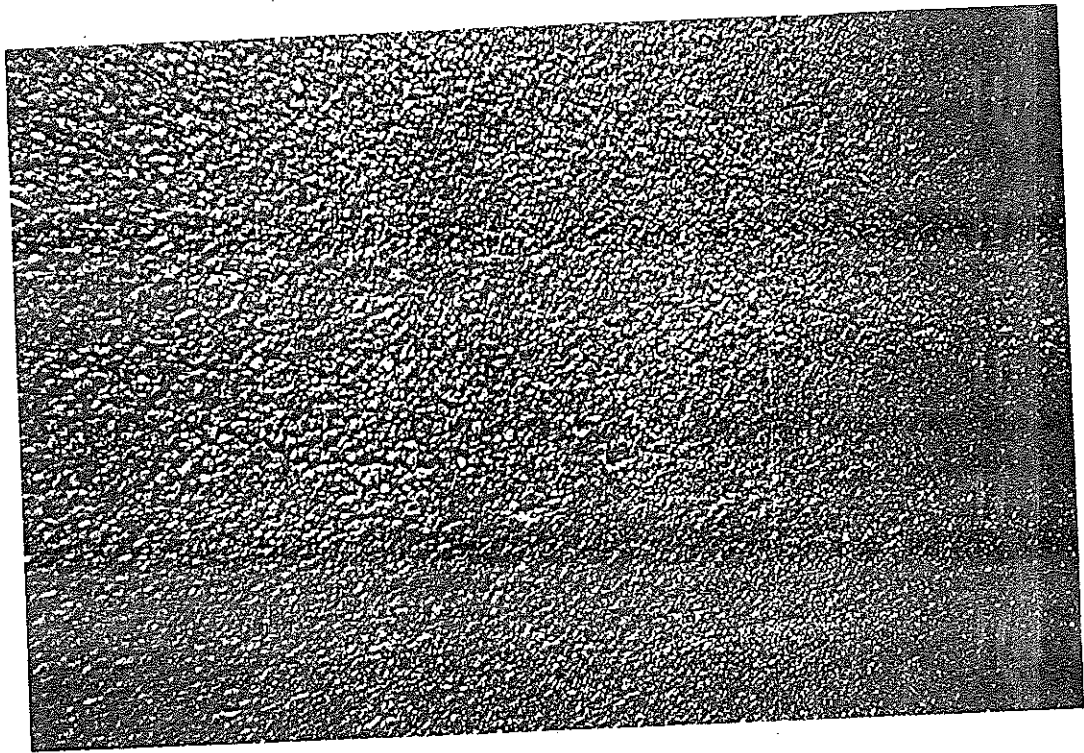
Photo 3 - 4 : Longitudinal Cracks with Raveled Surface

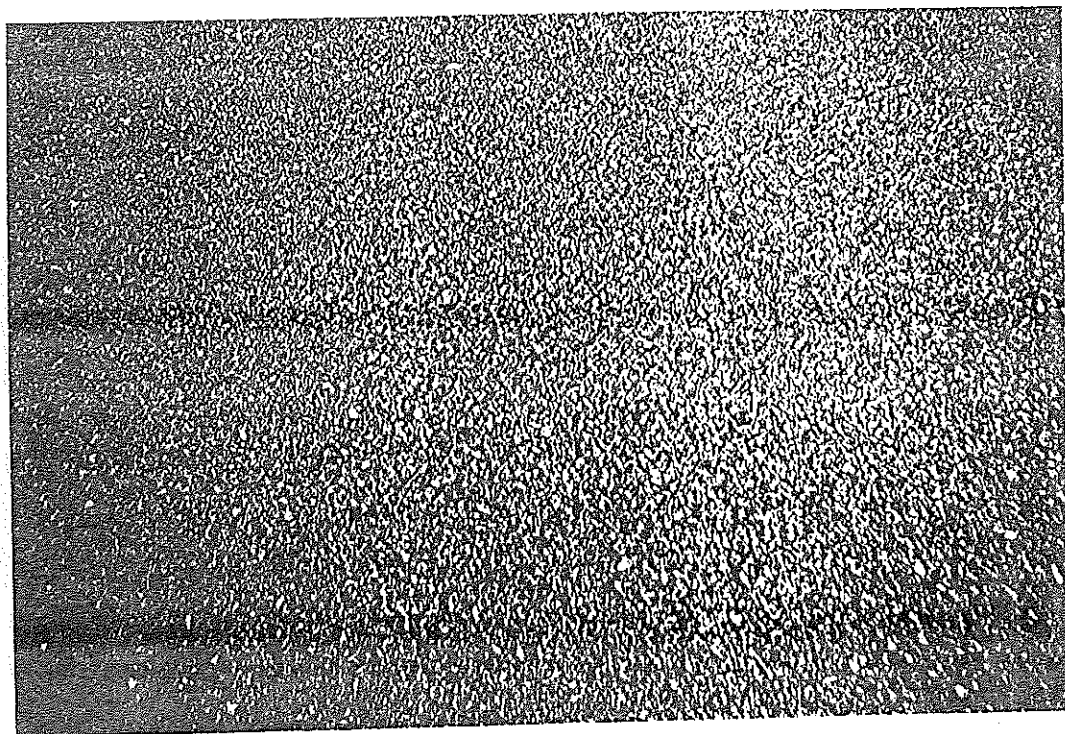
- c) Almost 60 percent of the main runway pavement length was found with medium severity of ravelling/ weathering whereas only 1500 feet was observed with high severity.

Photo 9 : Typical Weathered and Raveled Surface

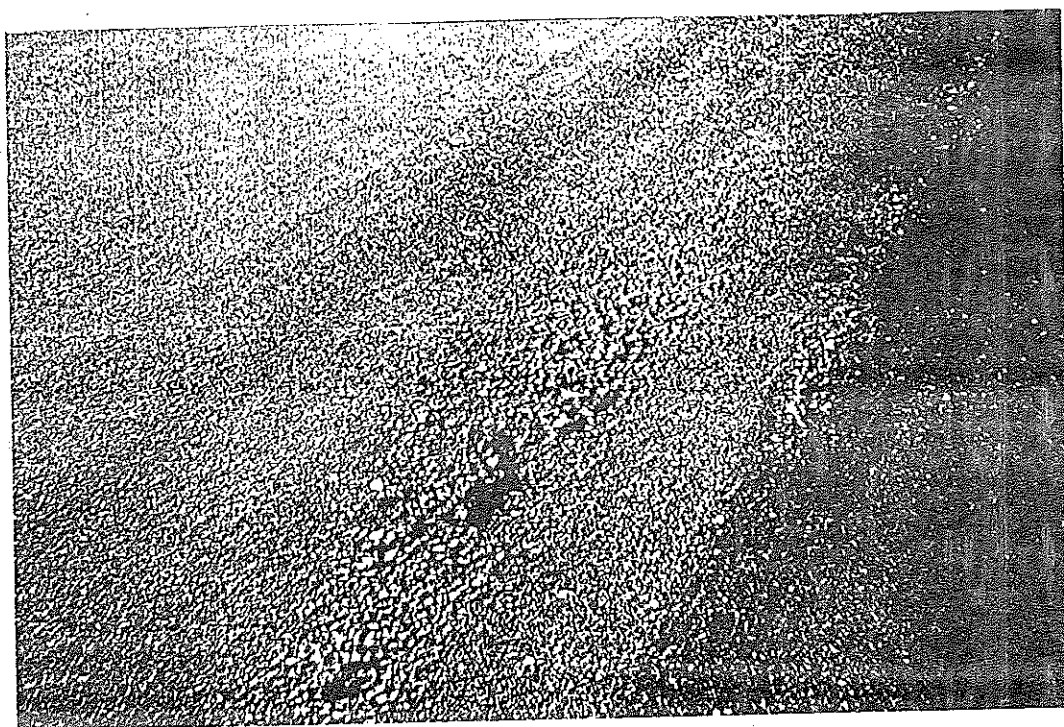
Photo 10 : Raveled Surface with Sign of Longitudinal Cracks

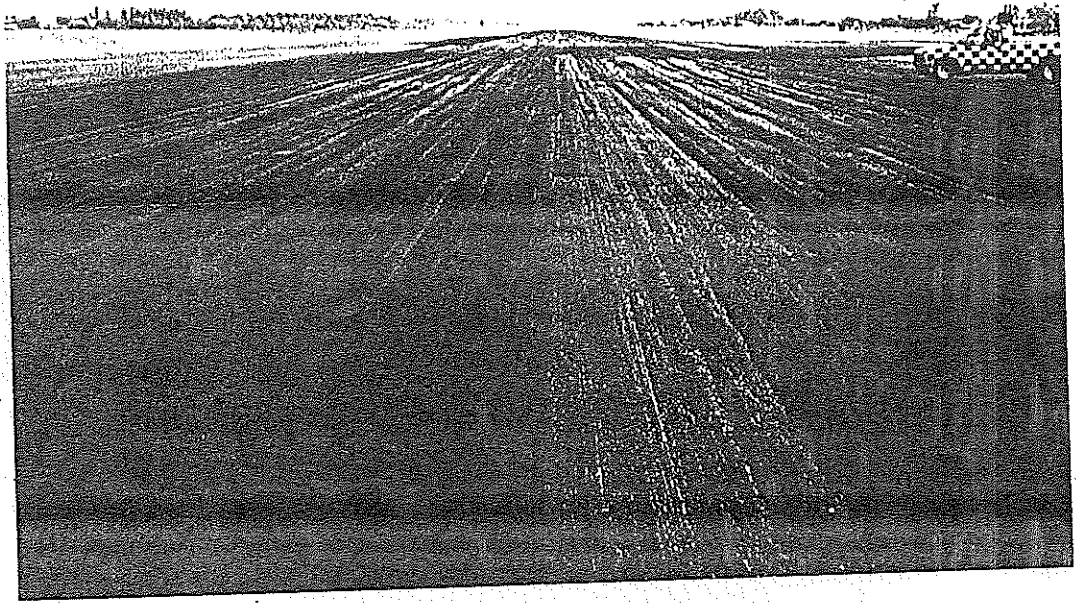
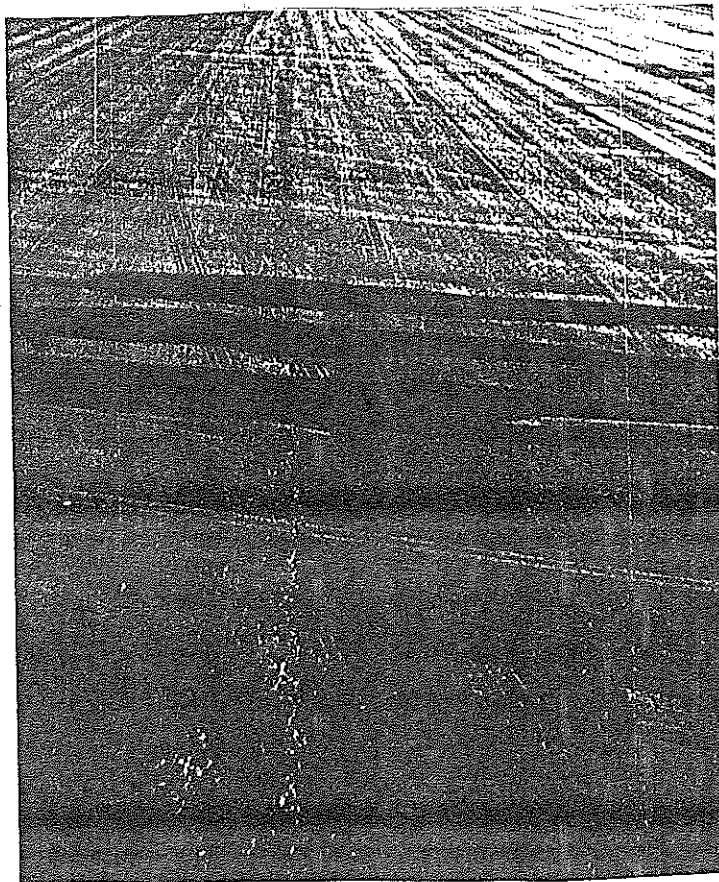
- d) Half of the main runway pavement length was found with the low severity of rutting, however almost 2000 feet of runway length was identified with medium to high severity level of rutting.

Photo 11 - 12 : Pavement with Sign of Rutting

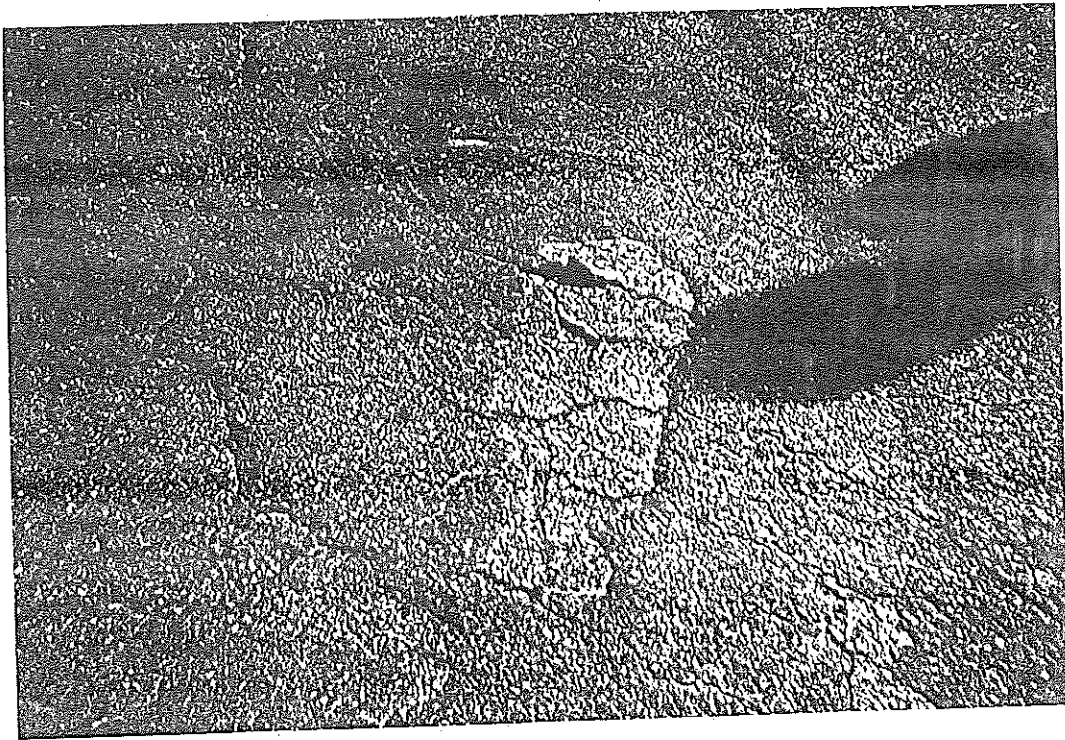
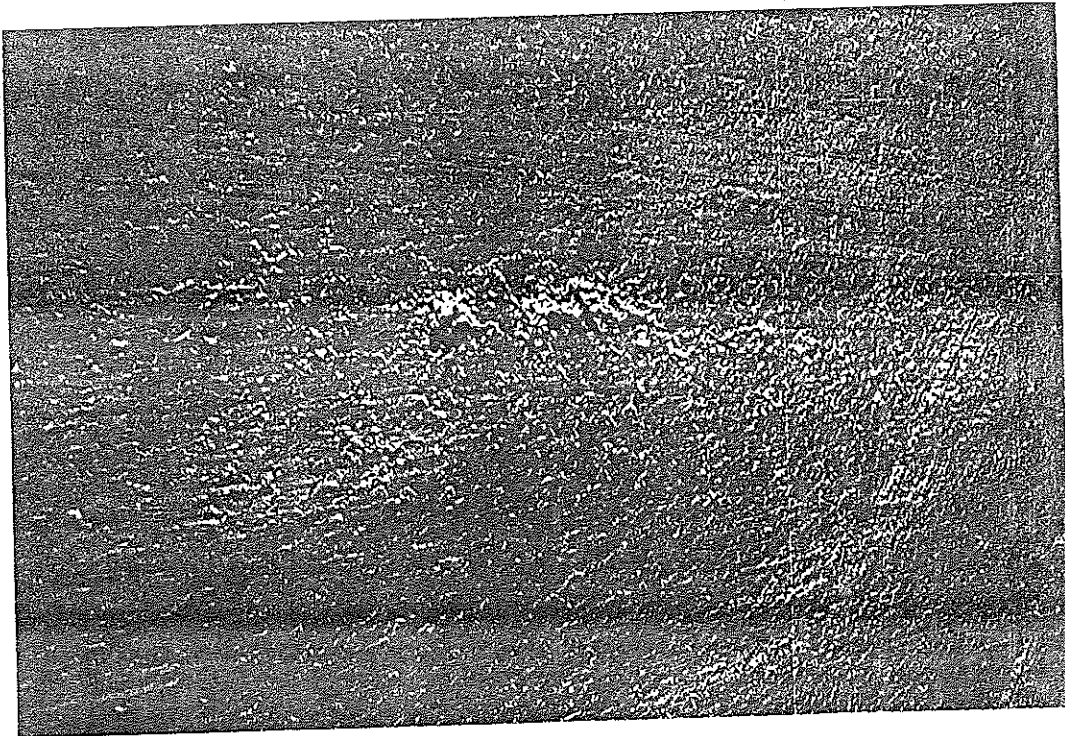
- e) Slippage cracks on 500 feet length of runway with medium to high severity level was also notice.
- f) The 1100 feet length of the extended pavement at the 1-2 end of the main runway was reportedly constructed using 4" asphaltic concrete layer over compacted brick ballast base course shows some sign of distresses.

Photo 13 - 14 : Typical Slippage Crack
