NATIONAL TRANSPORT RESEARCH CENTRE

DISTRESS ANALYSIS
OF
KASHMIR HIGHWAY

NTRC-215

April, 2000

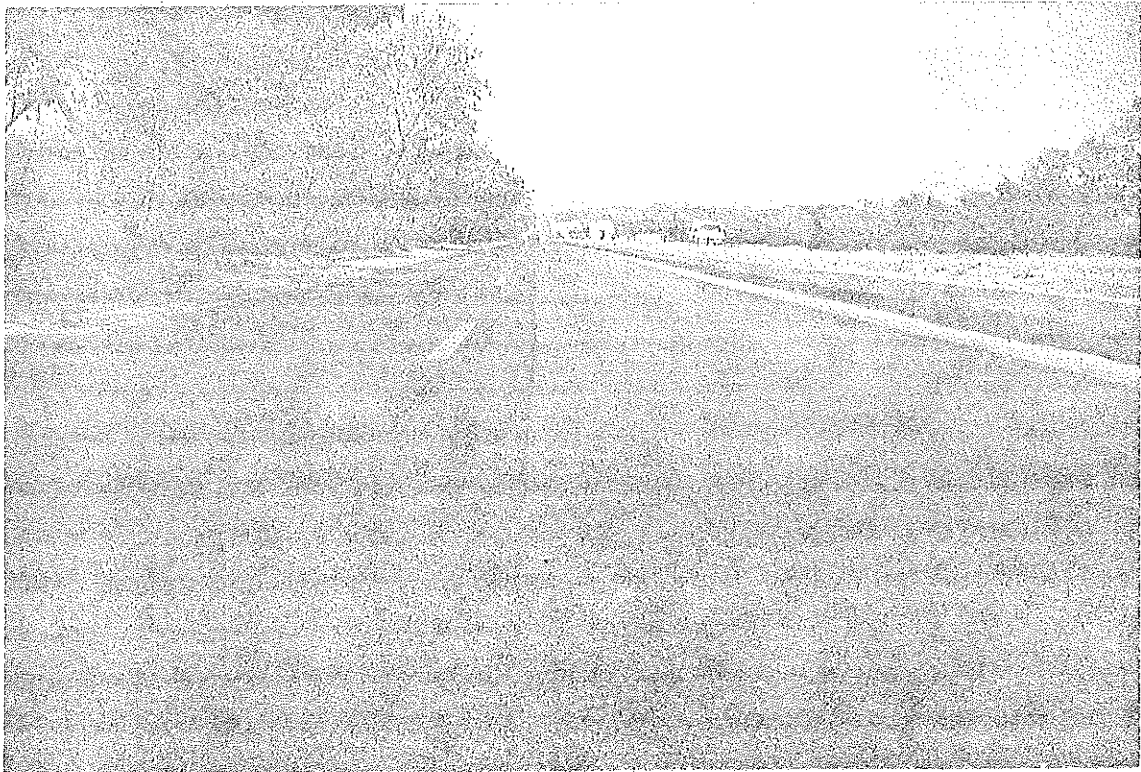
Plate 7.1(a) Completely milled outer lane of the old highway, exposing the texture to weathering. Polished surface of 2nd lane is also detectable.

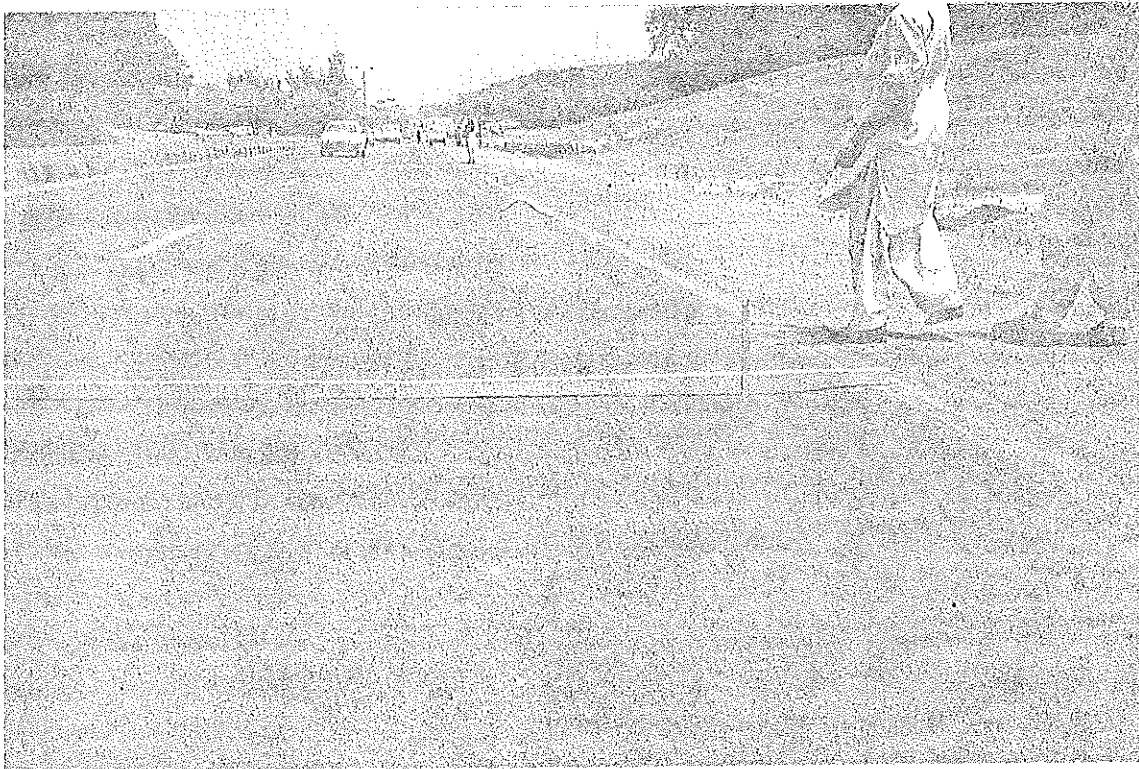
Plate 7.1(b) Partially milled outer lane of New Carriageway

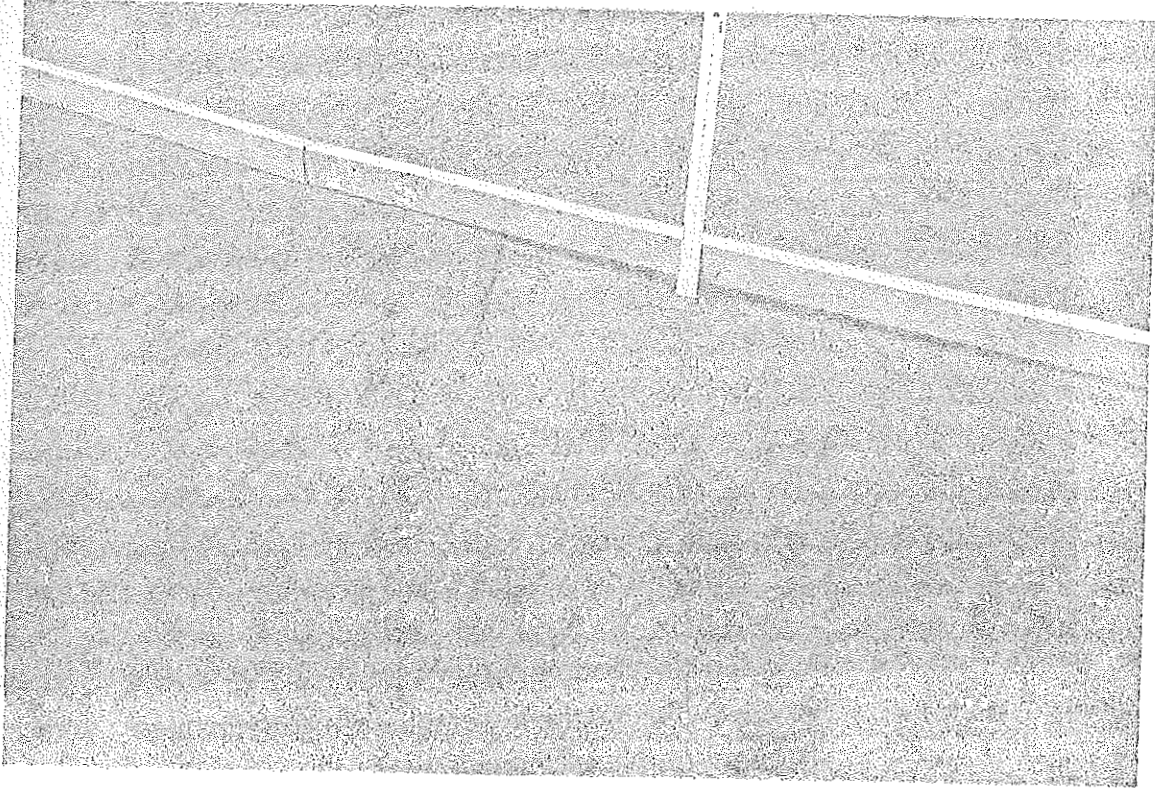
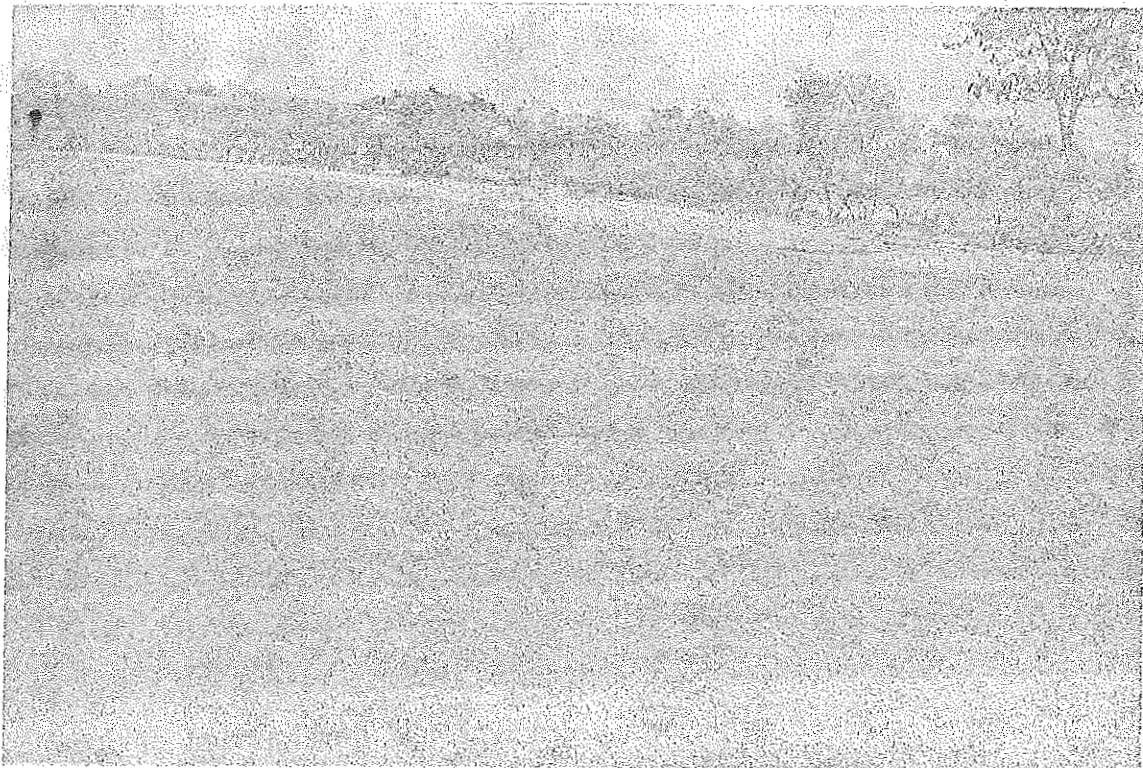
Signs of alligator and fatigue cracking, a series of interconnecting cracks caused by asphalt concrete failure, were observed on eight locations of the new highway. The cracks were of low severity at two locations and were of high severity at six sites and were spread over a large area of 15 meter to 30 meter in length. These cracks were located in the truck lane. While on the old highway, six locations were found to be severely cracked. Nearly a quarter of the outer lane of the old highway had been patched and half had been milled. This patching is spread over a number of sections of 25 meters to 200 meters long as shown in photographs 7.3-1 and 7.3-2.

- i) Passage of heavy axle loads caused excessive deflections/deformations of subbase and subgrade. Big part of these deflections/deformations were recovered after the removal of load as a 350 mm sub-base and 250

mm subgrade is quite resilient enough to bounce back. This fact is substantiated by high values of DCP results. But the bituminous pavement was not flexible enough due to low tensile strength to follow these deformations and hence alligator cracks have appeared.

- ii) Passage of heavy axle loads with high intensity of traffic at slow rates kept the pavement under stress for long periods. In such cases a major part of stress was relieved while a small part kept accumulating causing the pavement to crack (fatigue).

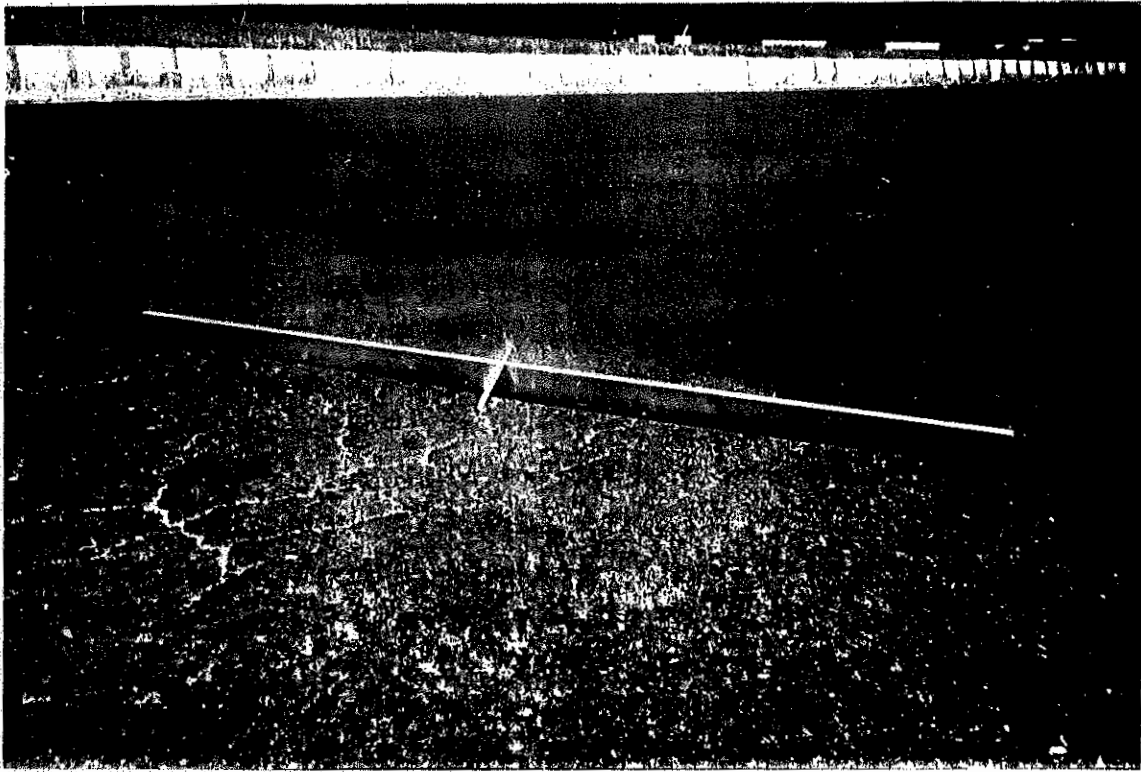
Plate 7.3-2(a) Severe wheel track cracking accompanied with severe stripping on New Carriageway.

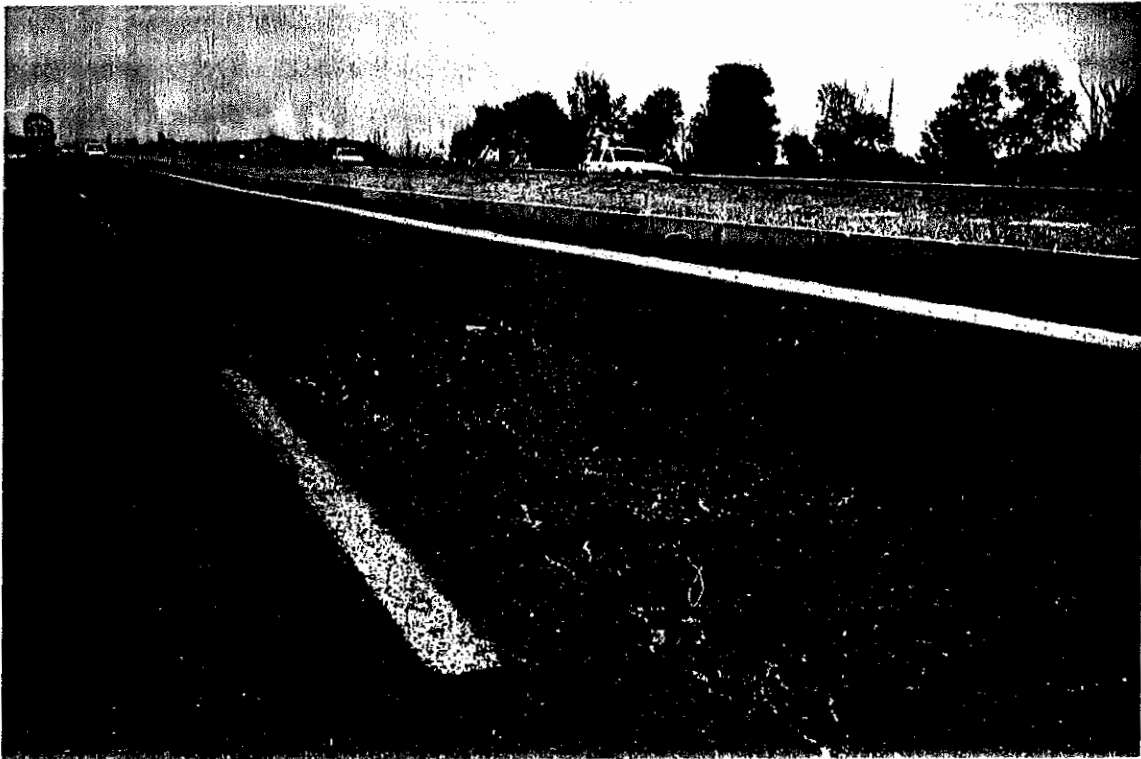
Plate 7.3-2(b) Severe wheel track cracking and development of potholes on Old Carriageway.

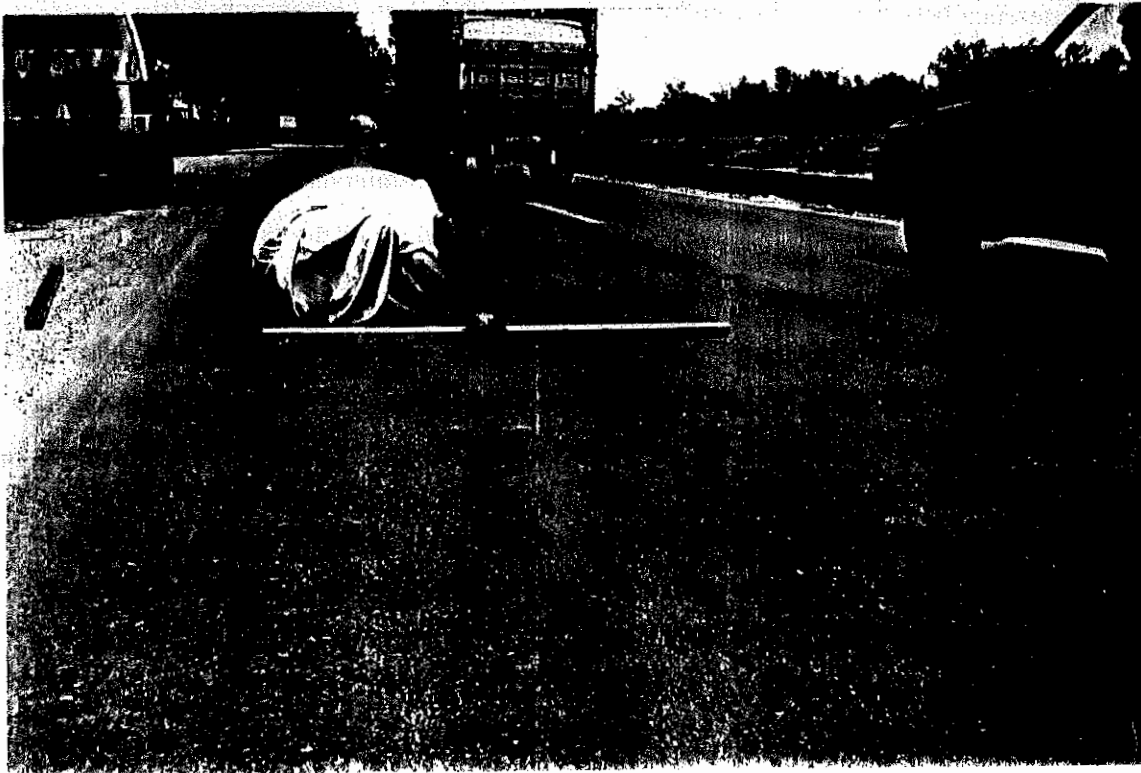
Bleeding or flushing, i.e. a film of bituminous material on the pavement surface was observed to have started at several locations of the new highway, while the old highway had many. Bleeding of asphalt over pavement surface has created a shiny, viscous glass like reflecting spots at the moment on the new highway. It appears that bleeding has been caused by secondary compaction of asphalt concrete by heavy commercial vehicles in hot weather, as the asphalt content in the plant mix was found well within the design range. The additional densification filled the voids and then flushed the bitumen to surface as shown in pictures. Bleeding may have also been caused by too heavy seal/tack coat. Bleeding is a great safety hazard and considerably reduces skid resistance of the pavement surface. This phenomenon is shown in photograph 7.5-1 & 2.

Plate 7.5-2 The rich surface texture provides ample evidence of bleeding on Old Carriageway.

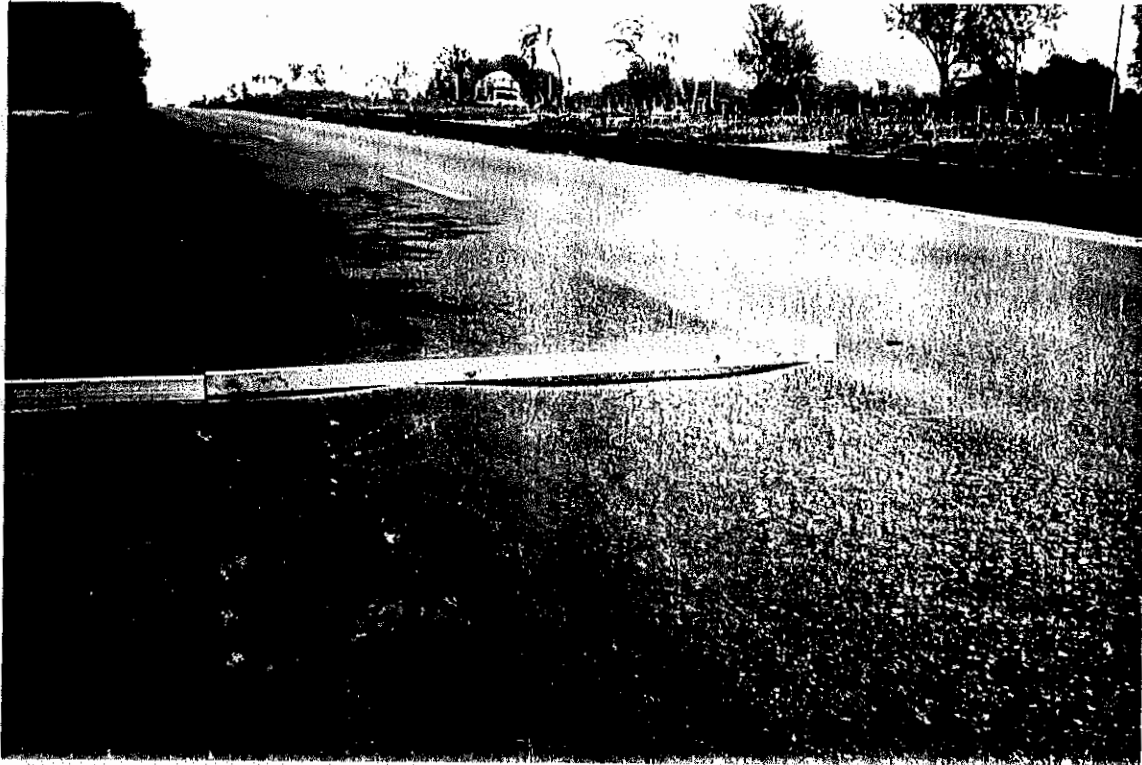
Plate 7.7-1

As corrugation usually occurs at a point where vehicles accelerate or decelerate, therefore, it was observed where trucks had to climb up the hill, take a sharp turn and had to stop. The severity was medium on the new carriageway while the old highway was severely effected at many places even at minor rises or decents, as shown in photograph 7.7-1 & 2.

High severity rutting. Material shoved along the both sides of the rutted wheel paths on Old Carriageway.

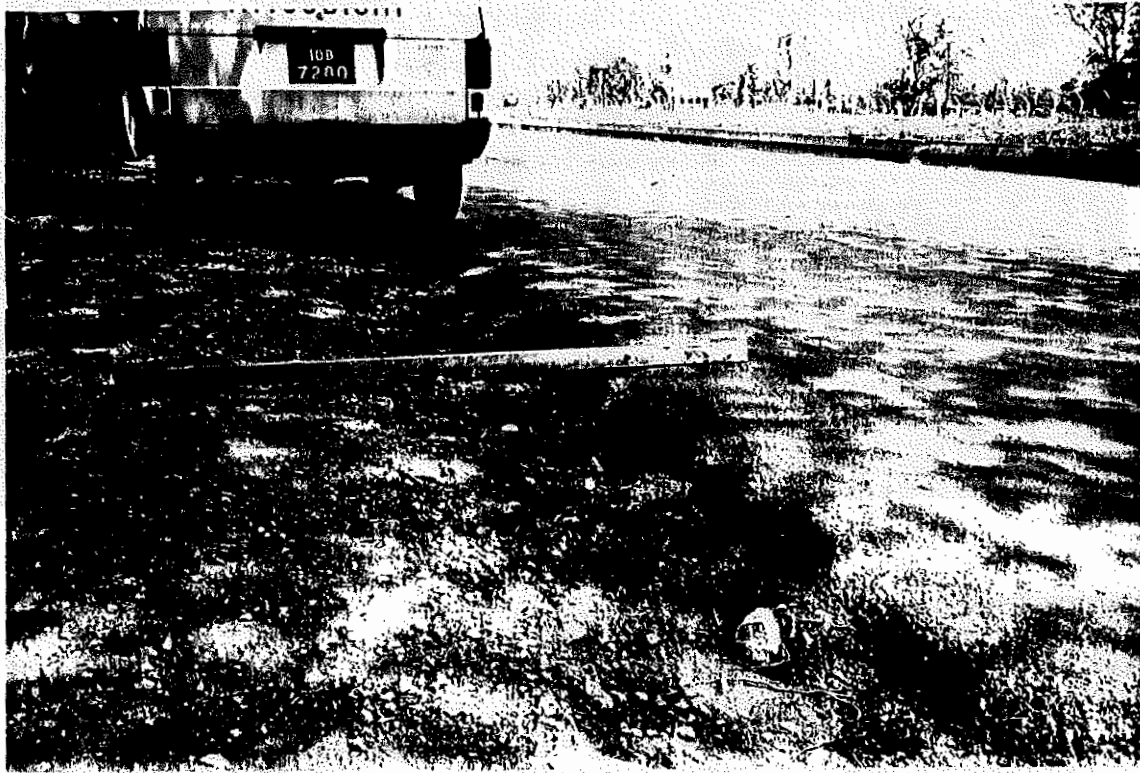
Plate 7.10

Signs of edge cracking were not observed in the new highway while the old highway had many. The probable cause was no lateral support and moisture difference between shoulder and pavements, as shown in photograph 7.10.

No difference of level in elevation between the traffic lane and shoulder were observed on the new highway. The shoulder of the new highway is treated one, while the old highway was through out its length had a difference of atleast 4" - 6" between the shoulder and the outer lane as shown in photograph 7.10. Repair work and construction of a paved shoulder was in progress.

An eight inch shoulder drop-off accompanied with edge cracking

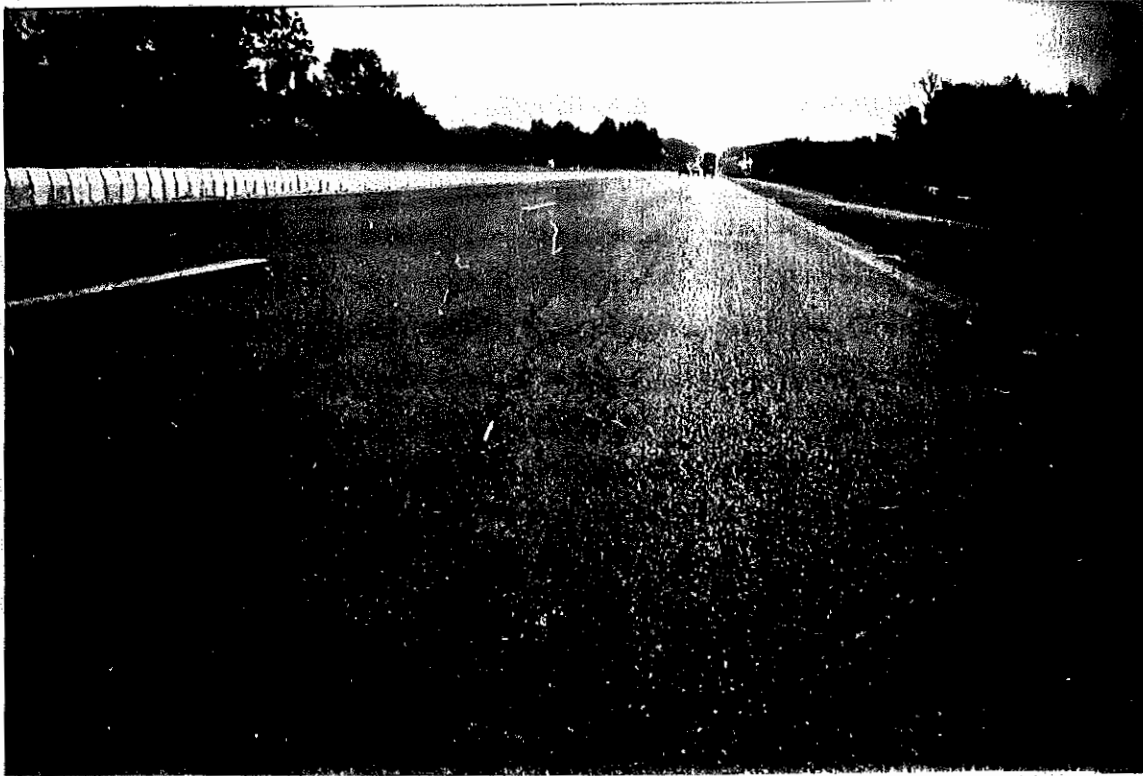
Signs of low-medium longitudinal and transverse cracking were observed on many sections of the new carriageway. The asphalt mix appeared stiff and dry. Longitudinal cracks were found on four sections of the new carriageway, all located in large fill areas. These cracks were running parallel to the direction of the pavement and were sometimes two, three and four in numbers. They varied in lengths, ranging from 9-30 meters.

- (a) The tensile strength (marshal stability) of the asphalt mix was low.
- (b) Temperature variations have caused the age hardening of asphalt mix and heavy axle loads have aggravated the problem.
- (c) Volume changes in subgrade might have also been responsible for longitudinal cracks.
- (d) Volatility of bitumen was high, and was not suitable to environmental requirements.
- (e) Perhaps, to avoid rutting, a hard grade bitumen was used, which resulted in a stiff mix.

If instant repairs are not carried out, structural damage would occur. Photographs 7.12-1 and 7.12-2 show the picture.

Plate 7.12-1 Clearly visible longitudinal cracks. Structural damage is also visible on New Carriageway.

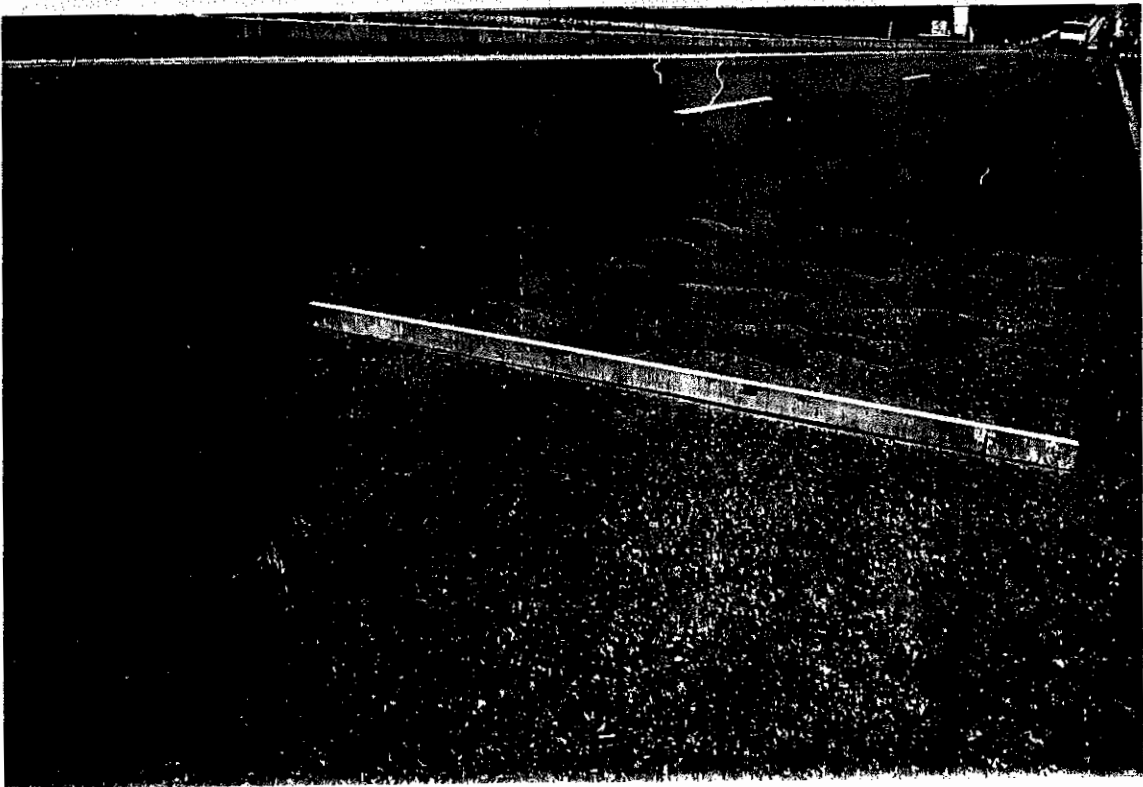
Transverse cracks were mostly found at regular intervals in the wheel paths of the outer lane, having a size of approximately one meter in each wheel track. More than fifteen locations were marked with such cracks. The investigations showed that these cracks were propagating from top toward the bottom of asphalt layer. At two locations cores were drilled, which broke into pieces as the cracks have propagated to bottom.

Plate 7.12-2 Transverse cracks on New Carriageway.

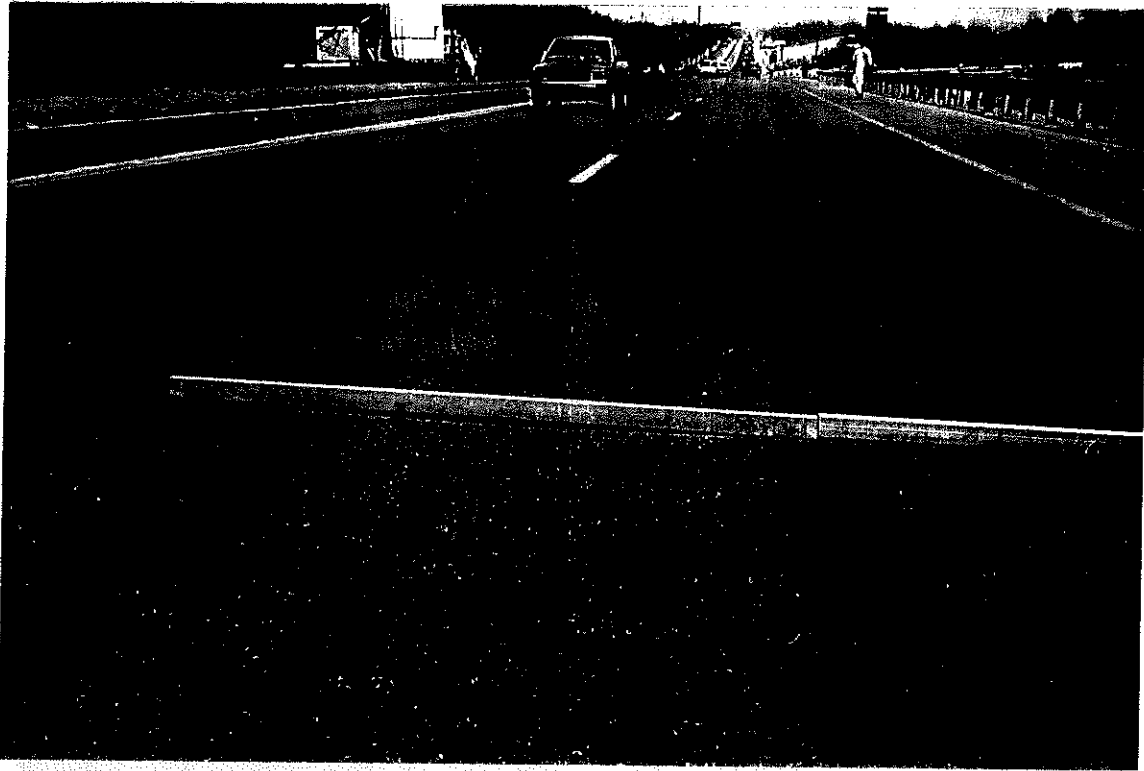
Significant signs of polishing of aggregates were observed at several locations and aggregates were found to be protruding above asphalt surface and were not rough at several locations on the new carriageway. Some polishing of aggregates on the right lane of the old carriageway was also observed. Nearly a quarter of the highway is patched and approximately half is milled, while a quarter is extremely rutted. These milled and rutted sections have very polished aggregates, which reduces skid resistance. The photographs 7.14-1 and 7.14-2 show the picture.

Plate 7.14-1 A view of polished aggregates on New Carriageway.

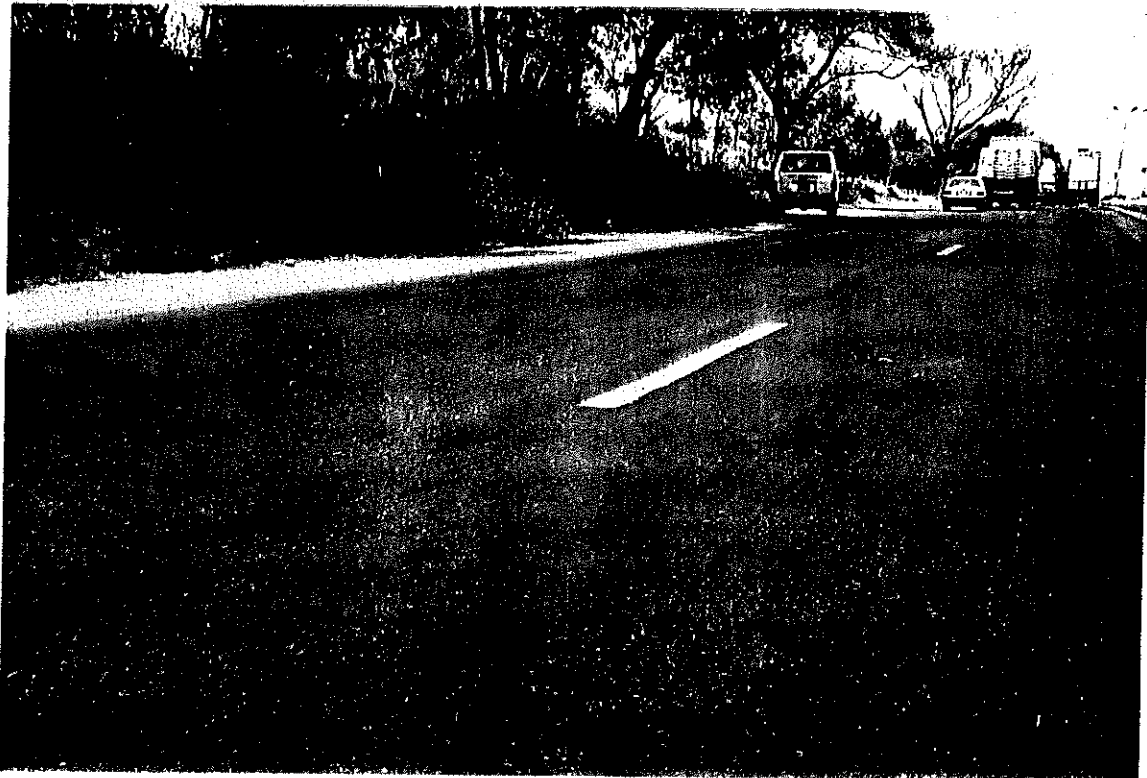
Plate 7.14-2 A view of polished aggregates on Old Carriageway.

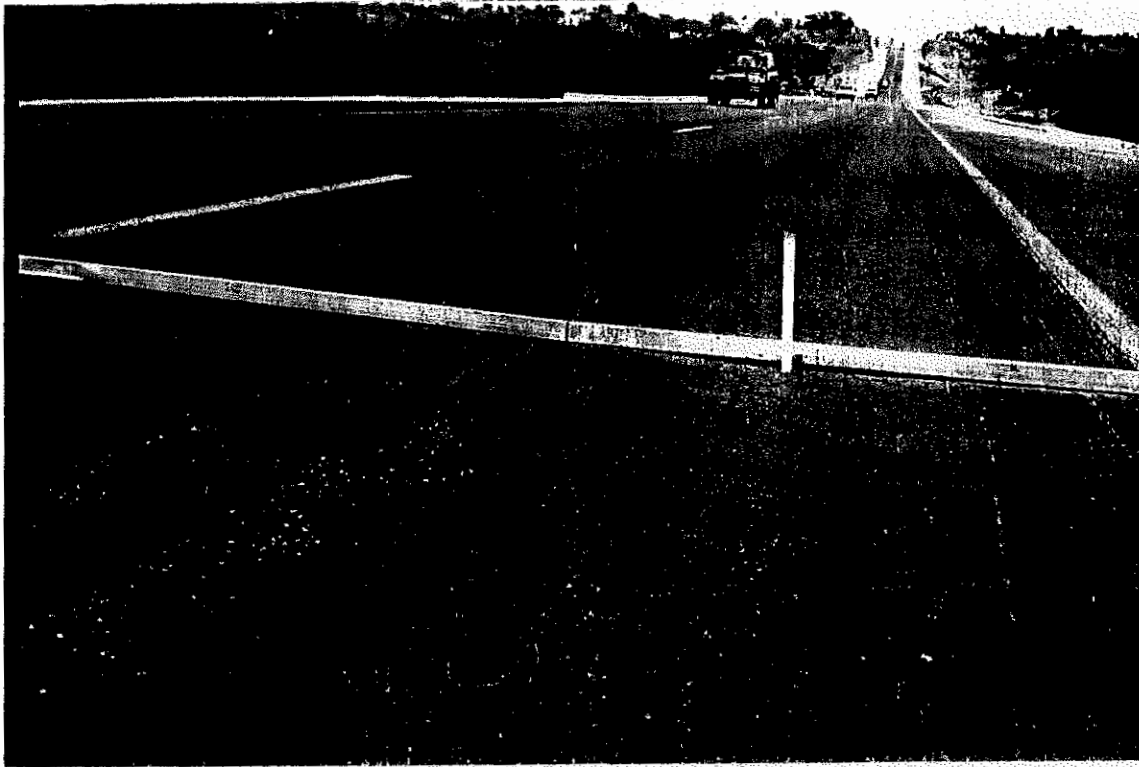
Potholes, the bowl-shaped holes of various sizes were found on only two locations of the new highway while at eight locations these potholes were found on old highway. Similarly in cracked areas, it was observed that if no remedial measures will be taken, potholes would develop quickly due to accumulation of water. Potholes are ultimate stage of raveling. These are caused by alligator cracking, raveling, pounding etc. and can be avoided by regular maintenance. The photographs 7.15-1 and 7.15-2 show the picture.

Plate 7.15-2 Initiation of potholing on New Carriageway.

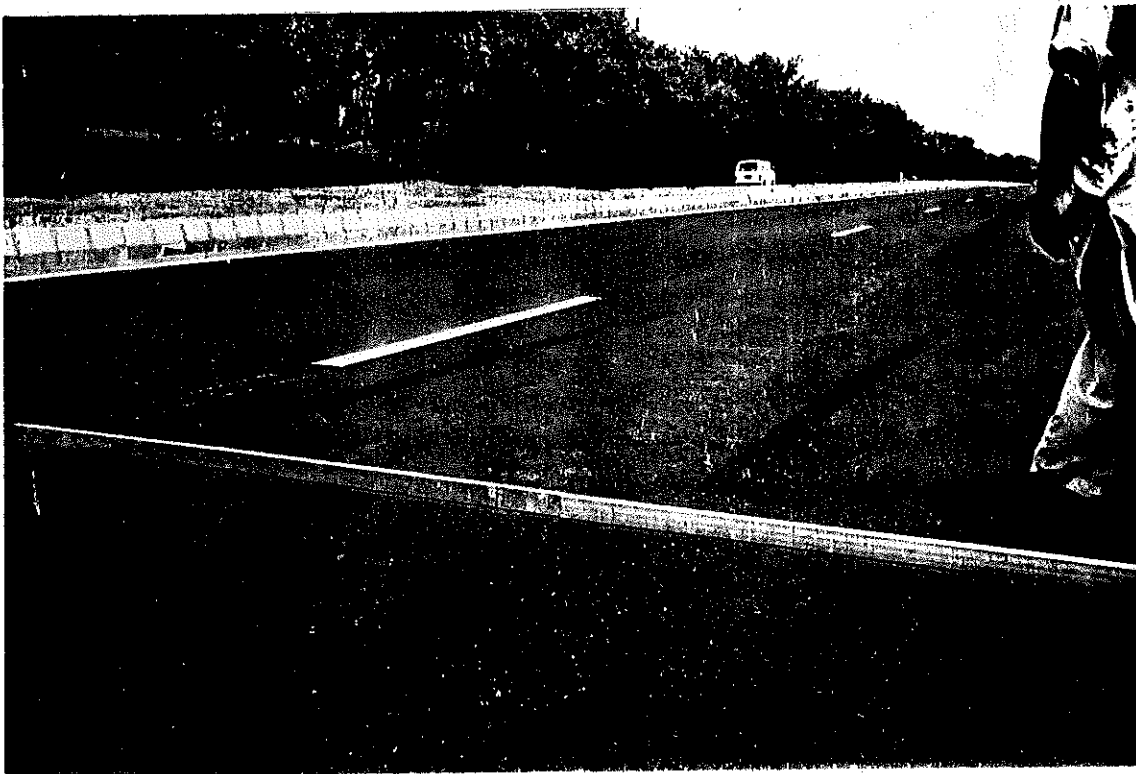
Raveling is a measure of durability of asphalt concrete. Signs of raveling, weathering (stripping), which is the progressive separation of aggregates from pavement and separation of binder from aggregates respectively, were observed under wheel paths almost throughout the length of the new carriageway. Old highway had fewer signs. At places "resin" of pavement has started. The possible causes are:

Plate 7.17-2 Medium severity stripping of aggregates from the pavement on New Carriageway.

- i) Construction during wet or cold weather
- ii) Dirty aggregates
- iii) Perhaps, the asphalt was over-heated
- iv) Aging of asphalt plays an important role.

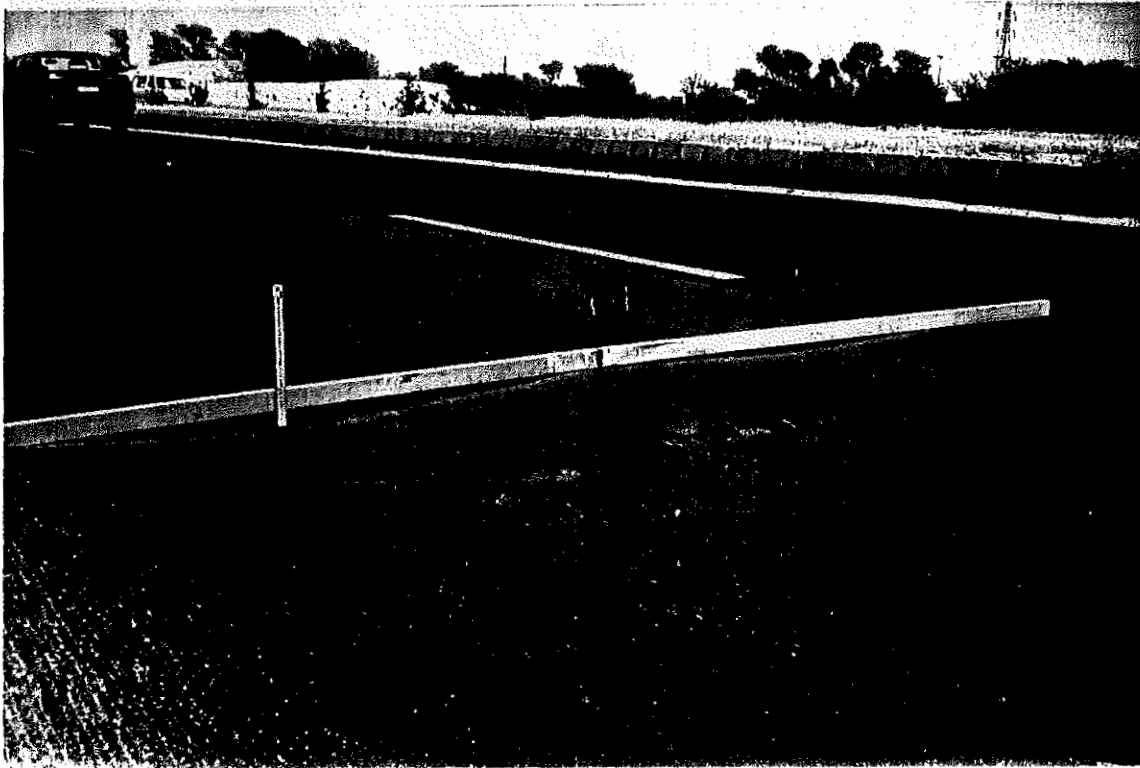
Plate 7.18-1 Severe rutting on New Carriageway (40 mm).

It became obvious from the variation in height of drilled cores, carried out at the adjacent lane/section that the principal rutting has taken place in the bituminous layer, while at many milled locations the core (asphalt concrete) thickness was very small (as small as 75 mm on the old highway) as compared to the "accumulated" portion. The most probable causes of bitumen layer rutting are:

- a) Inadequate stability of the asphaltic concrete mix, which in turn is dependent on:
 - i) High bitumen content in the mix
 - ii) High filler content in the mix
 - iii) Utilization of round aggregates
 - iv) Utilization of high penetration grade bitumen
- b) Inadequate compaction of the bituminous courses
- c) Over compaction of the bituminous layer due to heavy and channeled traffic.

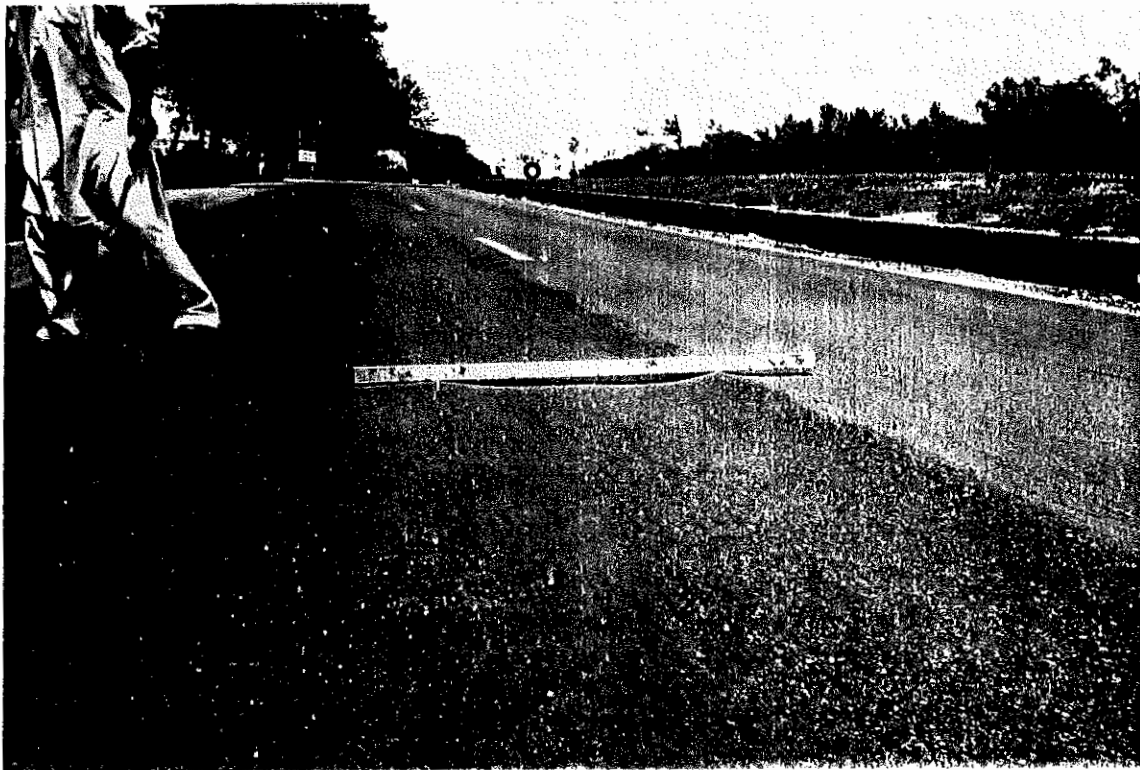
Plate 7.18-2 Severe rutting on Old Carriageway (50 mm).

As already mentioned that the outer lane of the old highway is in a dilapidated condition, the rut depth of 120 mm was observed on one location. Nearly all the sections have been rutted due to passage of heavy axle loads. The plastic flow (shoving) conditions were evident on a number of locations.

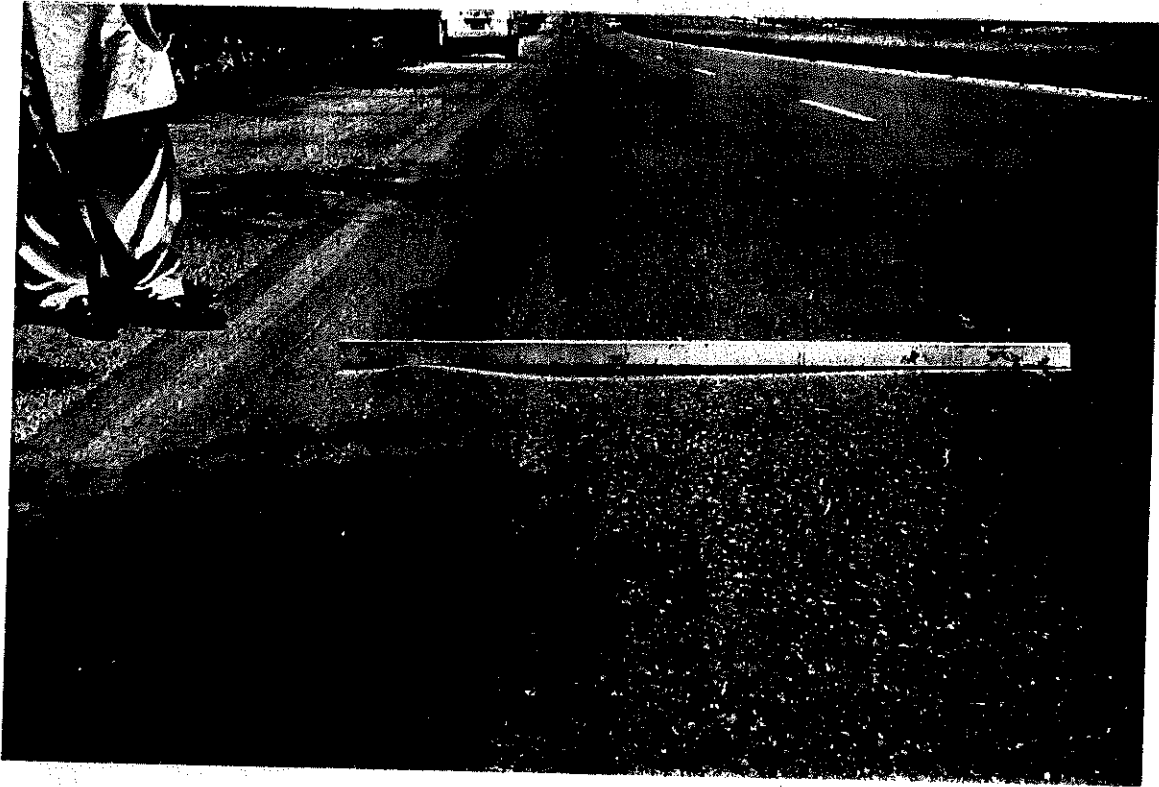
Plate 7-18-3 Severe rutting being observed and shoving along the side of rut is clearly visible on Old Carriageway.

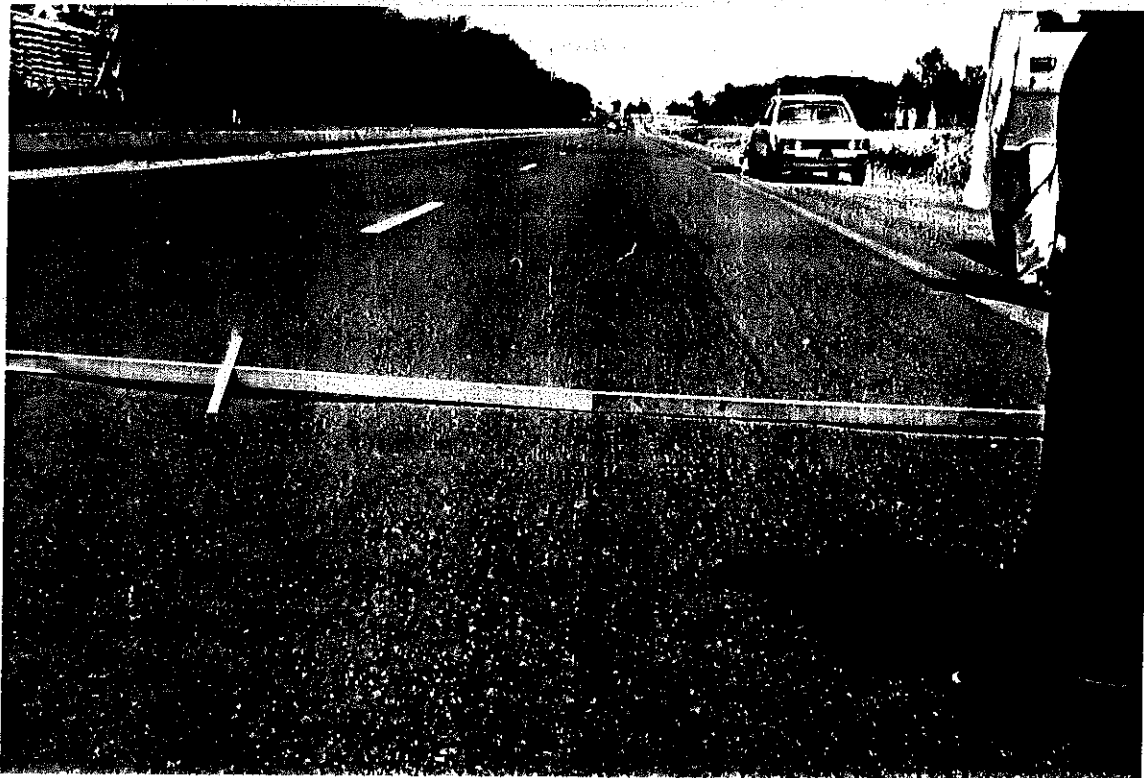
Plate 7.18-4 A view of milled section of new carriageway and re-development of severe rutting on New Carriageway.

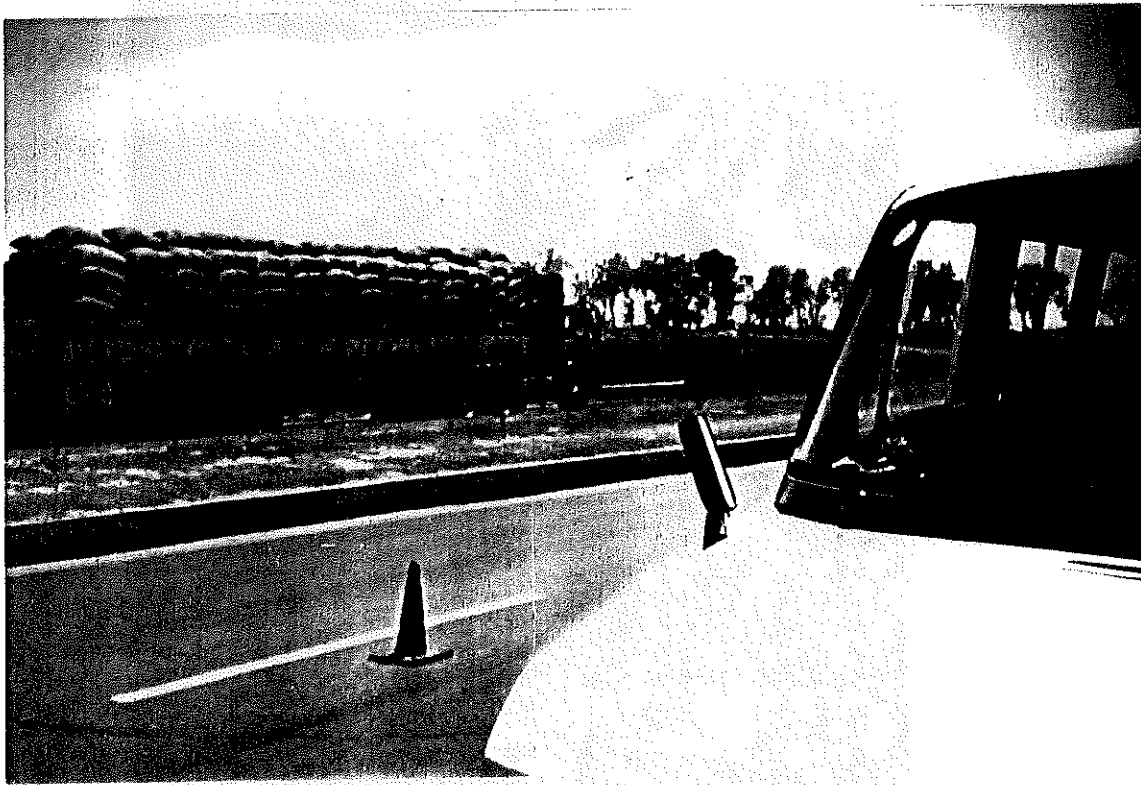
Plate 7.22

Signs of subsidence (Volume change) in subgrade of old highway. In the background a heavily loaded truck (60 tonnes approximately) is also visible on Old Carriageway.

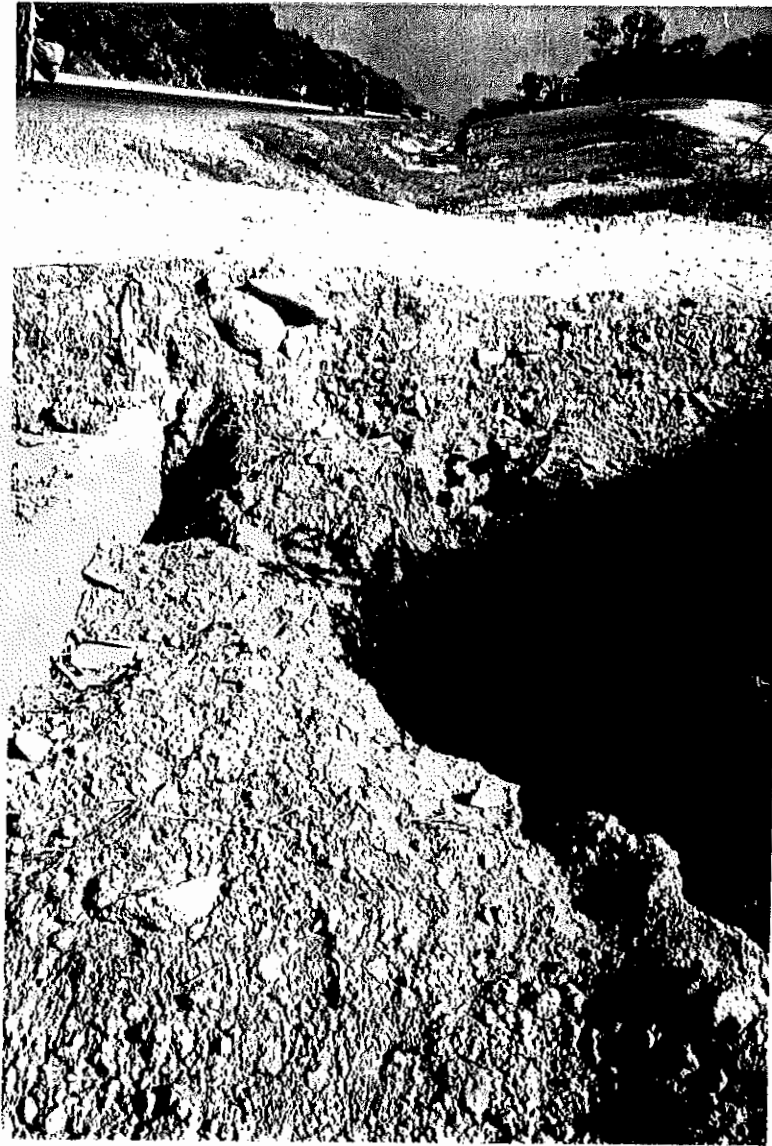
Plate 7.23-1

A view of a pass made on the drain. The utility of drain is wiped out as the debris is lying in the drain and only one pipe has been provided that too has clogged (in shade)

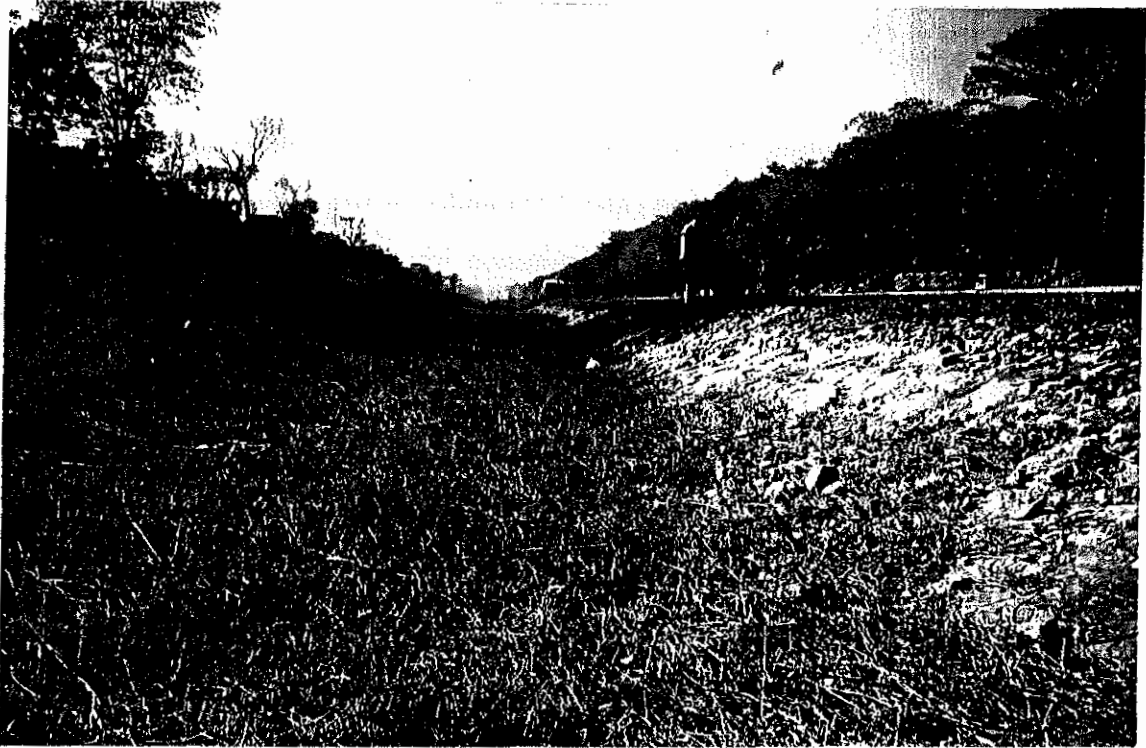
Plate 7.23-2(a) Completely clogged side drain of new carriageway. Already a large section of Kashmir Highway from Zero Point to Aabpara has failed due to drainage problem.

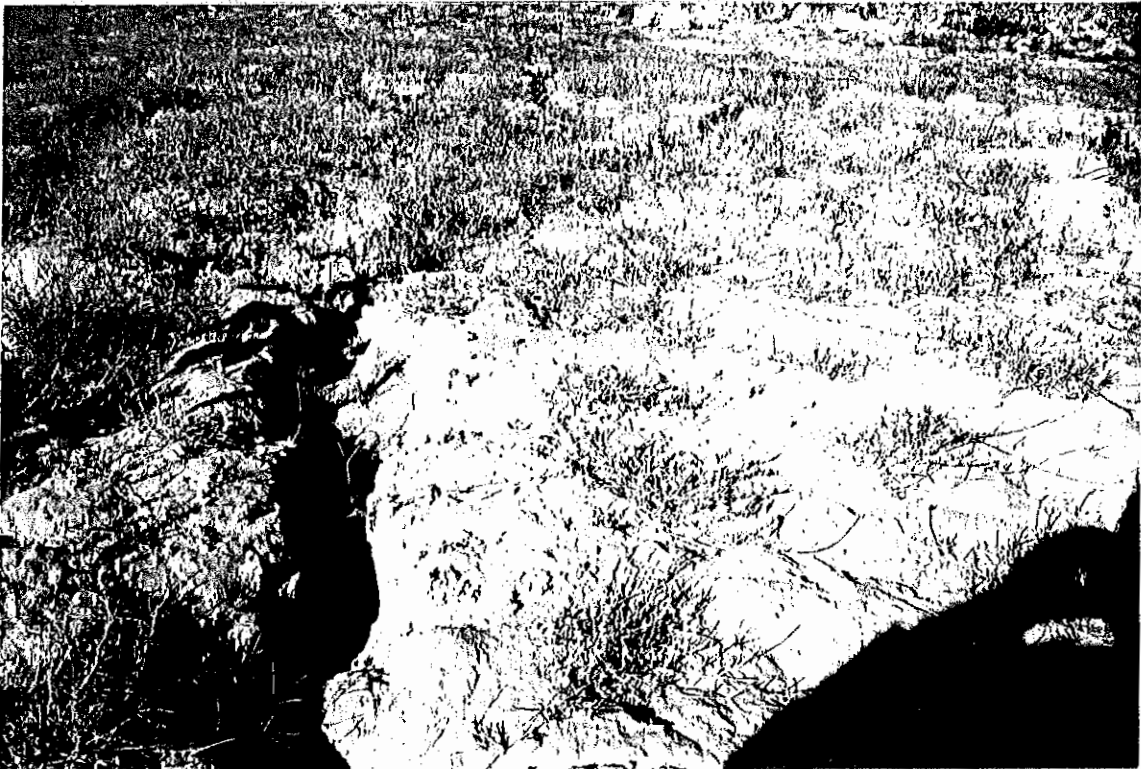
Plate 7.23-2(b) A view of unstable slope. Water crosses carrying soil to the drain are clearly visible.
