GOVERNMENT OF PAKISTAN
MINISTRY OF COMMUNICATIONS
NATIONAL TRANSPORT RESEARCH CENTRE(NTRC)

FAILURE ON
NOWSHERA - PESHAWAR SECTION (N - 5)
(INTERIM REPORT)

July, 2006

SUBJECT: FAILURE OF NOWSHERA - PESHAWAR SECTION OF NATIONAL HIGHWAY N - 5

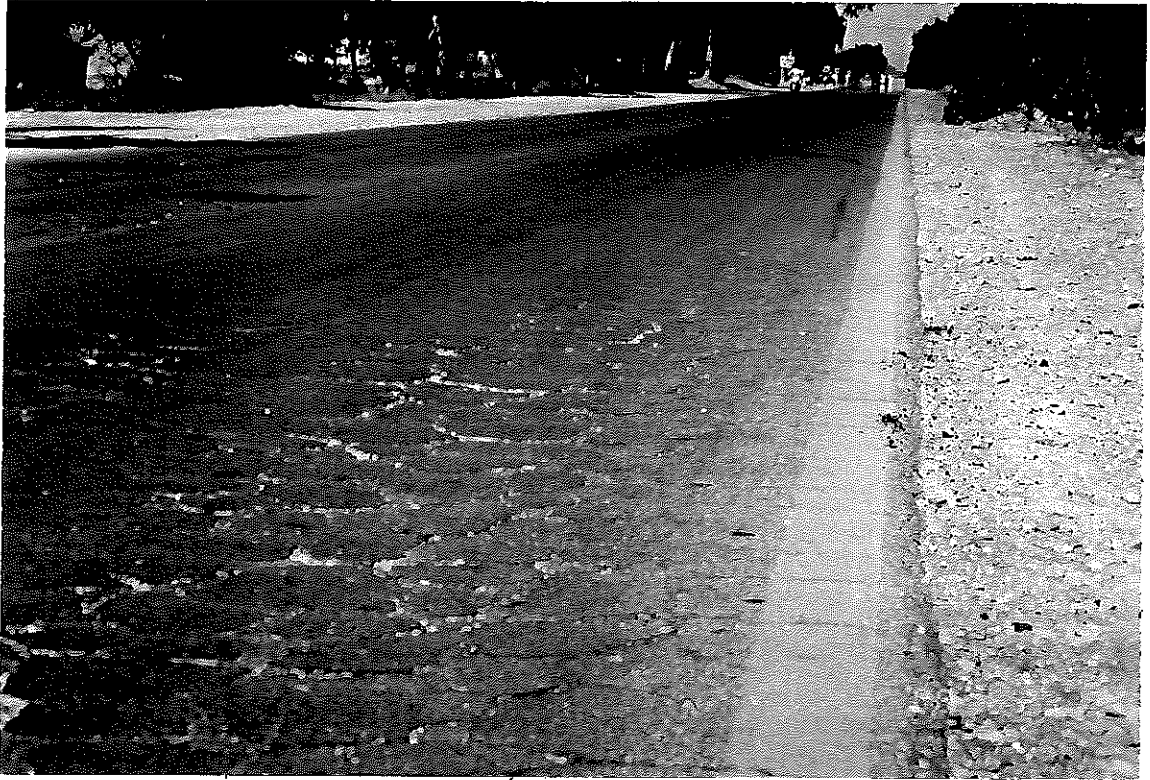
Soon after opening to traffic, signs of distress / failure like cracking, rutting and settlement appeared in the pavement and the pavement deteriorated rapidly thereafter (Photo No. 1,2,3 & 4).

**Photo No. 1 CRACKS VISIBLE ON PAVEMENT SURFACE
(Rehabilitated Section)**

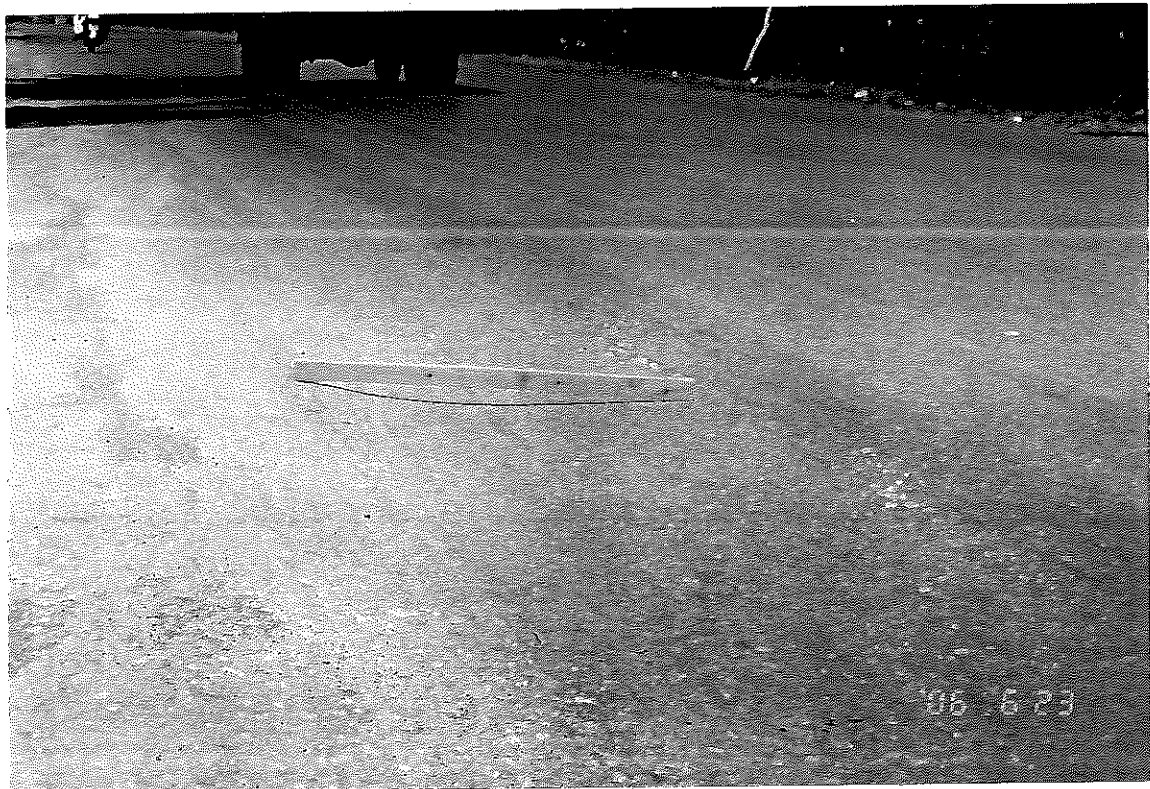
**Photo No. 2 RUTTING / DEFORMATION
(Rehabilitated Section)**

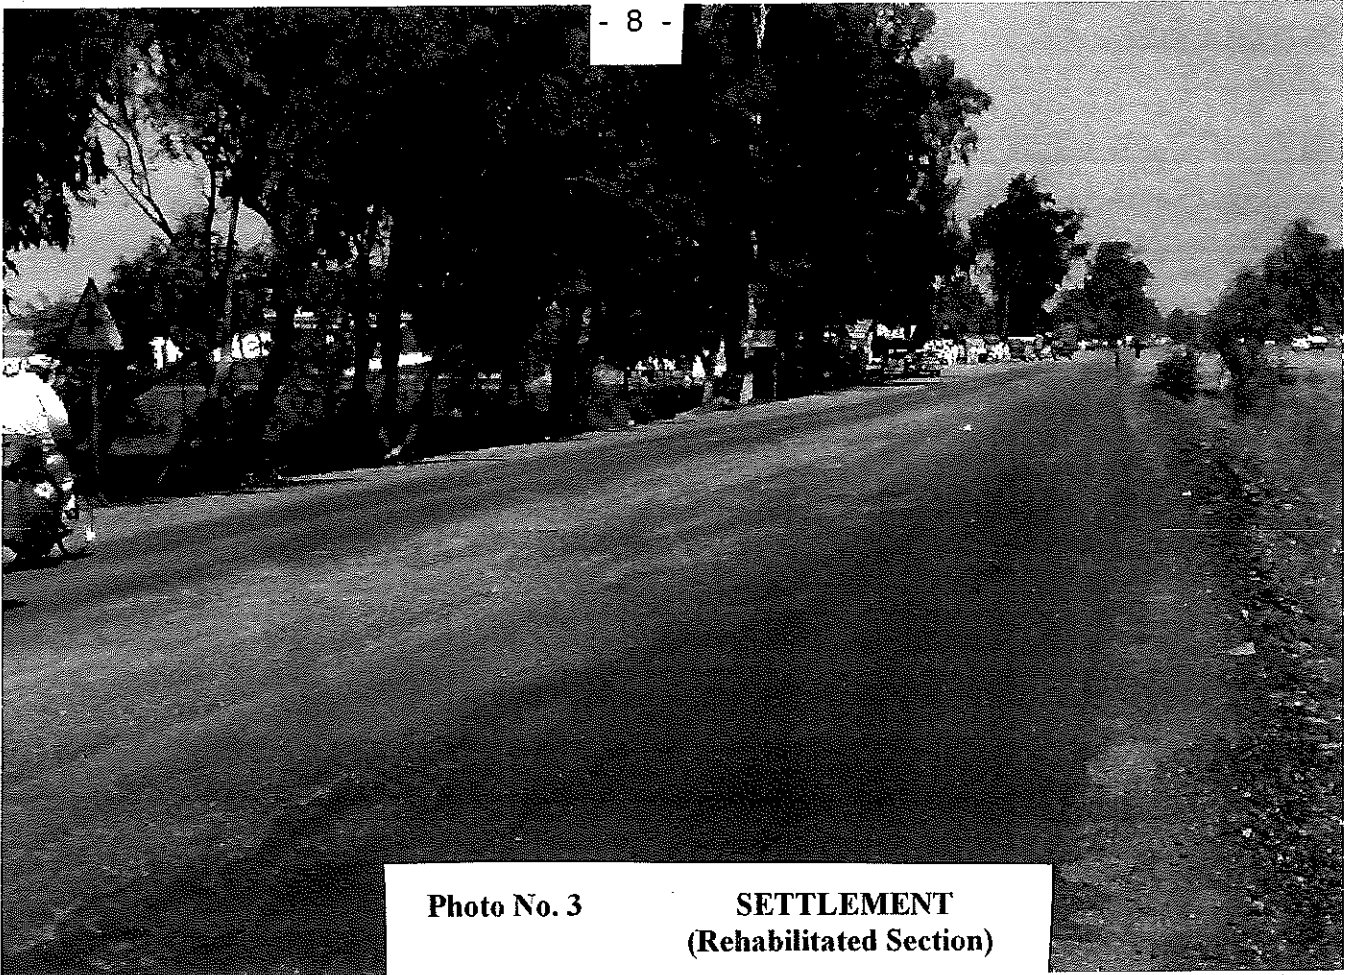
Photo No. 3

**SETTLEMENT
(Rehabilitated Section)**

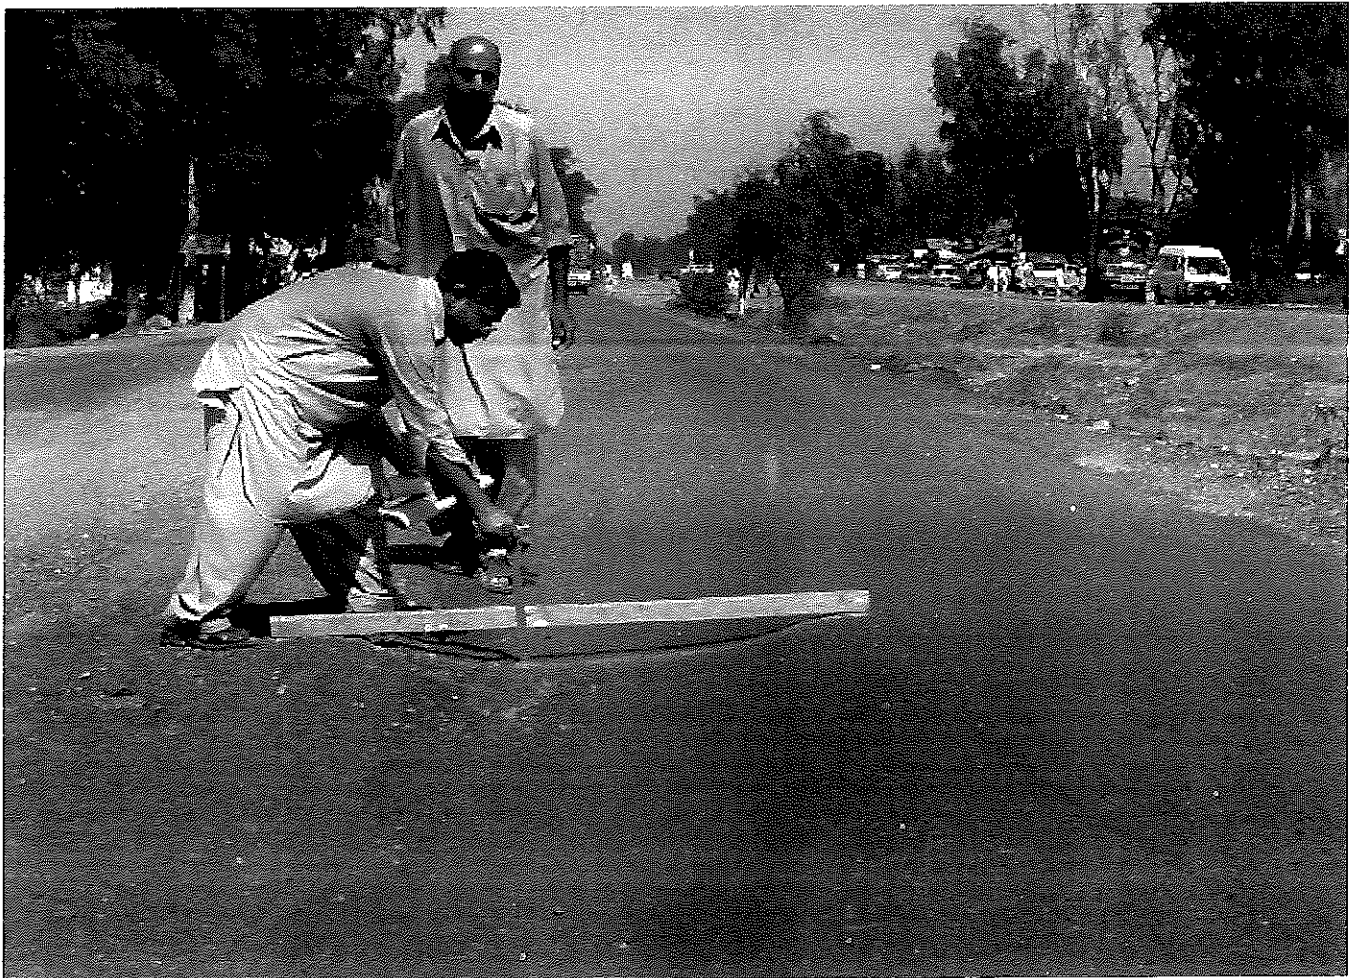
Photo No. 4

**DEFORMATION
(Rehabilitated Section)**

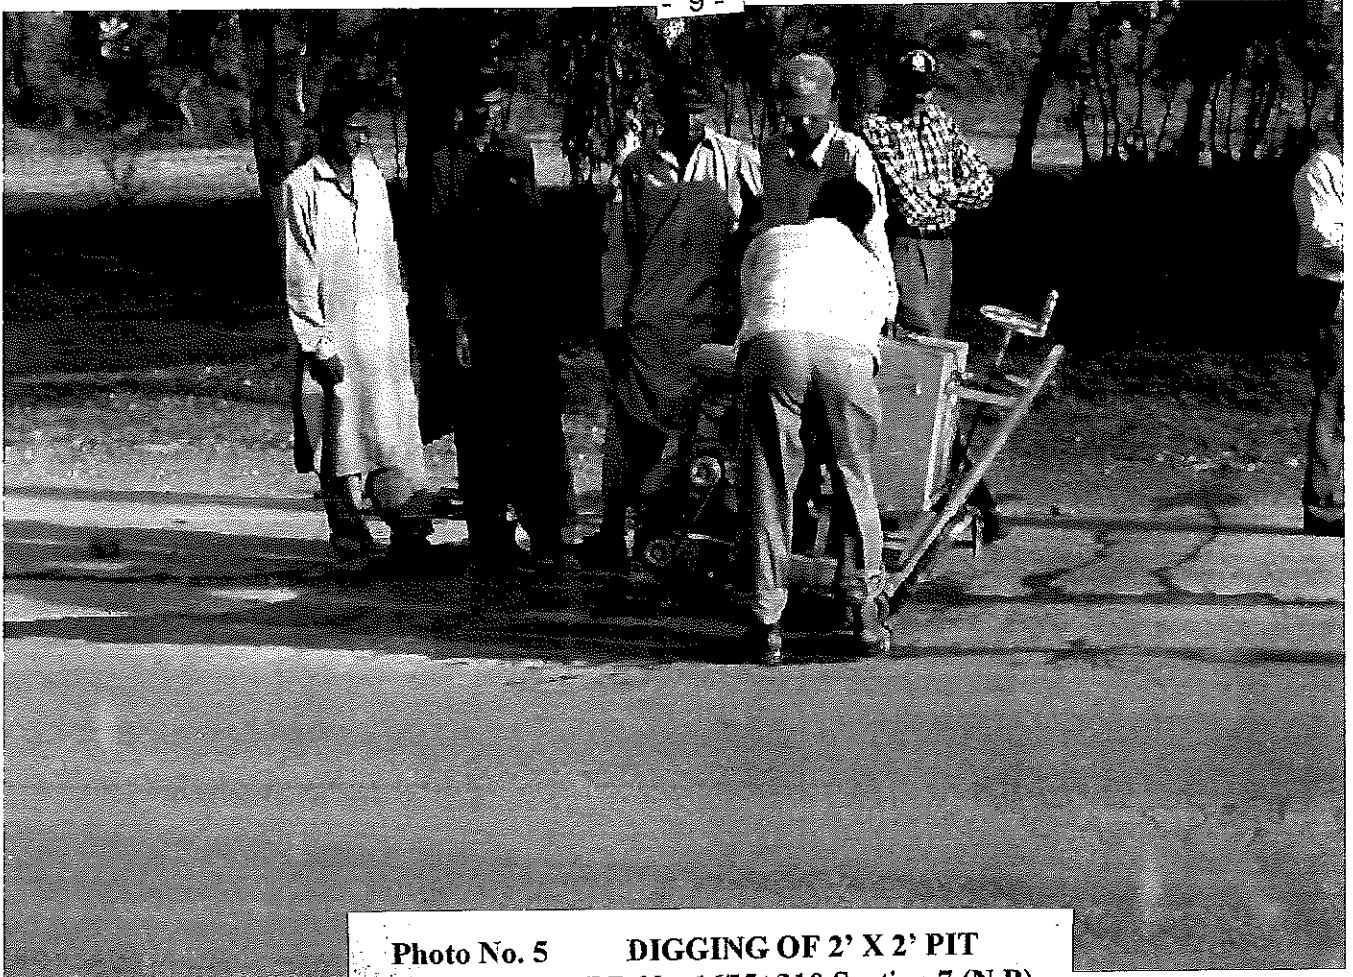
material and to check the thickness of pavement layer and compaction of Granular Base Course (Photo No. 5, 6 & 7).

Photo No. 5 DIGGING OF 2' X 2' PIT
RD No. 1675+310 Section 7 (N.B)

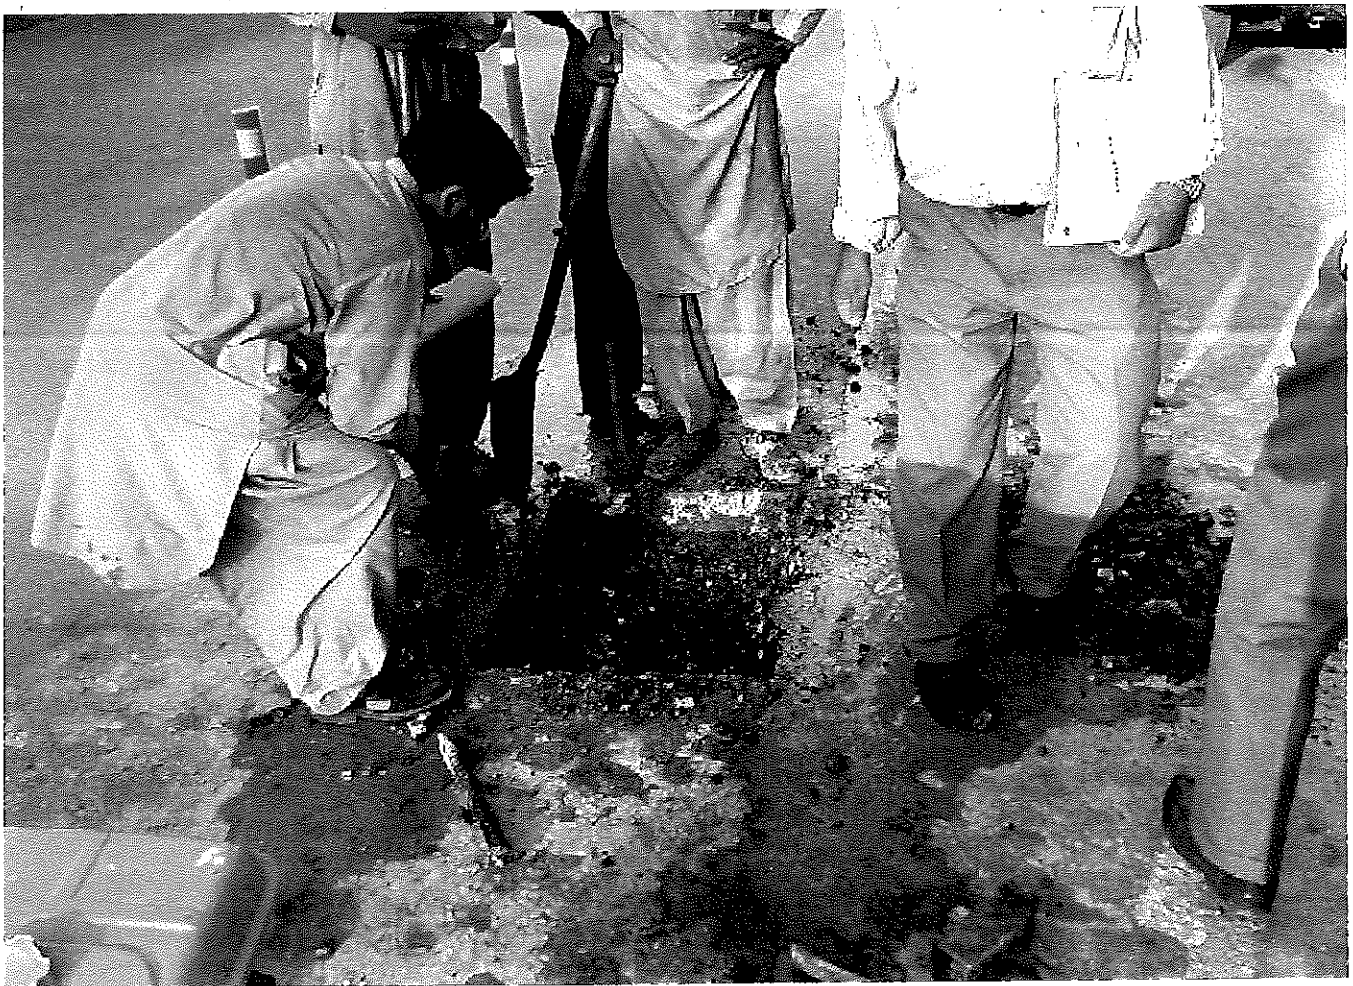
Photo No. 6 DIGGING OF 2' X 2' PIT
RD No. 1675+310 Section 7 (N.B)

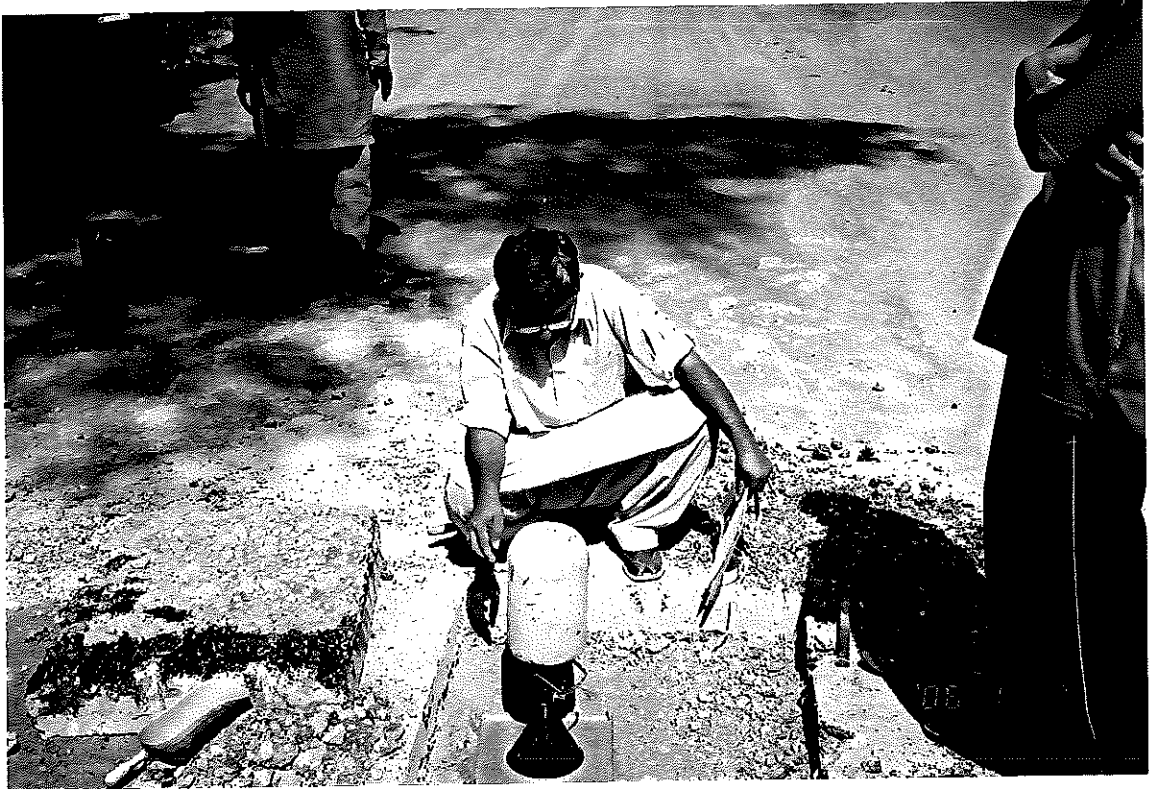
Photo No. 7

**FIELD DENSITY TEST
RD No. 1685+385 Section 6 (S.B)**

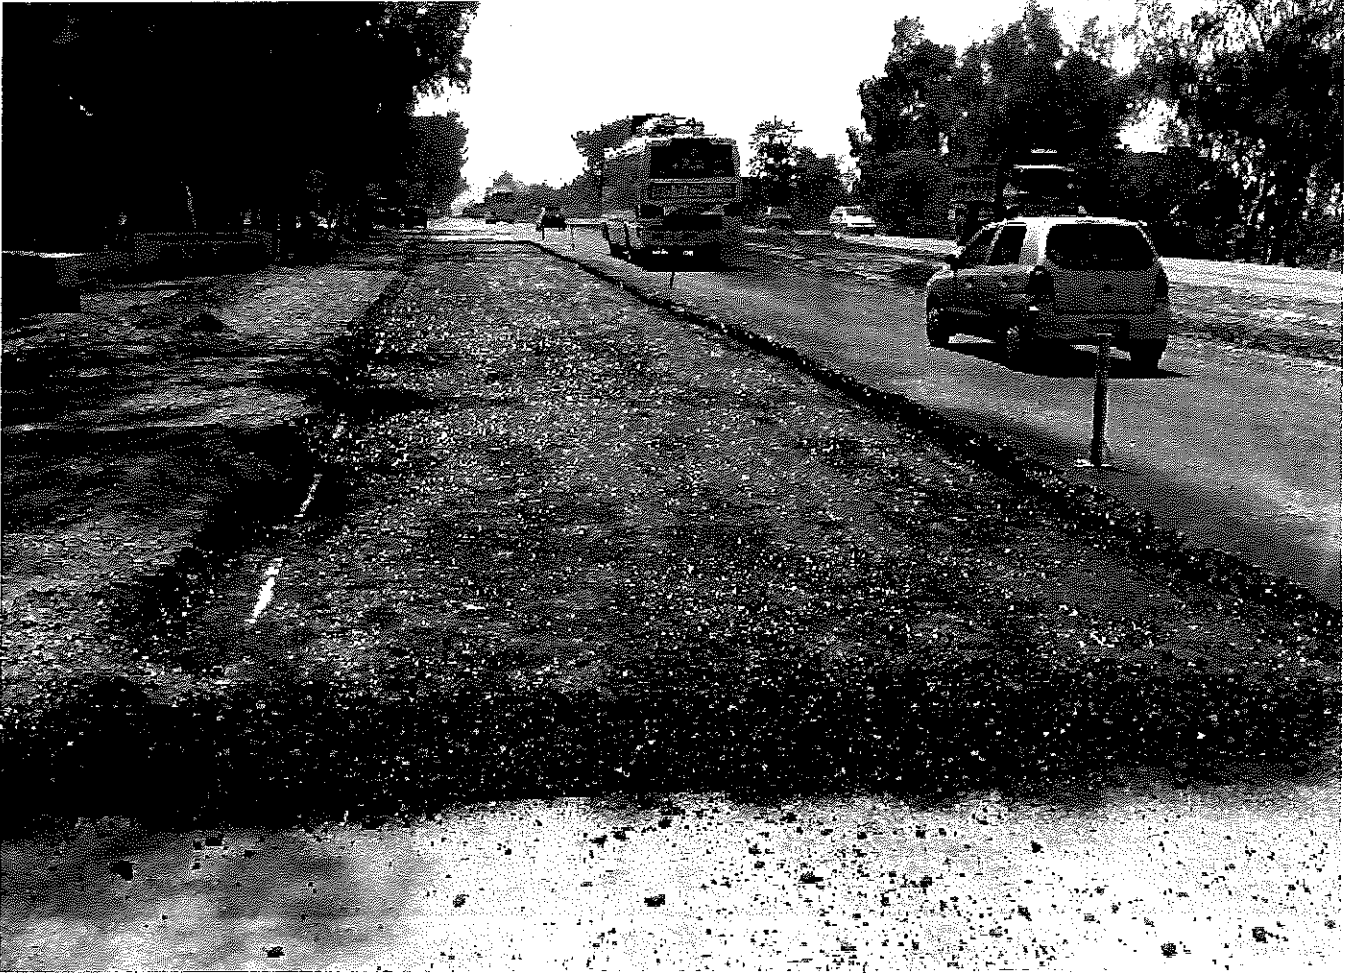
Photo No. 8

REPAIR WORK IN PROGRESS

- Aggregate Granular Base Course material was also collected from primed section, which was ready for Asphalt Base Course and Asphalt Wearing Course. At some locations, the contractor has also started repair works. (Photo No. 8)

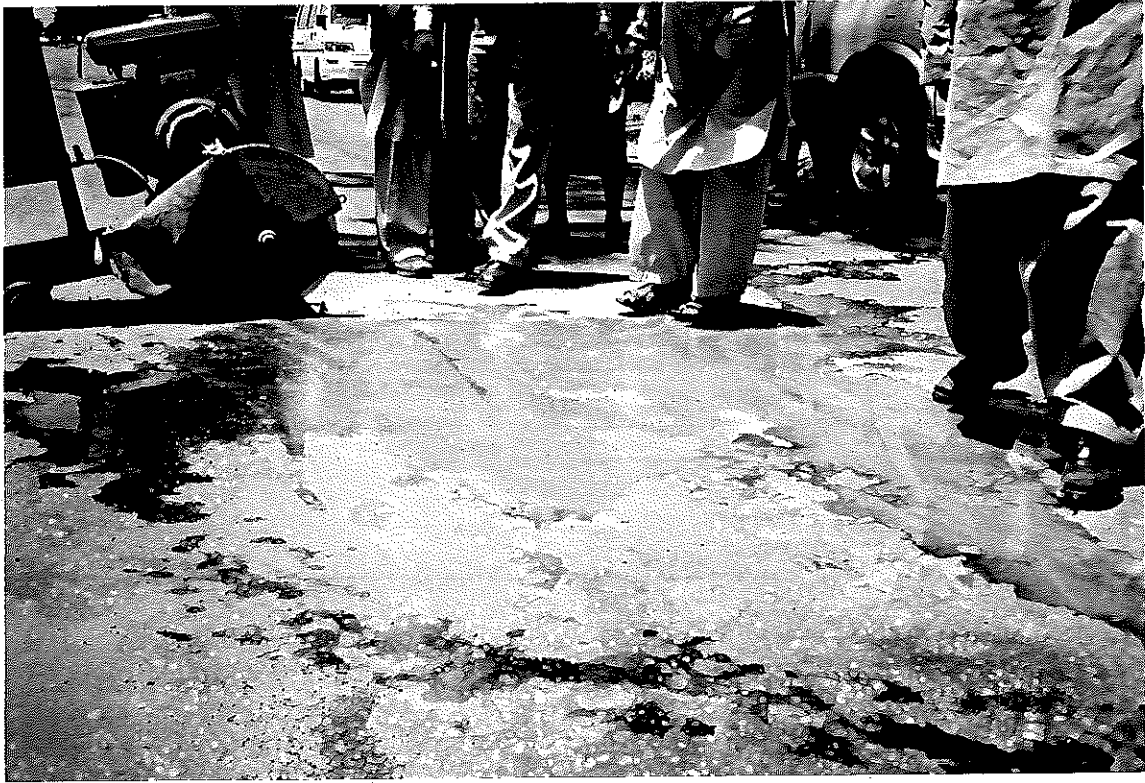
1. Large sections of rehabilitated highway have shown signs of pre mature distress.
2. Asphalt concrete extracted from Pits was found to be brittle and lacking adhesion.
3. During core cutting of 2'x2' pit, the appearance of clayey-silty slurry points to the usage of dirty aggregates and large amount of fines in the mix (Photo No.9).
4. Traces / lumps of mud were found inside the Asphalt Concrete mix extracted from pits.
5. All except one core, the asphalt concrete cores have 'dull appearance' and no clear indication of Asphalt Wearing Course and Asphalt Base Course (Photo No.10)
6. Coarse and fine aggregates were found in 'bunches' rather than in uniform distribution. Some times all fine aggregates and at other times, all coarse aggregates were found packed at one place.

**Photo No. 9 APPEARANCE OF CLAYEY - SILTY
SLURRY DURING CUTTING OF 2' X 2' PIT
RD No. 1885+385 Section 6 (N.B)**

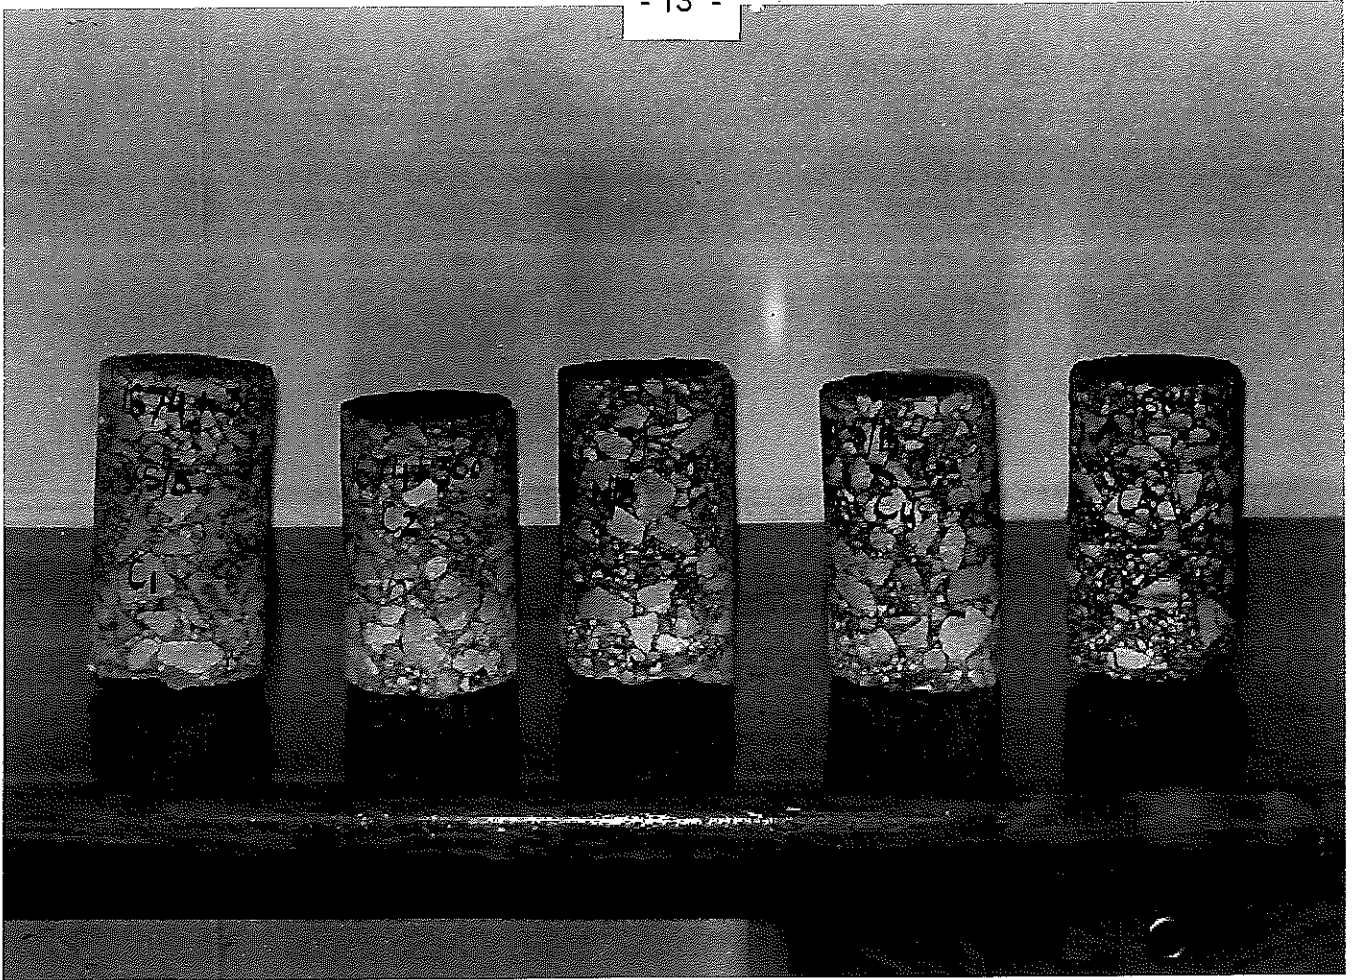
- Five cores were extracted, three from failed sections & two from the section still working satisfactorily.
- Two pits of 2' x 2' were dug to obtain the Asphalt Wearing Course, Asphalt Base Course and Granular Base Course

Photo No. 10 FIVE CORES TAKEN FROM THE SITE
