NATIONAL TRANSPORT RESEARCH CENTRE

FAILURE CAUSES
OF N-35
(SARAI - SALEH TO MUSLIMABAD)

NTRC-226

August, 2000

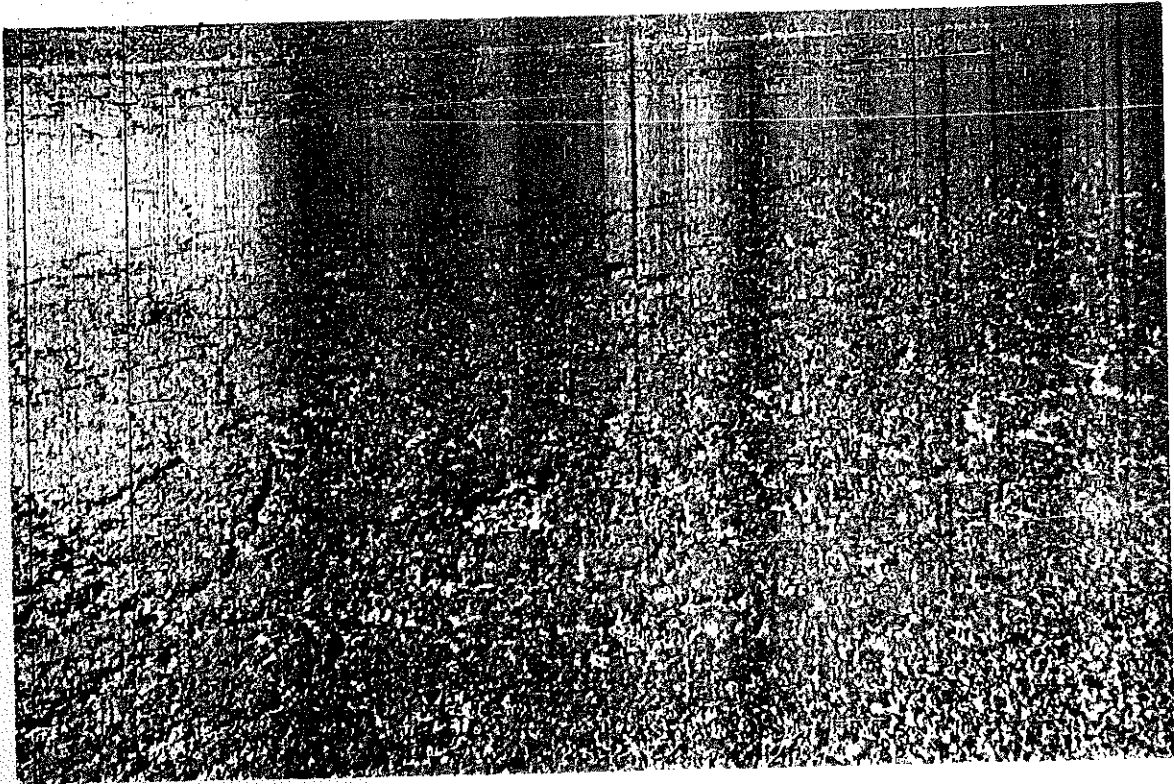
Visual examination of the section revealed high severity alligator (fatigue) cracking with depressions varying from 1-3 cm at few places. The cracked pieces were found more severely spalled at edges & loosened. Medium to severe stripping/ravelling was also observed.

1. High severity cracking and potholing. Spalled and loosened pieces are clearly visible

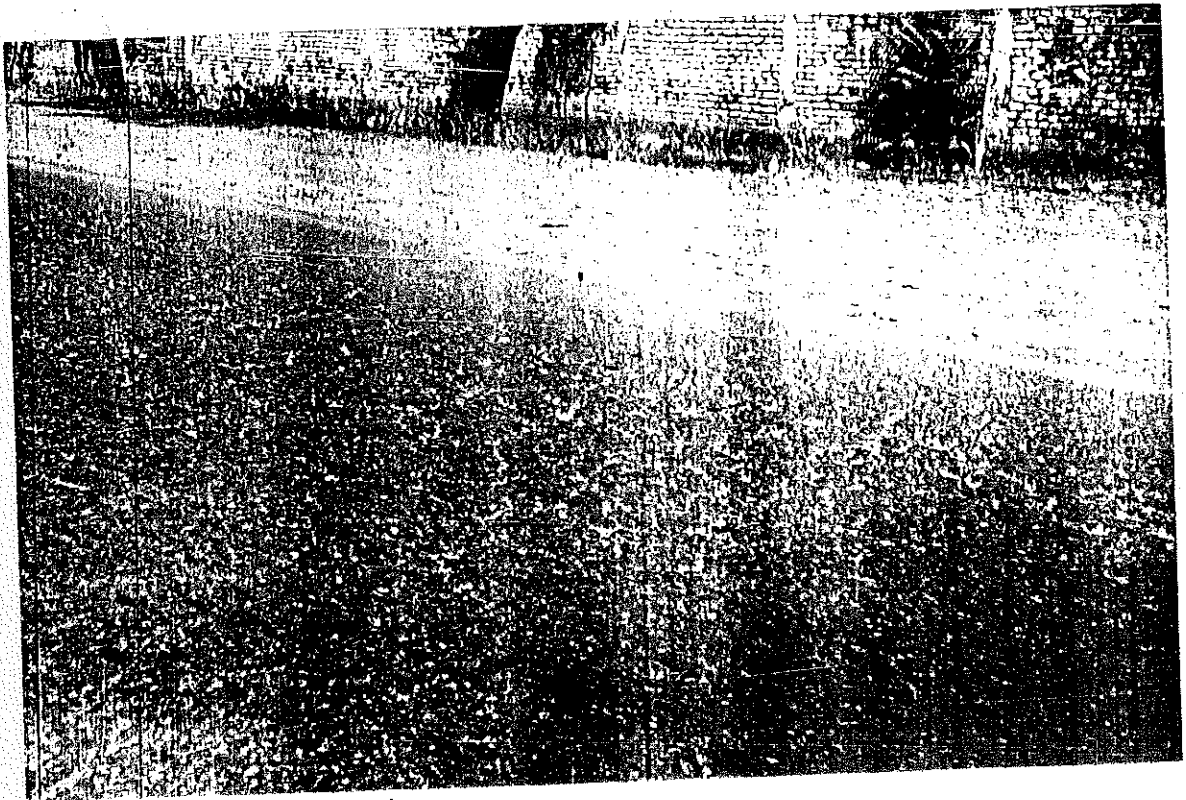
Signs of alligator (fatigue) cracking, a series of interconnecting cracks caused by asphalt concrete failure, were readily observed and easily identified during a close inspection of the highway

These cracks have most probably developed because of poor quality of mix. The poor quality of mix has resulted either due to less bitumen content in the mix than the optimum at the time of mixing or due to high voids which allowed air entrance in the mix and accelerating the oxidation/decomposition of the mix.

2. A view of extensive cracking of the pavement

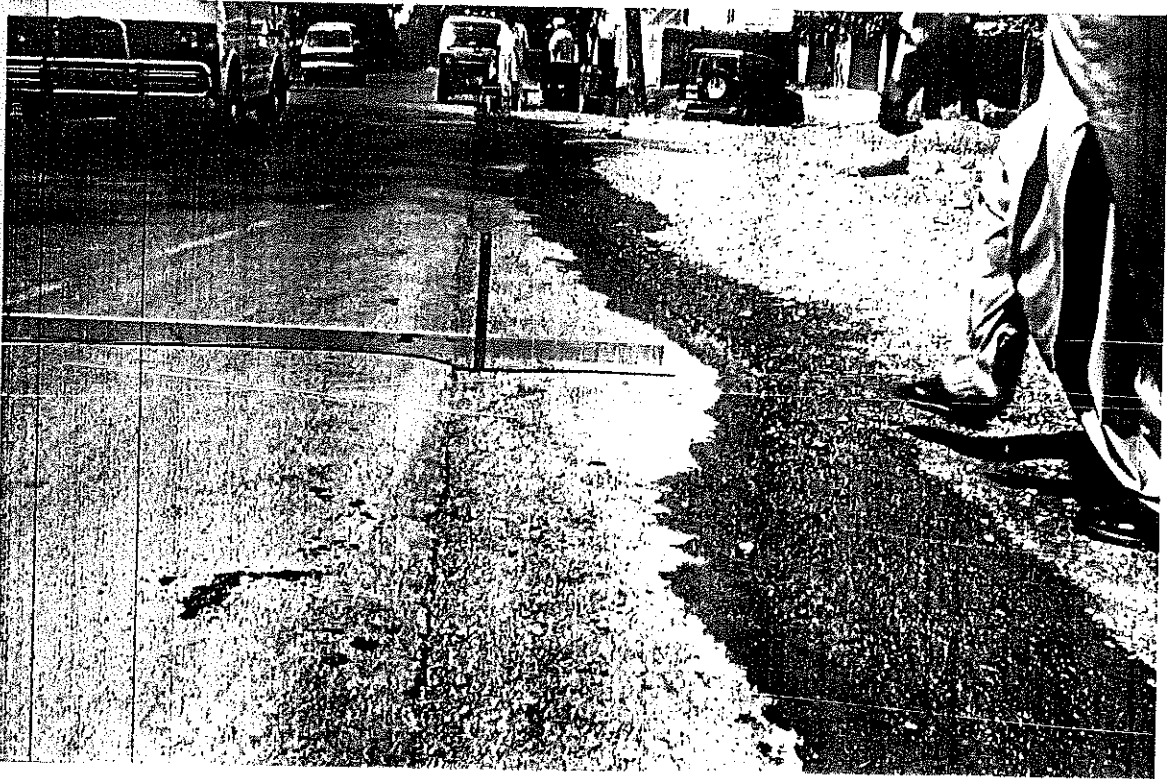
3. A view of overlaid section (done in the past)

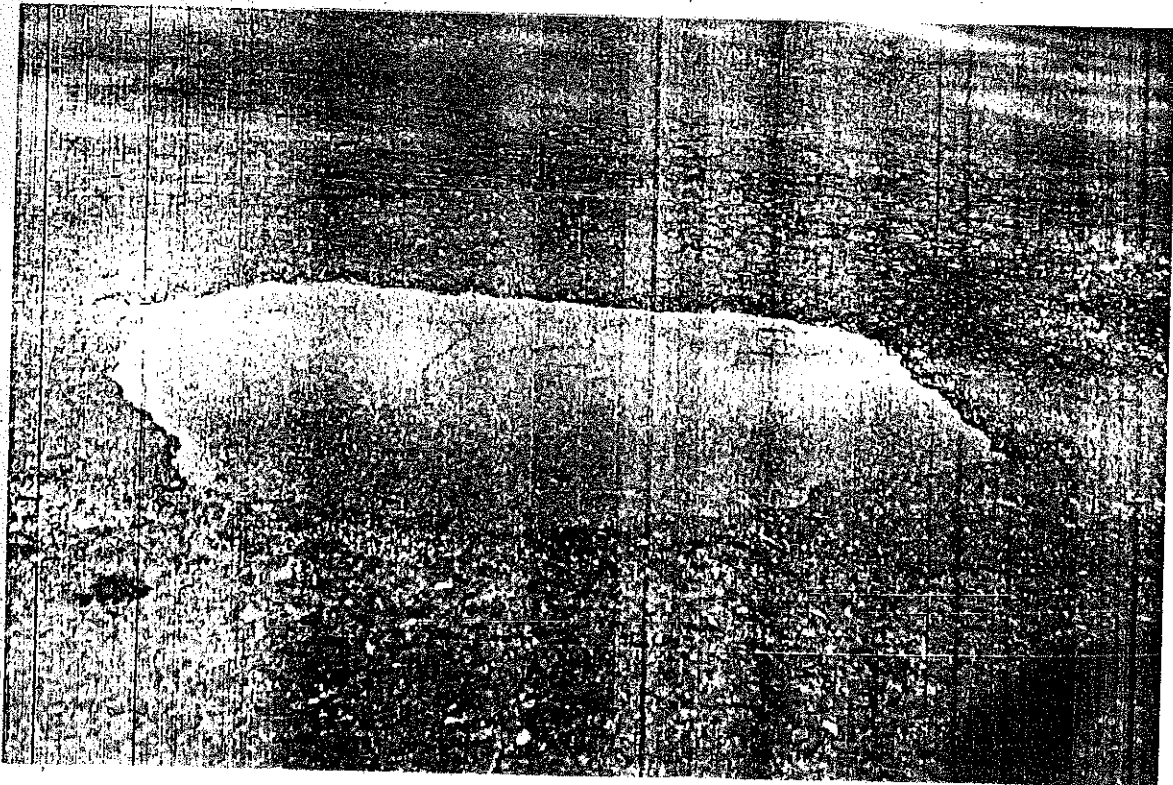
Since this solution is not based on eliminating the fault, cracks would reflect through the wearing course as was observed on a patched section. It would simply be waste of resources. Since asphalt concrete costs 4-5 times more than simple double surface treatment, the later being most appropriate should have been preferred.

4. A view of deteriorated overlaid section

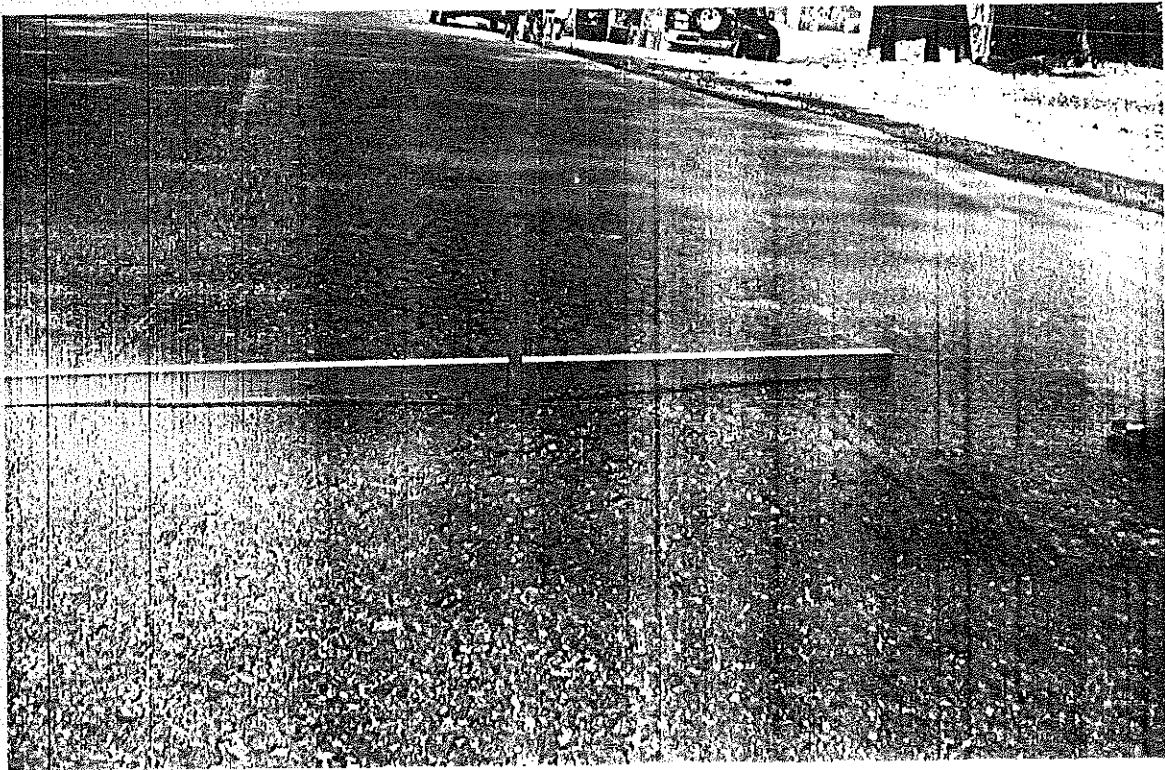
2) The deformation of pavement indicate seepage of water in the underlying layers. *observation*

4(a). High severity/Extensive cracking and settlement / depressions

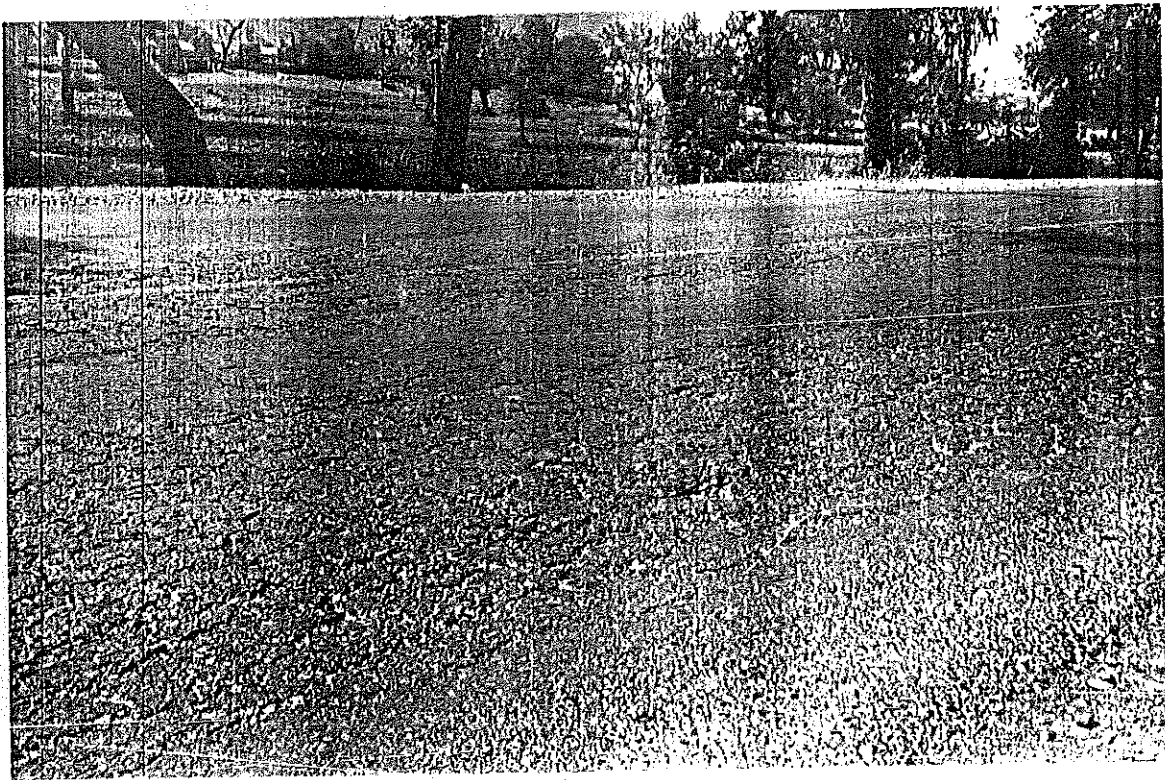
4(b). High severity cracking & potholing

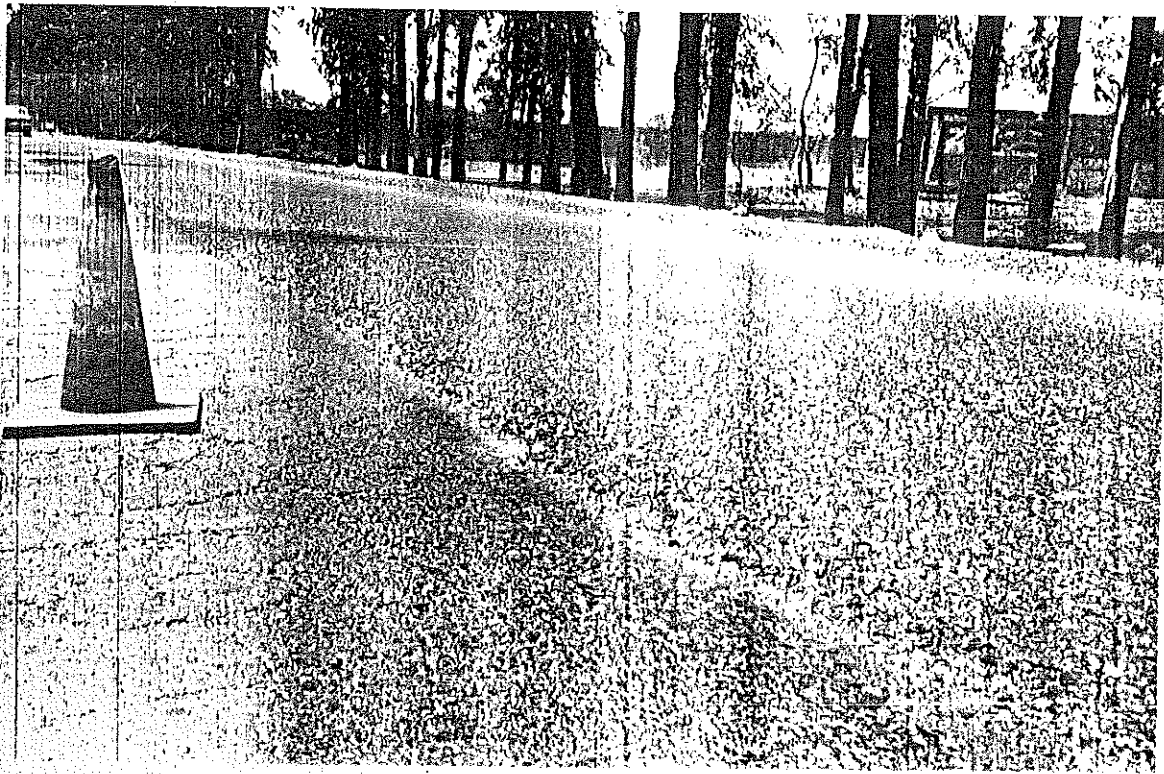
4(c). A view of high severity cracks and double surface treated lane

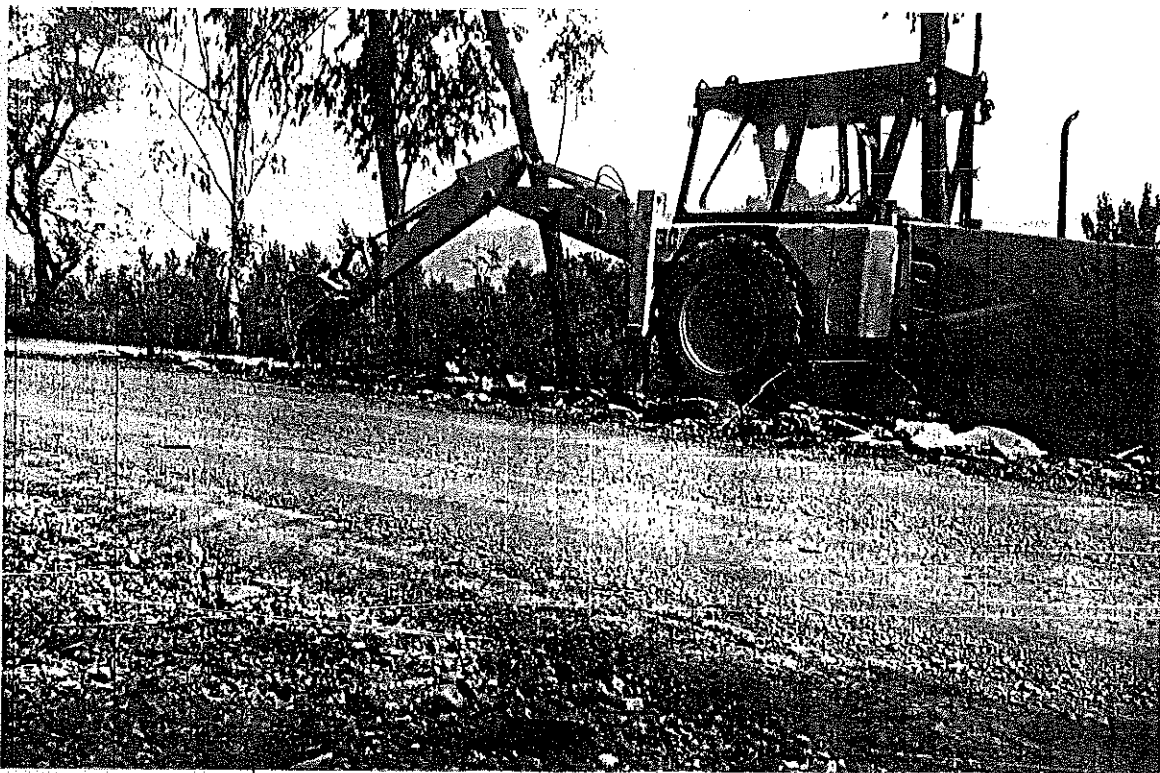
- c) Asphaltic base course surface was closely observed, which showed extensive cracking. The wearing course mix removed was carefully examined and it was observed that the bitumen was fully decomposed and its appearance was dry/oxidized.

5. Pavement wearing course layer being scarified using 'un-specified' technique. The base course is prone to damage

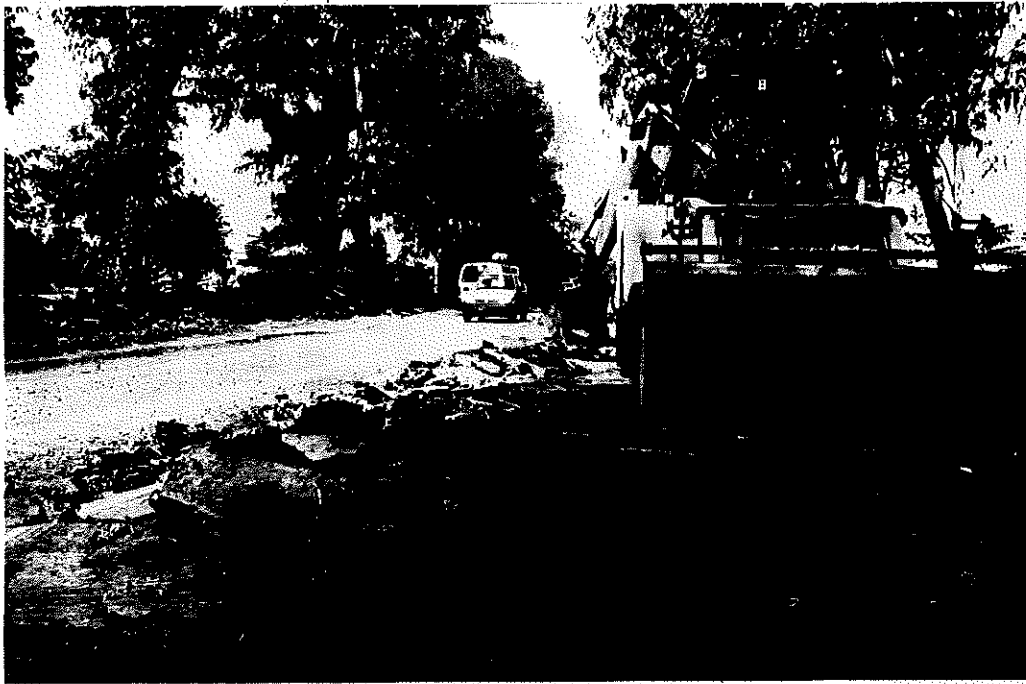
6(a). A view of scarification work. Works going on without any safety precautions

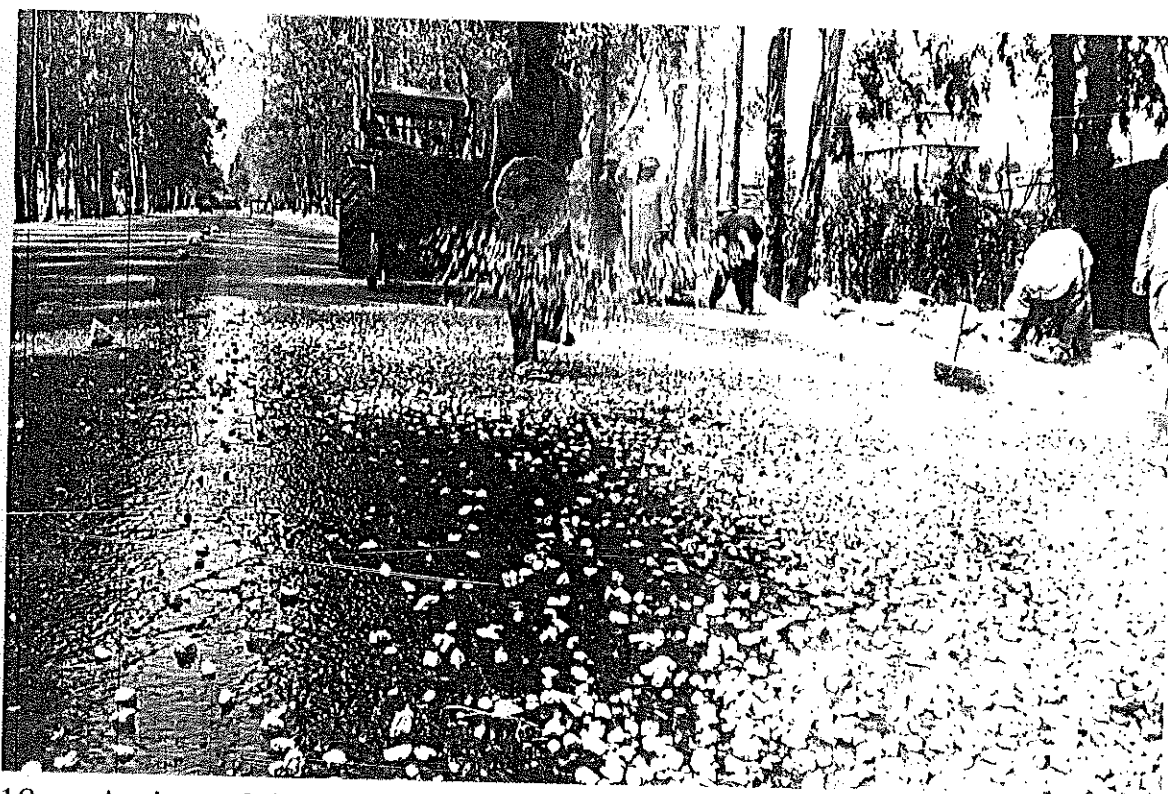
10. A view of double surface treatment works and also visible is blowing dirt

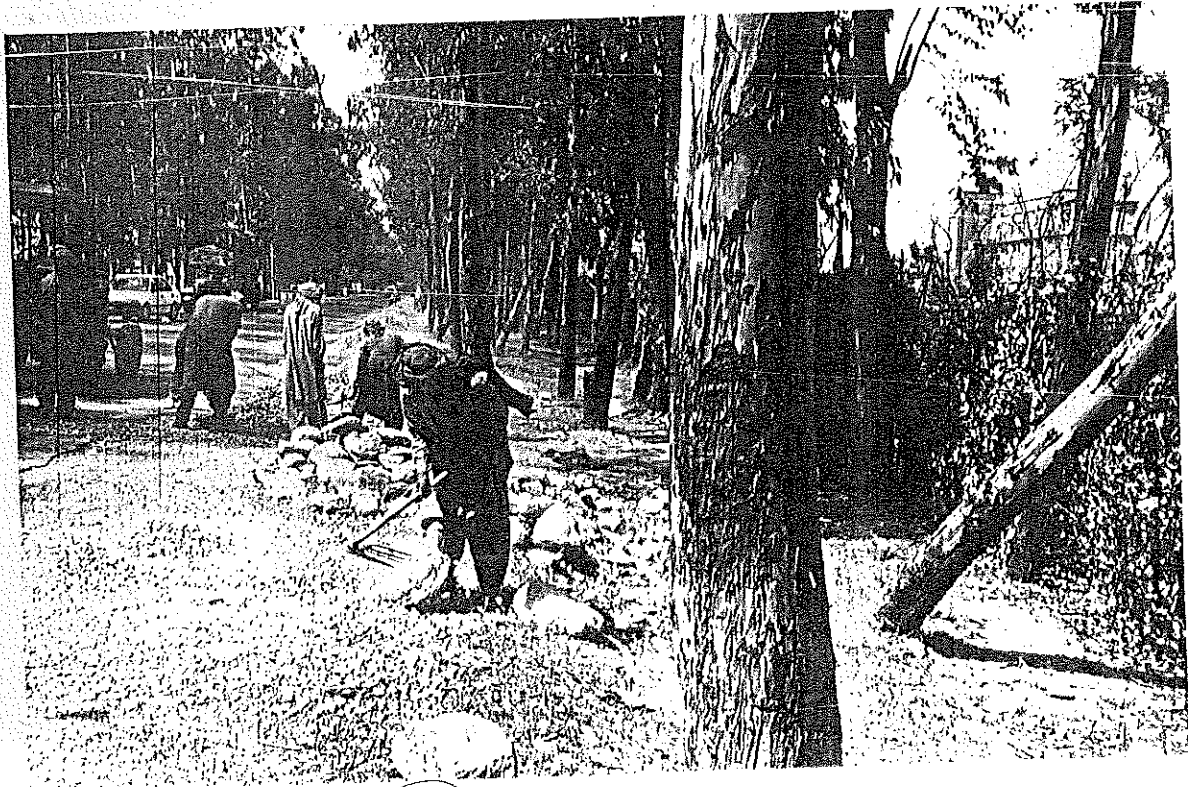
- i) Aggregates being spread over bitumen were found dirty, as shown in photographs.

- h) The aggregates used for double surface treatment were found dirty which retards adhesion to binder. Later on this action results in reduced riding quality due to stripping of aggregates.

11. Dirty aggregates being are clearly visible

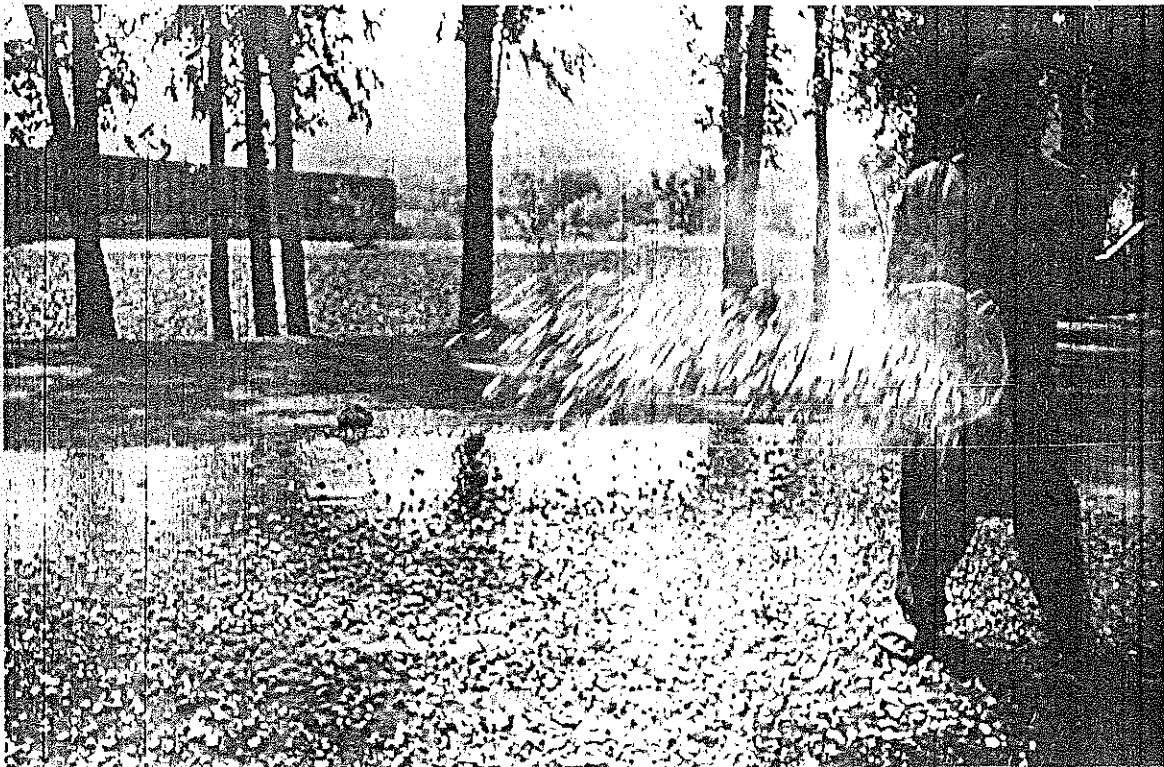
f) The aggregates used for resurfacing were twice (38mm) the specified size (18 mm - first course) and were being spread by twirling baskets, as against the specified mechanized method.

14. A view of DST work using out-dated bucket throughing technique ?
