LABORATORY TESTING
OF
KASHMIR HIGHWAY
(Zero Point – Aabpara Section)

LABORATORY TESTING
OF
KASHMIR HIGHWAY
(ZERO POINT - AABPARA SECTION)

May, 1996

NTRC examined the possible cause(s) of premature failure of Kashmir Highway through field visits, in-situ and laboratory testing of materials.

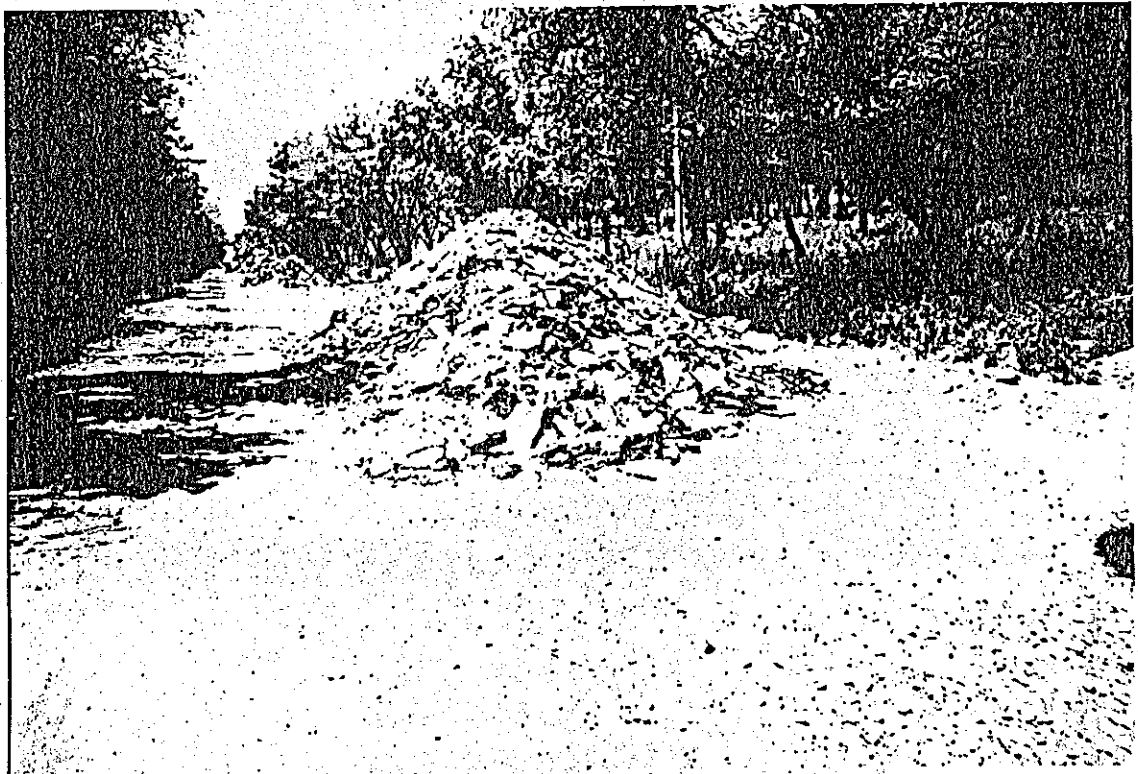
Fig. 5.1.1 Heap of Asphaltic binder and wearing course layers after removal by the bulldozer.

were found in heaps at site as may be see in photographs Fig. 5.1.1 to Fig.5.1.3

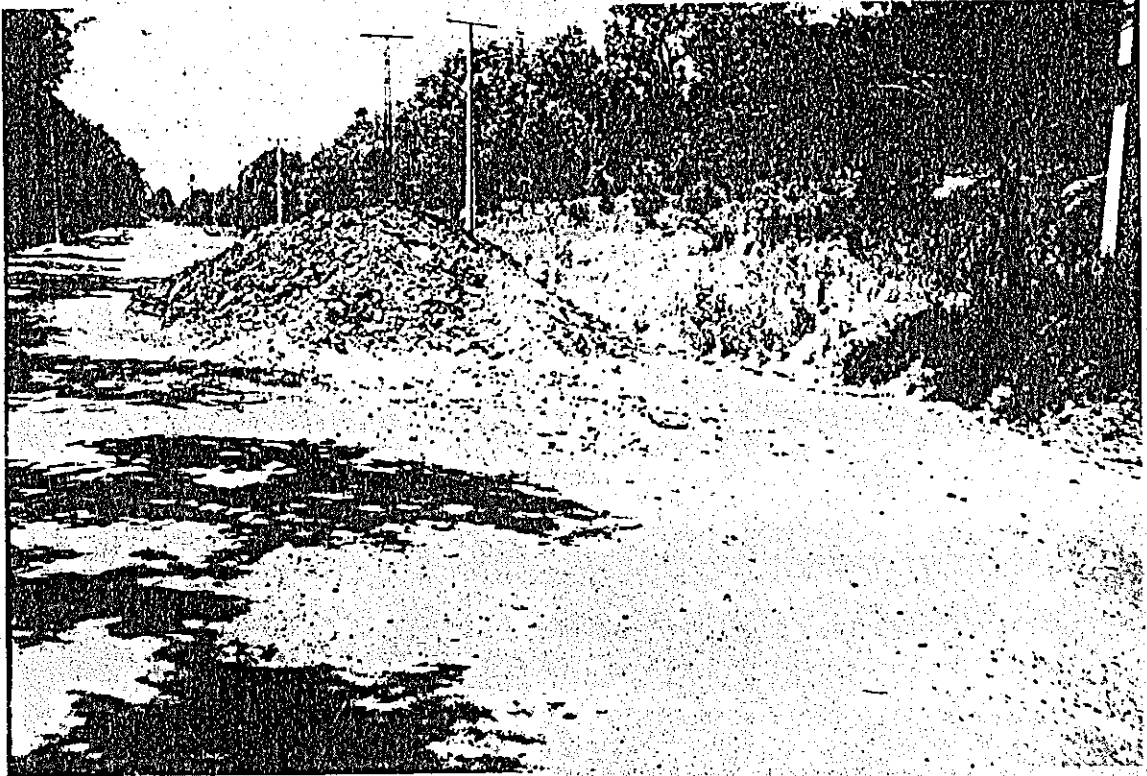
Fig. 5.1.2 Another site showing heap of asphaltic material

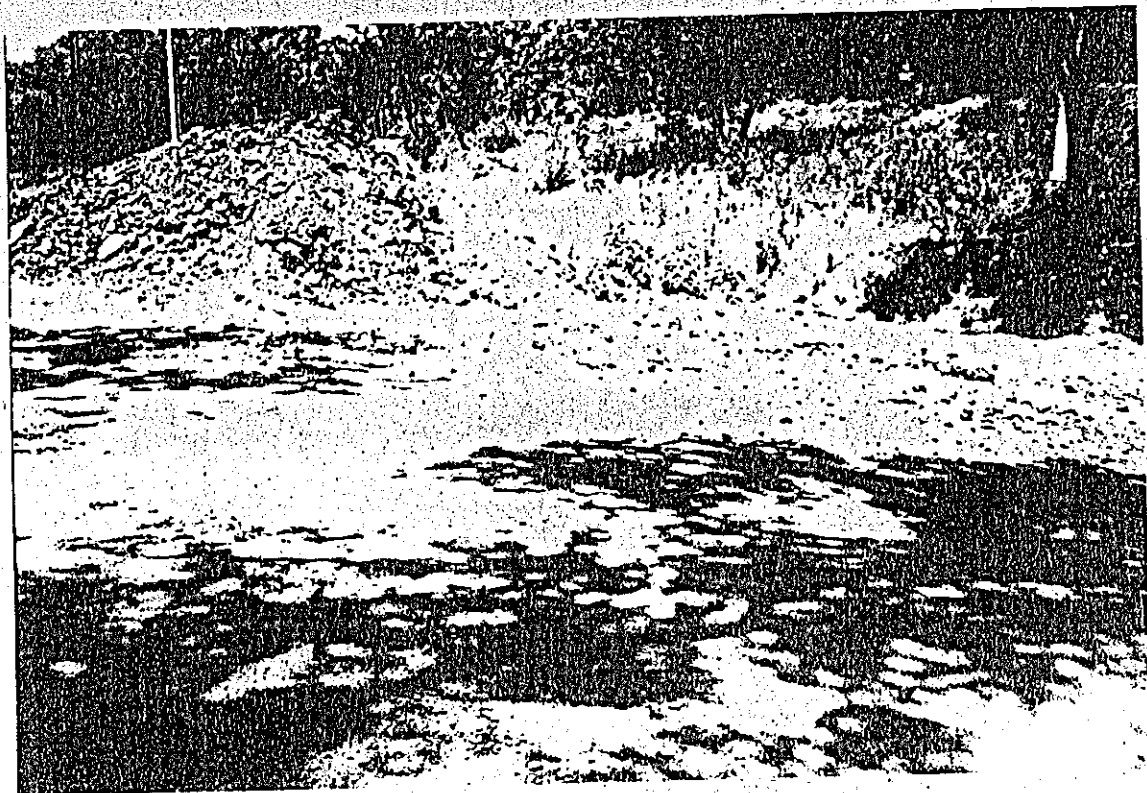
Fig. 5.1.3 Another place showing heaps of asphaltic layers.

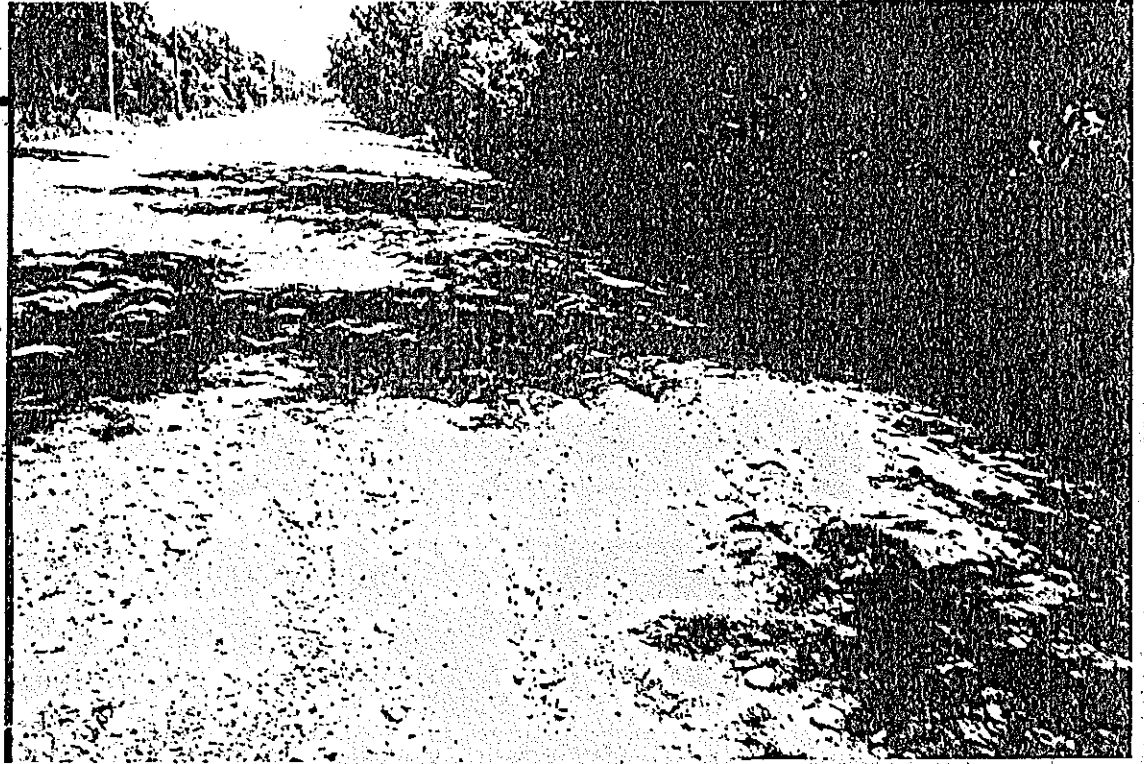
Fig. 5.1.4 At some locations, top of the base course layer has lost to some depth

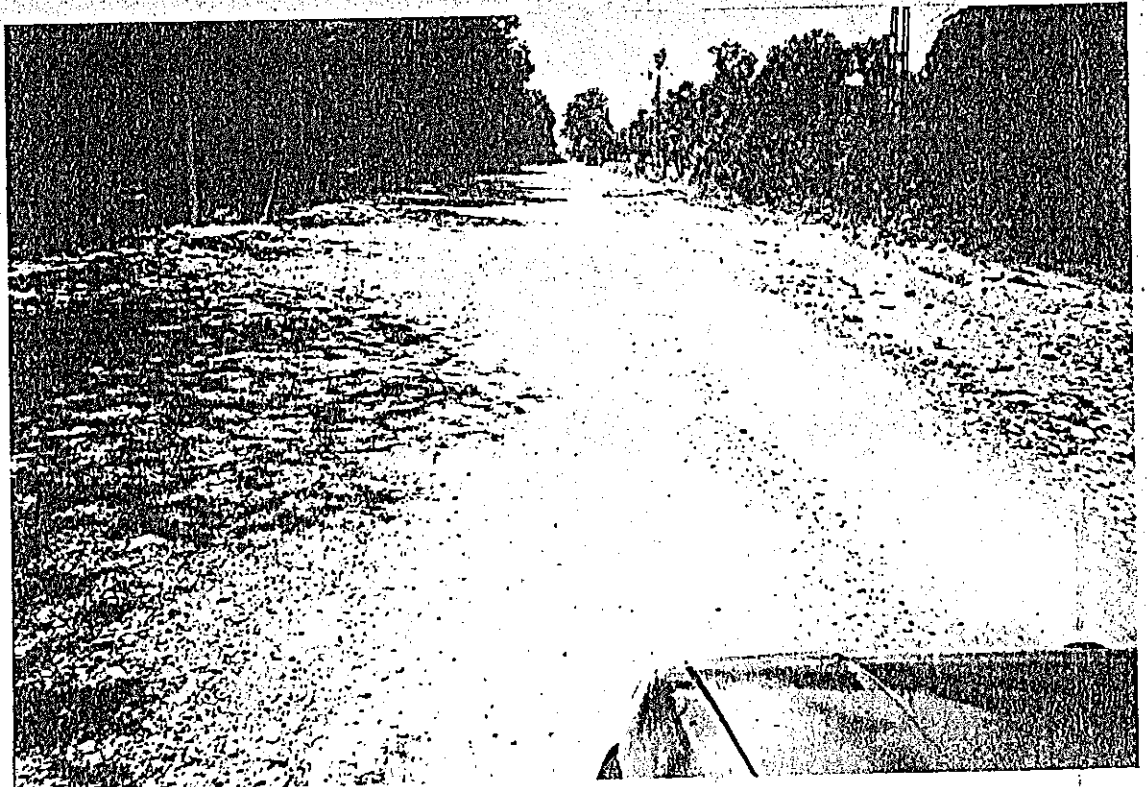
Fig. 5.1.5 Existing condition of the road surface after removal of Asphaltic Concrete surface.

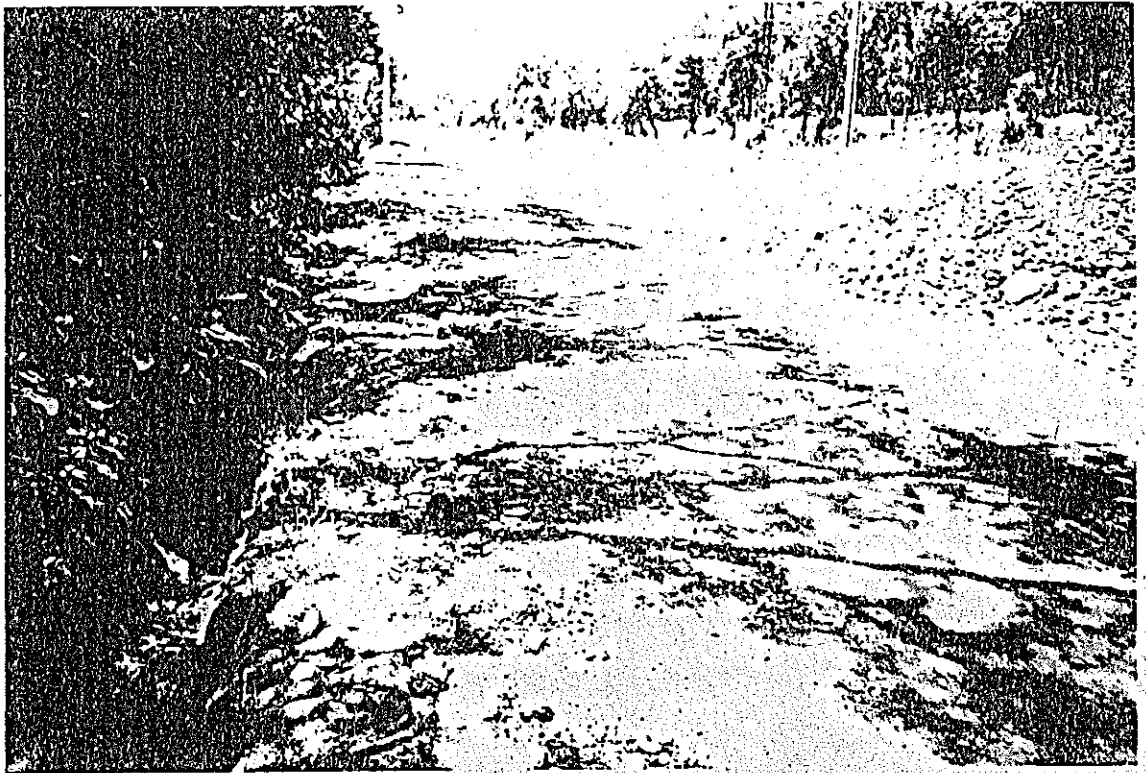
it was found being cleared off vegetation & deposited material by the CDA staff. Fig 5.1.6 shows the position of the drain. Fig 5.1.7 shows the drain being cleared by CDA staff, while Fig.5.1.8 shows the chocked drain on the left side of the road.

Fig. 5.1.6 Irregular shape and not properly maintained drain, filled with vegetation

- a) The bottom of the side drain was considerably less than 1.5 meter below the formation level required for efficient and safe discharge.
- b) The shoulders of the road section along most of its length were constructed with reverse slope to the pavement. This resulted in water creeping under the wearing surface and consequent stripping of the pavement layers.
- c) In Pakistan, soaked CBR is normally used as a criteria for designing of pavements. The test is an outdated one and has its limitations. Designing of pavement on the basis of soaked CBR value does not guarantee that the pavement would not fail under repeated heavy axle loadings once the subgrade becomes saturated due to poor drainage condition or rising of water table.
- d) There was a total lack of maintenance of the section. The side drains were found choked with vegetation.

On study site, the conditions of these portions of highway structure were found far from satisfactory. All drainage structures and appurtenances have to be kept in good working condition so as to provide free and unobstructed flow. Maintenance operations must be adequate enough to keep the ditches and culverts clean all the time. Those roads, that lack these operations normally meet the gate of failure. Conditions at the times of heavy rains and high water will give the best indication of the ability of drainage system to perform its functions properly without damage. Unfortunately this did not happen on Kashmir Highway.

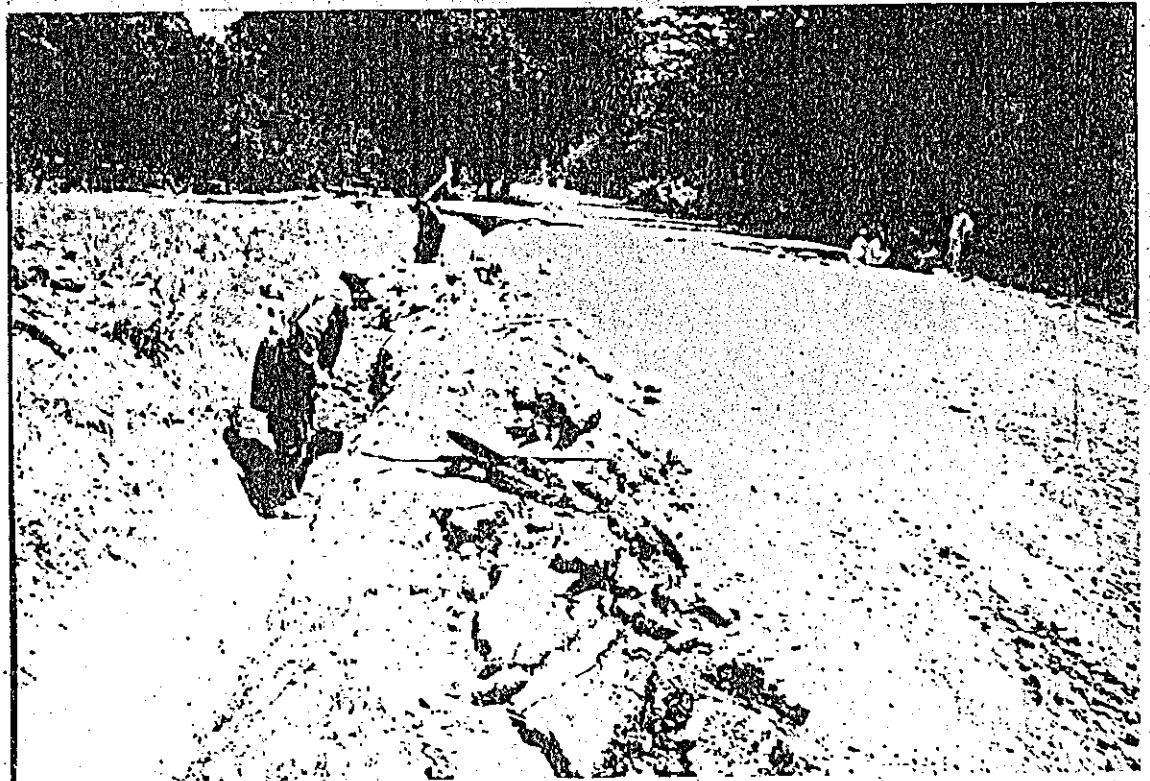
Fig. 5.1.7 Site drain was cleaning on the day of testing

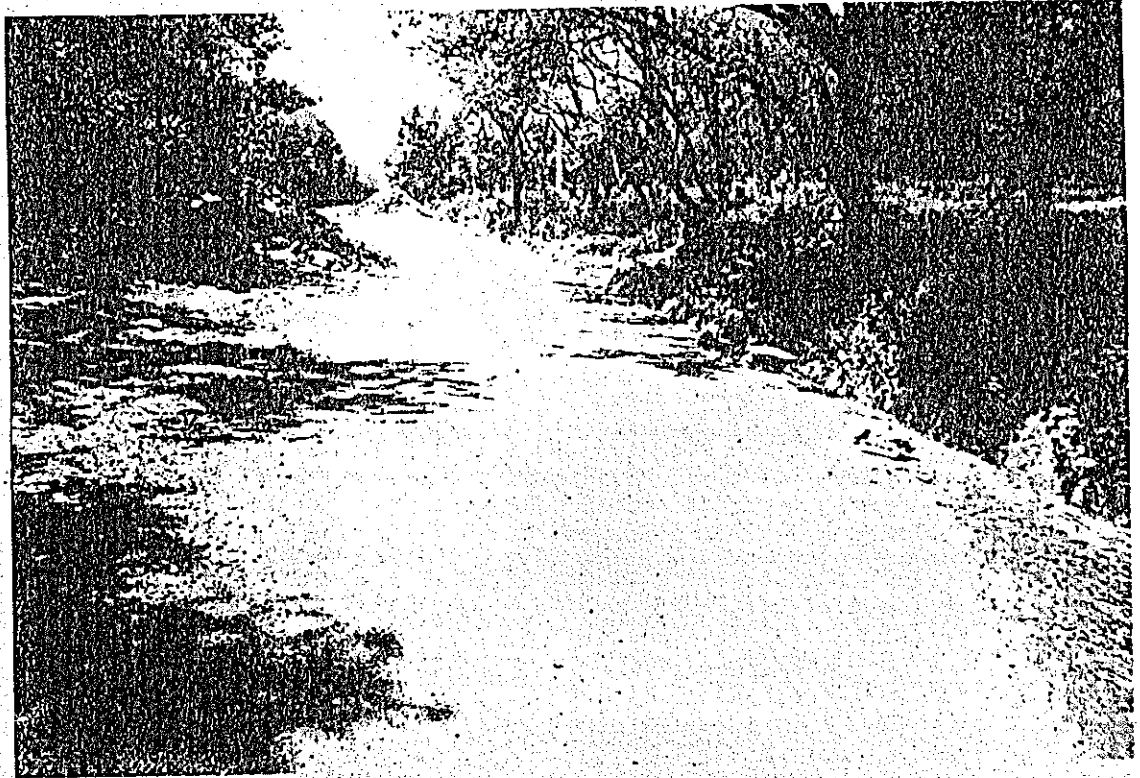
Fig. 5.1.8 Site drain on the left side of the road found chocked.

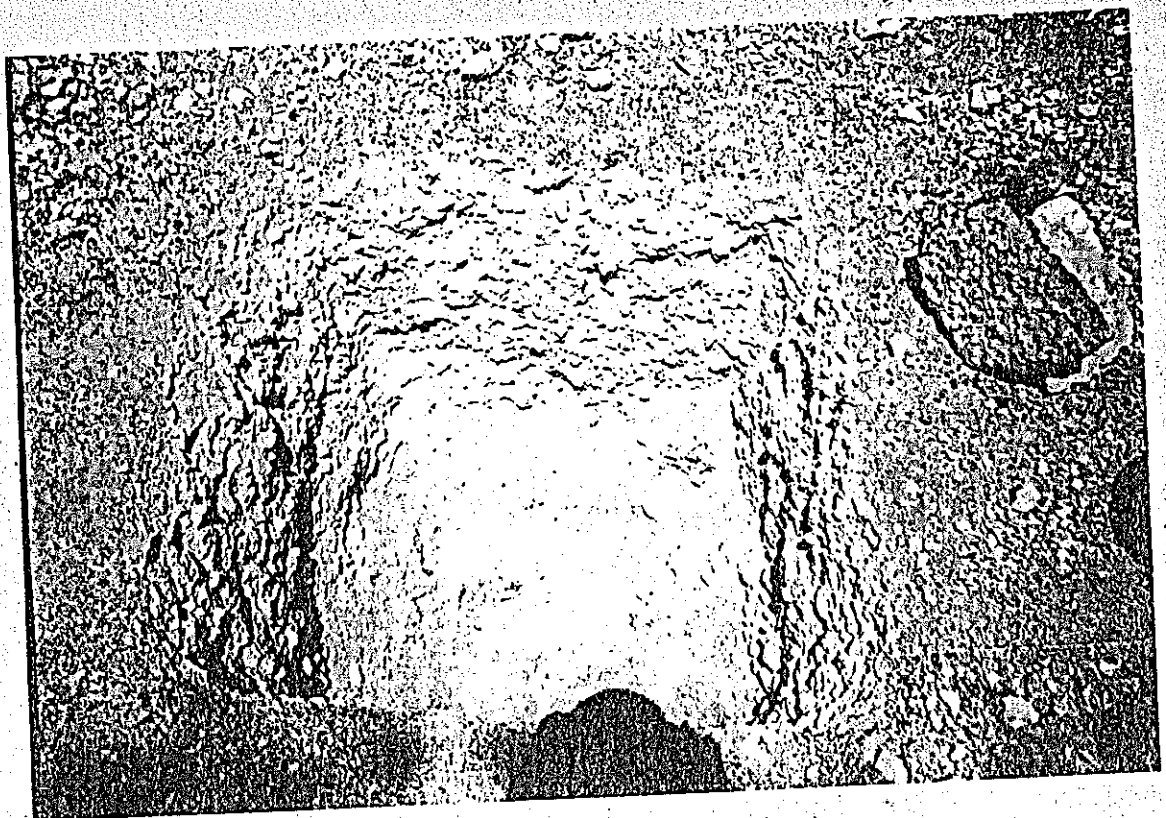
Fig. 5.2.1 Open pit No. 1 after completion of field density test by sand replacement method.

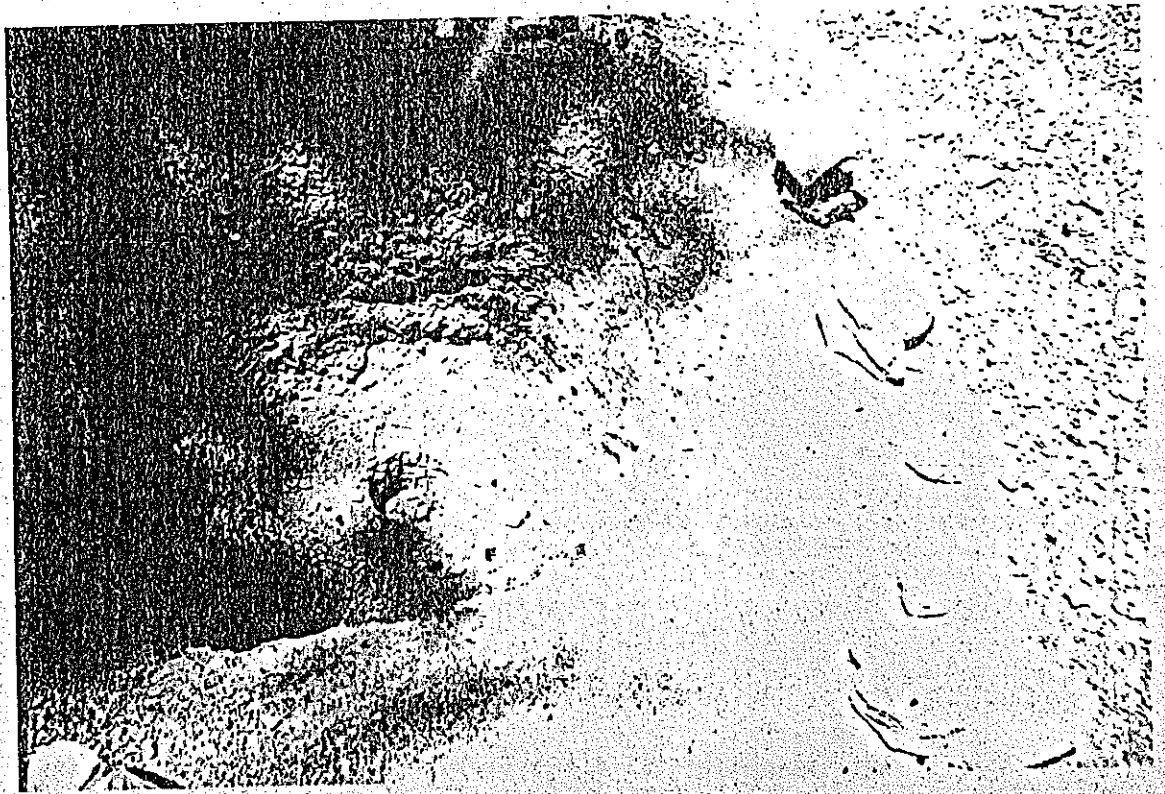
Fig. 5.2.2 Open pit No. 2 being tested by D.C.P.

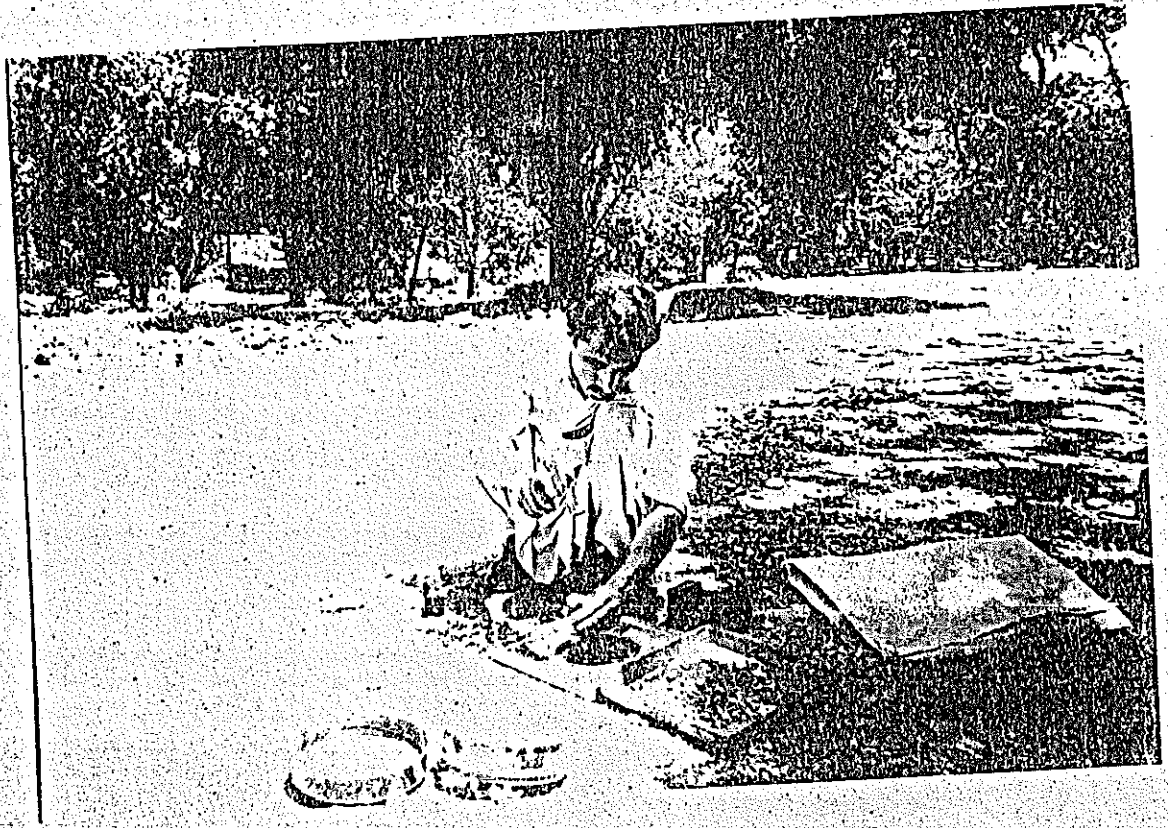
Fig. 5.2.4 Field density test of base course layer being carried out.
