# Overhead Bridge – Railway Crossing at Taxila

On Sarai Kala & Haripur Road

Bridge Directorate, Highway Department

May 2003

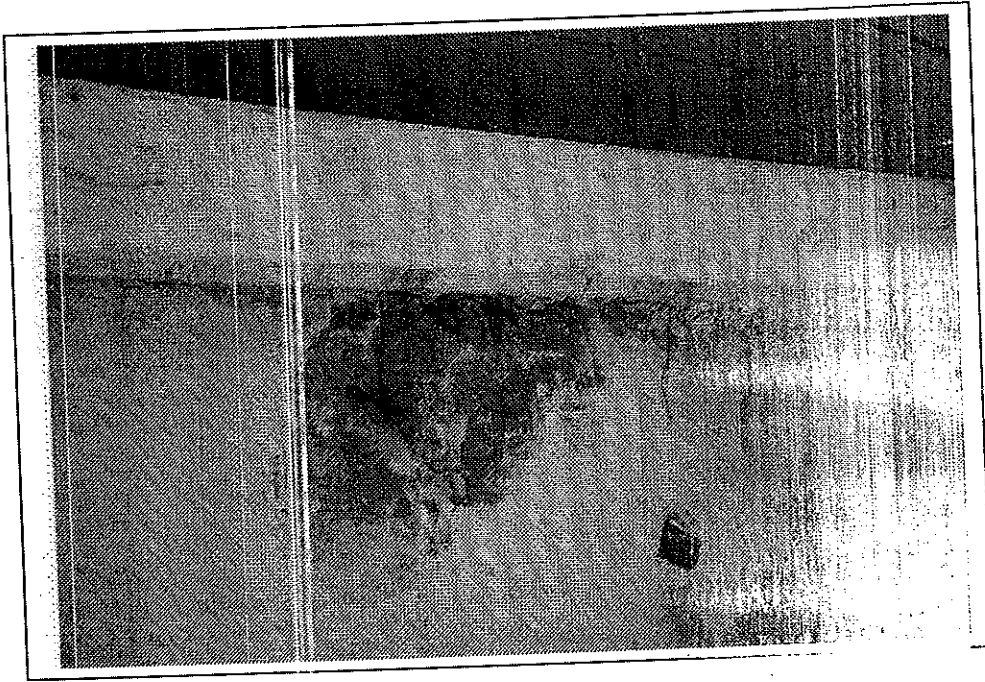
Figure 2. – Cracks in deck slab – view from ground level.

cracking at some locations. Figure 2. – shows cracks in deck slab. This view was taken from ground looking up. There is an indication of water leakage through the cracks. It was mentioned that a portion of the deck fell down and was replaced. Consequently some areas of the slab appeared to have been subsequently repaired. Cores were taken from certain visibly weaker areas of the slab. It would be interesting to see these cores as well as the results of any tests done on them.

- A 6000 psi @ 28 days concrete seems adequate for the required design strength. However, the quality of workmanship of the cast-in-place concrete appears to be questionable. It is suggested therefore that random core samples be taken and tested to determine the matrix and strength of the concrete in the deck slab. This would be the first measure to determine what remedial action if warranted should be recommended.  
Also, the actual location and the amount of reinforcing bars should be verified by non-destructive means. This is to ensure that their placement was done in accordance with the design drawings.

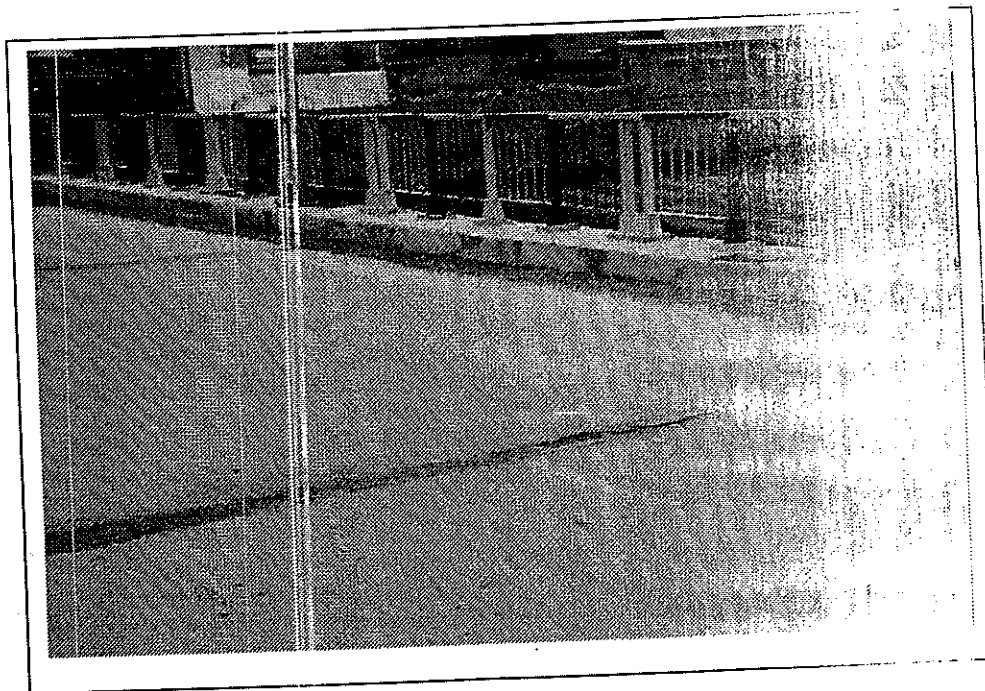
Figure 3. – Location of railing, lamp-posts and manholes in the area.

5. **Manholes in the Footpaths:** The reinforced concrete covers over the manholes are non-existent. Consequently, water and trash is gathering in the holes. This is not only an undesirable situation for the reinforcing but also the PVC pipes that are being damaged.

6. **The Lamp Posts:** The 3'-0" width of the walkways is partially consumed by the lampposts making it difficult for the pedestrians to walk on. These lampposts could have been located closer to edge of walkways. Figure 3. shows the location of railing, lampposts and manholes in the foot path.

- Manholes in the footpaths be cleaned and covered with the lids. Also the manholes should be provided with drain holes. This will enhance the overall service life of the structure.

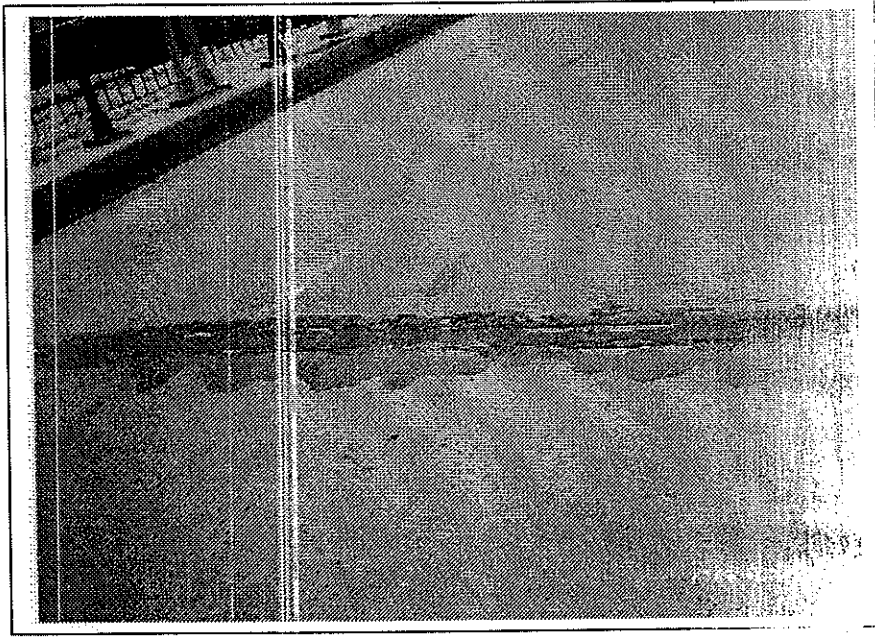
Figure 4. – Typical Expansion Joint – Asphalt have been used as an effective repair

2. **Deck Expansion Joints:** Almost all of the deck expansion joints have deteriorated and malfunctioning. They vibrate and create a lot of noise under traffic. The joint plates are broken off at locations and asphalt cover has been used as an ineffective repair. Water and dirt is leaking through these joints on to the bridge seats. Figure 4. shows a typical expansion joint. Figure 5. – shows a close-up view of the expansion joint shown in Figure 4.
3. **Deck Drainage:** Although deck is being drained due to slopes, a number of deck spouts are plugged and water is not draining through them.
4. **Approach Ramps:** On the roadway portion of the approach ramp a few soft pavement spots could be noticed. These may be attributed to insufficient compaction of the fill material beneath or thinner pavement. Figure 6. – shows a typical softer spot in the pavement of the approach ramp.

- The current expansion joints are weak both from the design and from the actual performance points of view. These joints should be replaced with those with a modified design. The new design should have wider and thicker plates.

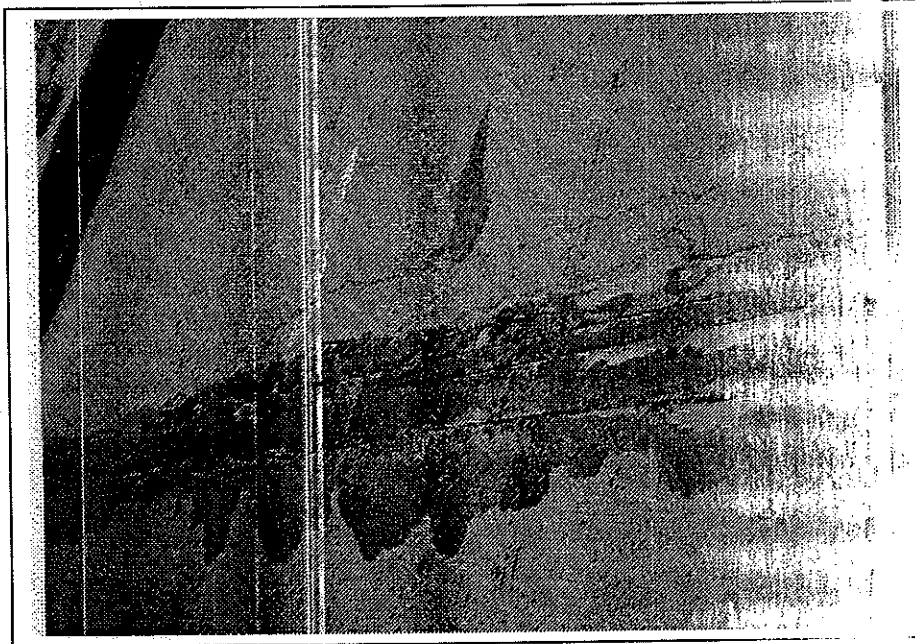
Figure 5. – A close-up view of the Expansion Joint shown in Figure 4

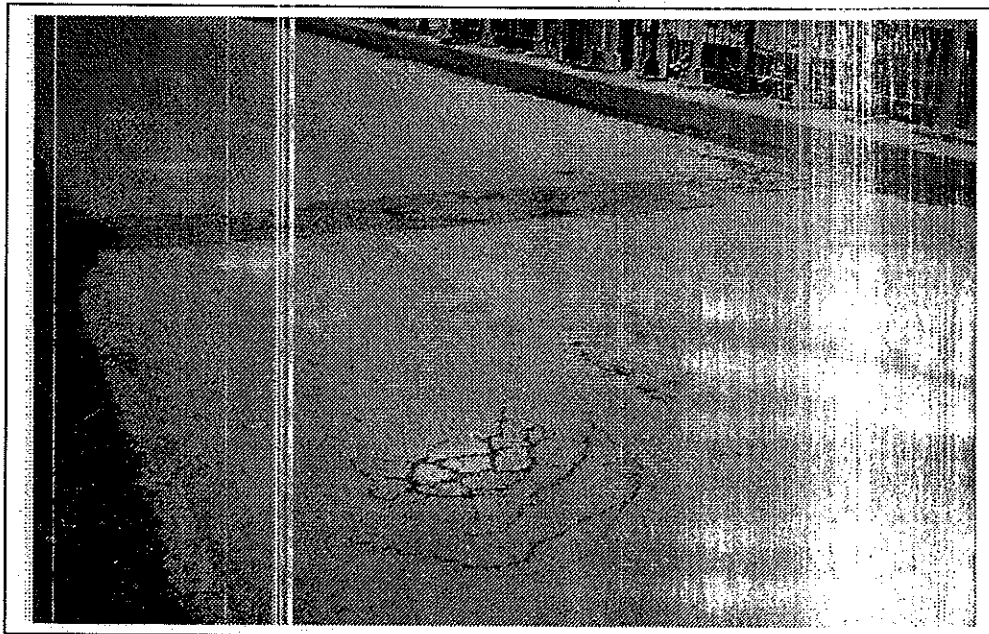
Figure 6. – A typical softer spot in the pavement of the approach ramp

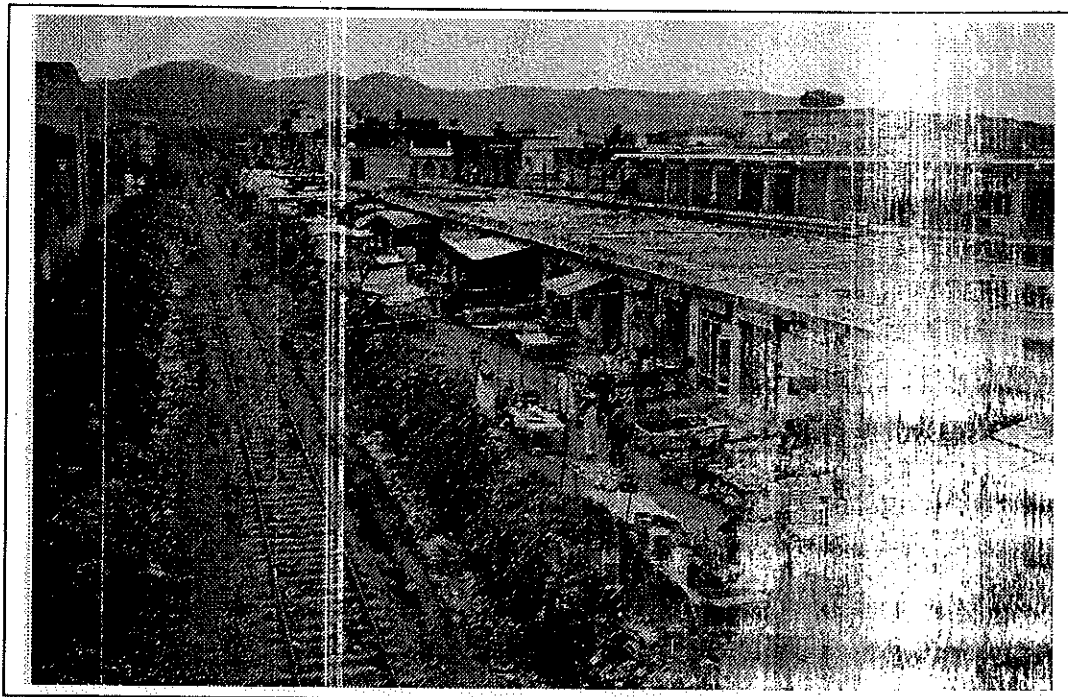
8. **Crossing Length:** For a mere railroad crossing, for an onlooker this structure seems unusually long. Understandably ramps are intended to provide a 3% grade. However, the trucks operate over the road at a reduced speed. A few trucks were seen using the service roads below on both sides of the structure. The structure is also dividing this quarter of the town into two whereby certain streets are blocked permanently by the structure. This structure could have been built shorter to avoid or minimize the above-mentioned issues as well as to save costs. This overhead structure could have been located at a less busy part of the town to prevent blockage of the street in the middle of the town. Figure 7. – shows a view from the bridge – the busiest part of the town

Figure 7. – A view from the bridge – the busiest part of the town
