NATIONAL TRANSPORT RESEARCH CENTRE

REPORT  
ON  
LAHORE - ISLAMABAD MOTORWAY

NTRC-201

June, 1997

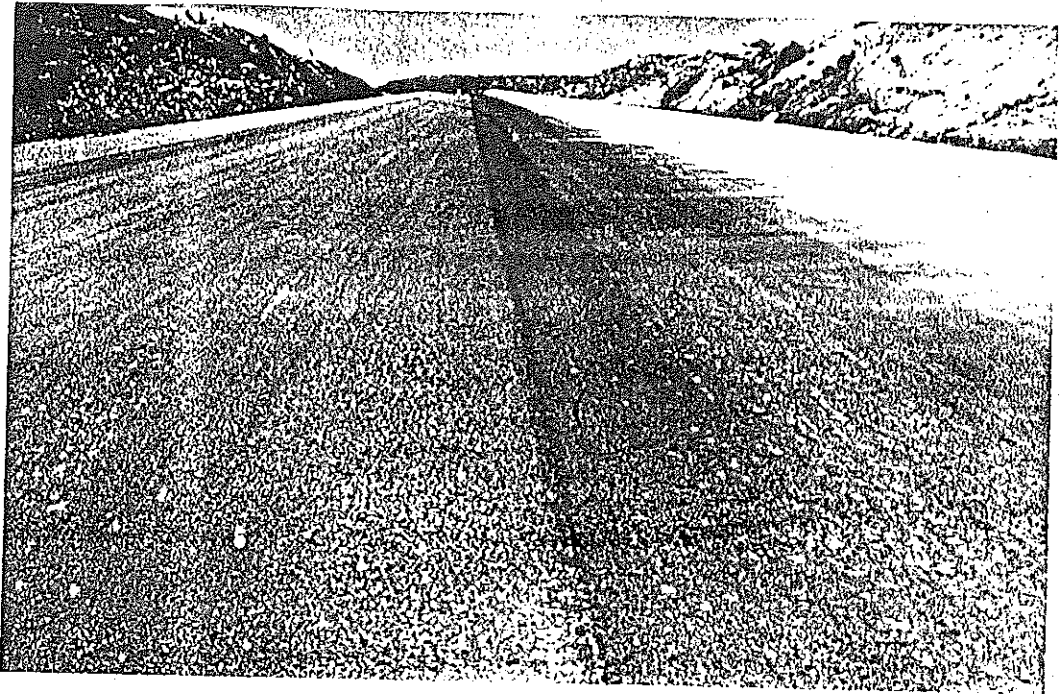
4.1 Surface Distress & Riding Quality: In order to check the surface distress such as cracking or rutting, thorough visual inspections were made along the whole length of section-III and section-IV and some locations randomly selected were thoroughly inspected. It was observed that riding surface was generally in good condition and there were no visible signs of any distress in the form of rutting or cracking. Plate-1 and Plate-2 exhibits close view of the surface showing no signs of any type of distress cracking or rutting. Similarly Plate-3 and Plate-4 show the longitudinal view of the pavement were no signs of distress in the form of rutting are observed. During the visual inspection of the surface, it was observed that road roughness was being checked using ARRB profilometer. The display of the profilometer showed the International Roughness Index (IRI) of 1.5 meter/kilometer. The IRI of 1.5 m/km is the roughness requirement for the Motorway at the time of its opening. Plates- 5 & 6 show the profilometer at work.

PLATE-3 : LONGITUDNAL VIEW OF MOTORWAY SURFACE

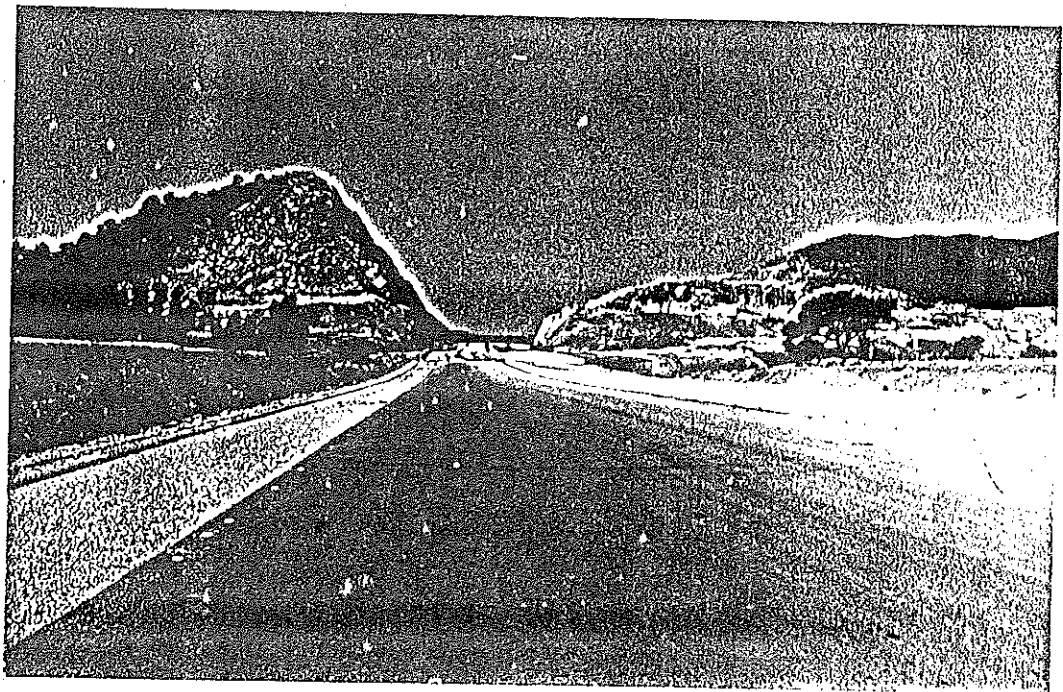
PLATE-4 : LONGITUDNAL VIEW SHOWING NO DISTRESS

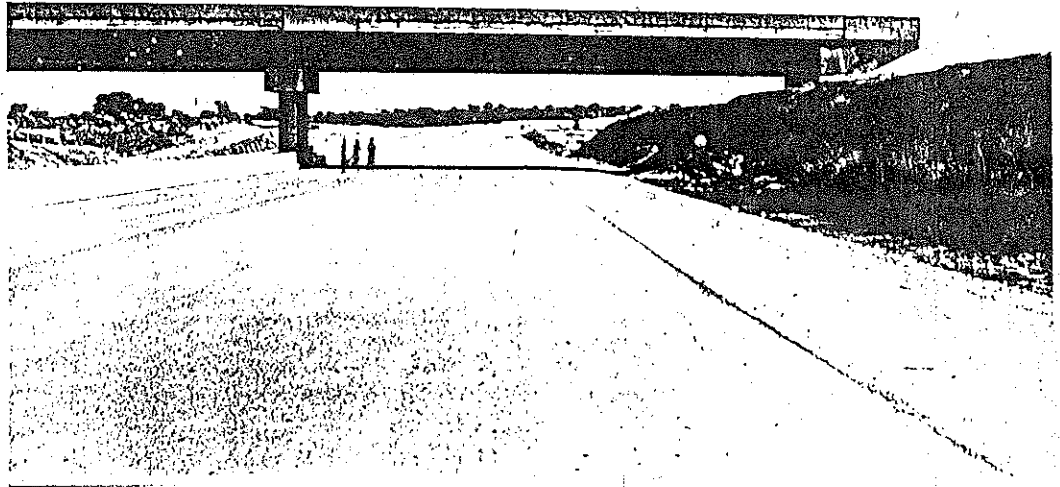
4.2 Fly-Over Bridges: It was also observed that at certain locations, the fly-over bridges on the motorway were without approach roads. No construction activities were

seen on the approaches which means that opening of the motorway to traffic without providing grade separated crossing facilities would pose serious safety hazards both for the Motorway traffic and the traffic crossing the Motorway. Plates-7 and 8 show the problem.

PLATE-7 : FLYOVER BRIDGE WITHOUT APPROACH ROAD

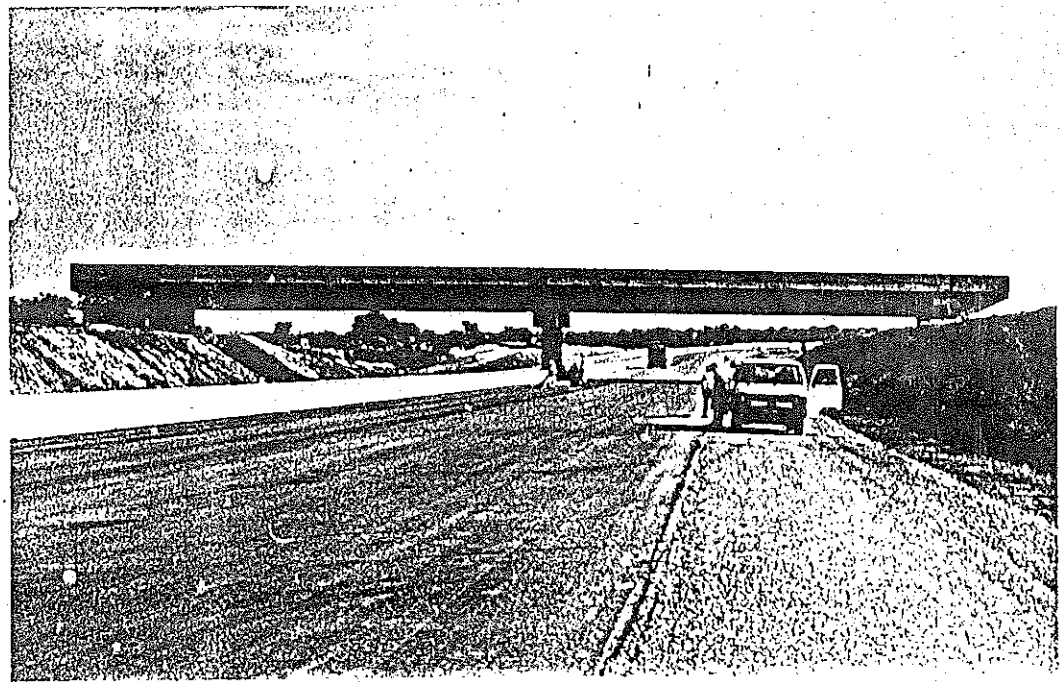
PLATE-8 : ANOTHER VIEW OF HANGING FLYOVER BRIDGE WITHOUT APPROACH ROAD

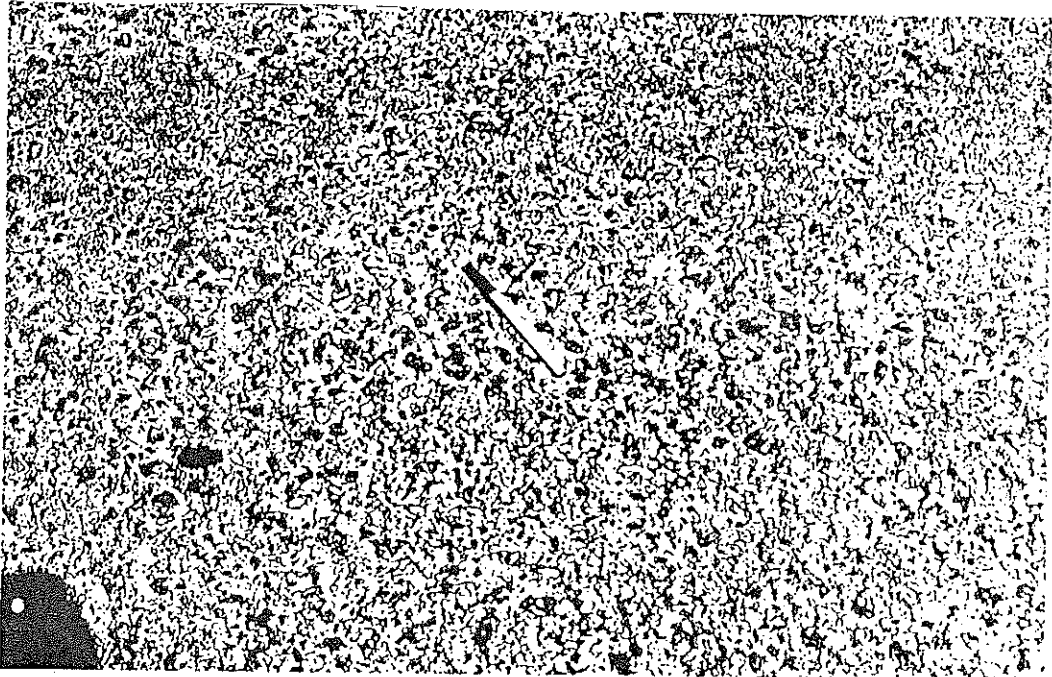
4.3 Binder Course Sections: At some locations only the binder course was laid on pavement and wearing course is still to be laid. This leads to confusion to the vehicle user about the riding quality at such sections. Plates-9 & 10 show such locations.

PLATE-9 : BASE COURSE SURFACE, WEARING COURSE STILL TO BE LAID

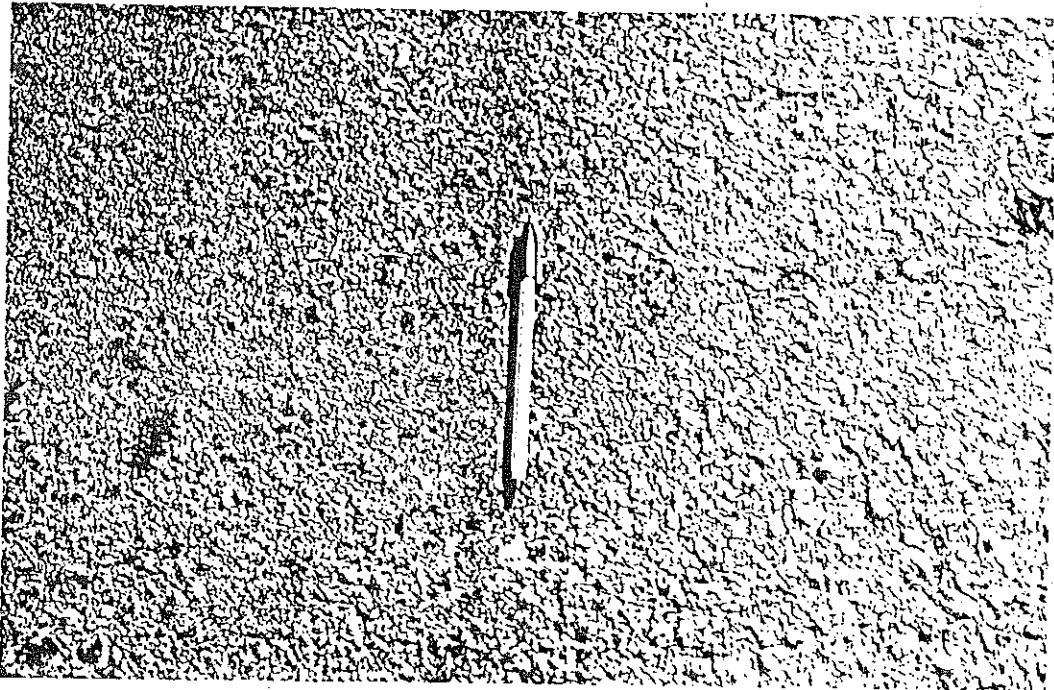
PLATE-10 : ANOTHER VIEW OF SURFACE TEXTURE ON BASE COURSE WITHOUT WEARING COURSE

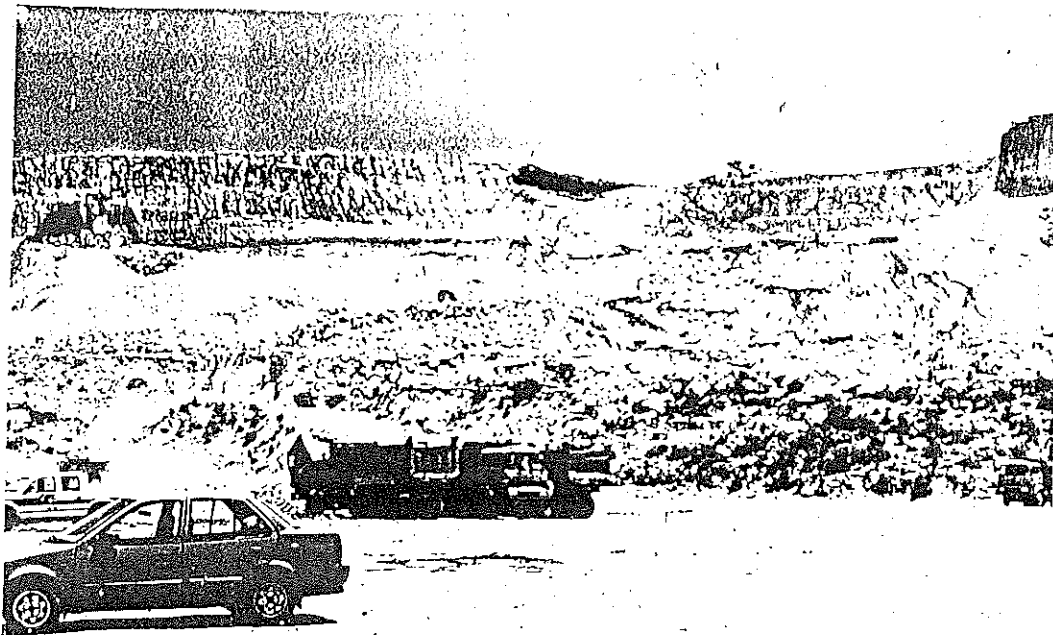
4.4 Landslide Problem in the Salt Range Area: The Motorway is passing through the salt range area near Kaler Kahar in about one kilometer length. When the hill was blasted to make the roadway, the land slide phenomena started. According to the consultants, they have properly designed the slopes keeping in view the geological properties of the rock and after removing the over burden material, they will bring the hill side to the proper slope and shall also provide stepping/benching. According to the Assistant Resident Engineer of the consultant M/s SMEC, gabions would also be placed to prevent the land sliding. According to the consultants, it is only a matter of time and when enough overburden material is removed from the top hill, the slopes will become stable. Plates-11 to 14 exhibit the landslide problem and the construction activities going on the site.

PLATE-12 : ANOTHER VIEW OF CONSTRUCTION ACTIVITIES IN LANDSLIDE AREA

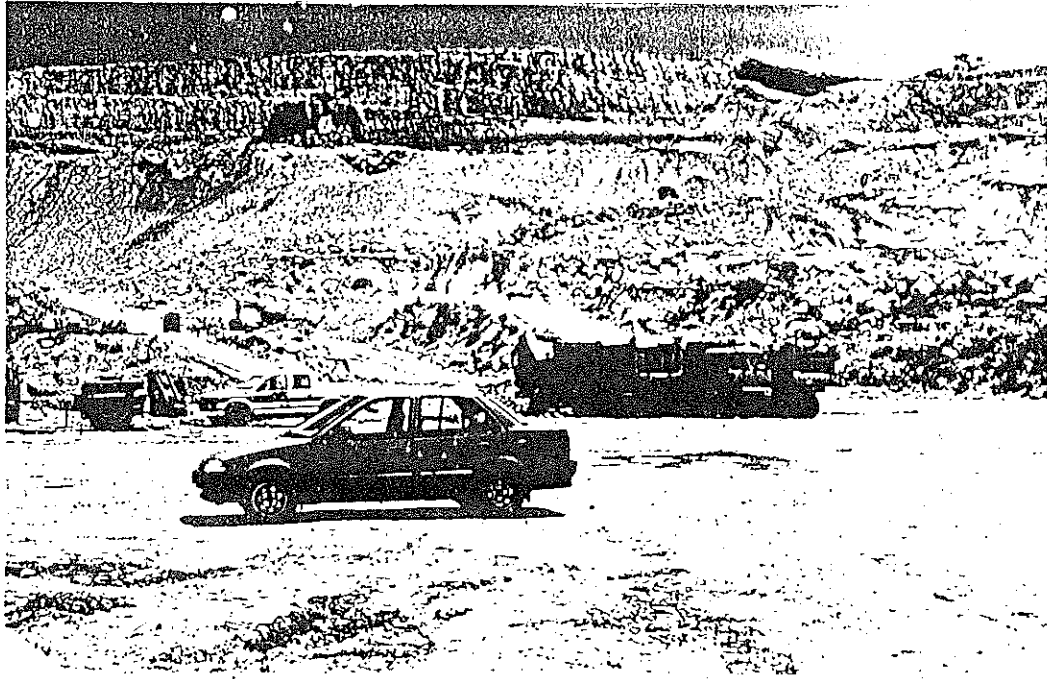
PLATE-13 : OVERBURDEN MATERIAL BEING REMOVED FROM  
SLIDING AREA

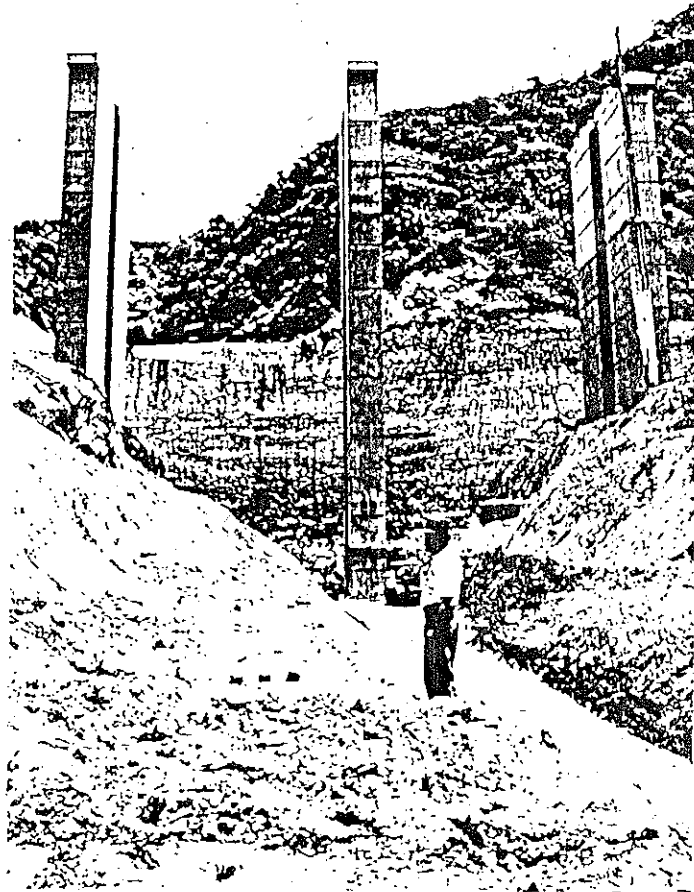
4.5 Observations at C-6 Bridge : The main problem at C-6 bridge was tilting and development of cracks around the height of the bridge piers. The bridge piers are about 270 feet high. The tilting and cracking in the piers developed due to un-balanced earth filling around the piers. The contractor filled earth around the piers so that gantry cranes could be put near the bridge piers for hoisting the bridge girders. In fact, the contractor's technique of hoisting bridge girders using gantry cranes was not in line with the procedure laid down in the contract document. In fact the contractor should

PLATE-15 : PIER AT C-6 BRIDGE (SIGNS OF EARTH FILLING  
UPTO TOP OF THE PIER ARE VISIBLE)

have used the launching platform to hoist the girders. Now the filling around the piers have been removed and the hollow section of the pier is injected with cement concrete. After removal of the earth filling around the piers and injection of cement concrete, the cracks have been rectified and the bridge piers are now in correct position. The contractor has also mobilized proper launching platforms for hoisting the girders. Plates-15 to 19 show the problems encountered and the present position after remedial measures.

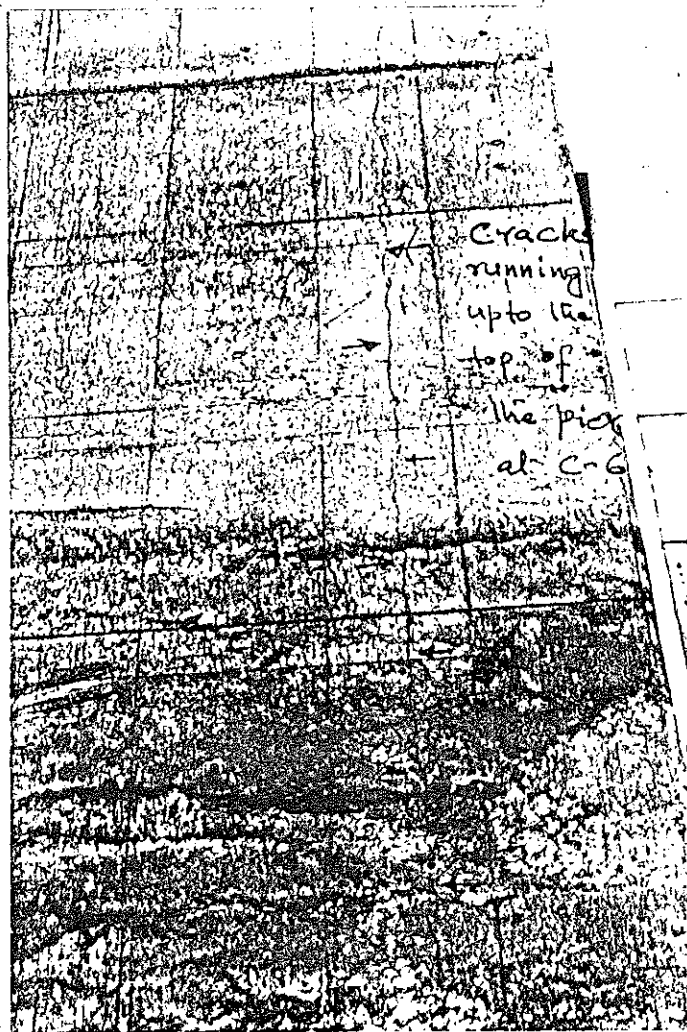
PLATE-16: LONGITUDINAL CRACK IN THE C-6 BRIDGE'S PIER  
DUE TO UN-EVEN EARTH FILLING

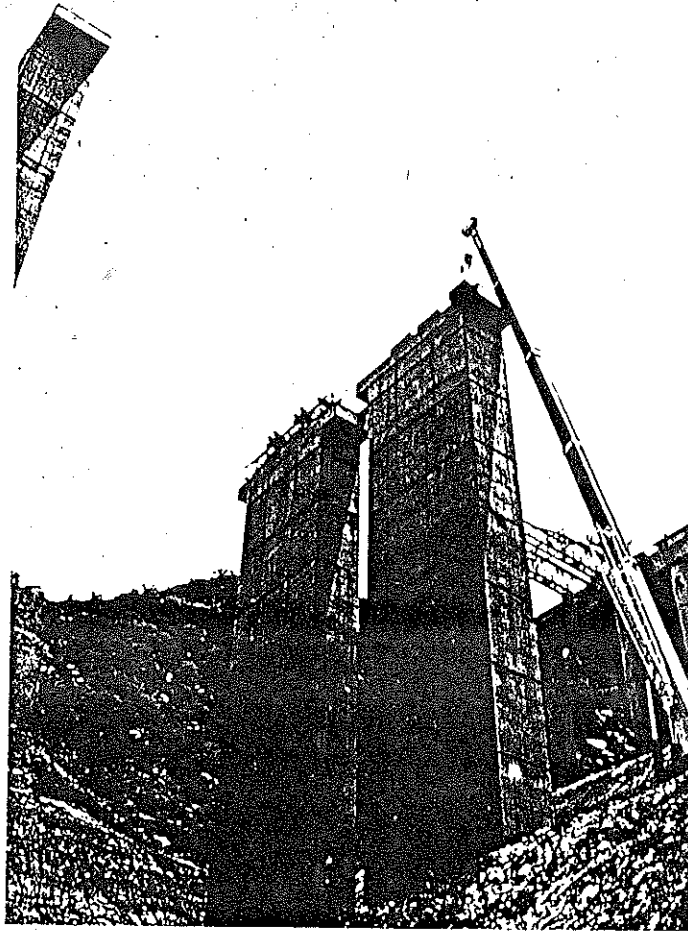
PLATE-17: GANTRY CRANE PLACED AT THE EARTH FILLING TO HOIST THE BRIDGE GIRDERS. LAUNCHING PLATFORM IS ALSO SEEN IN THE PHOTOGRAPH

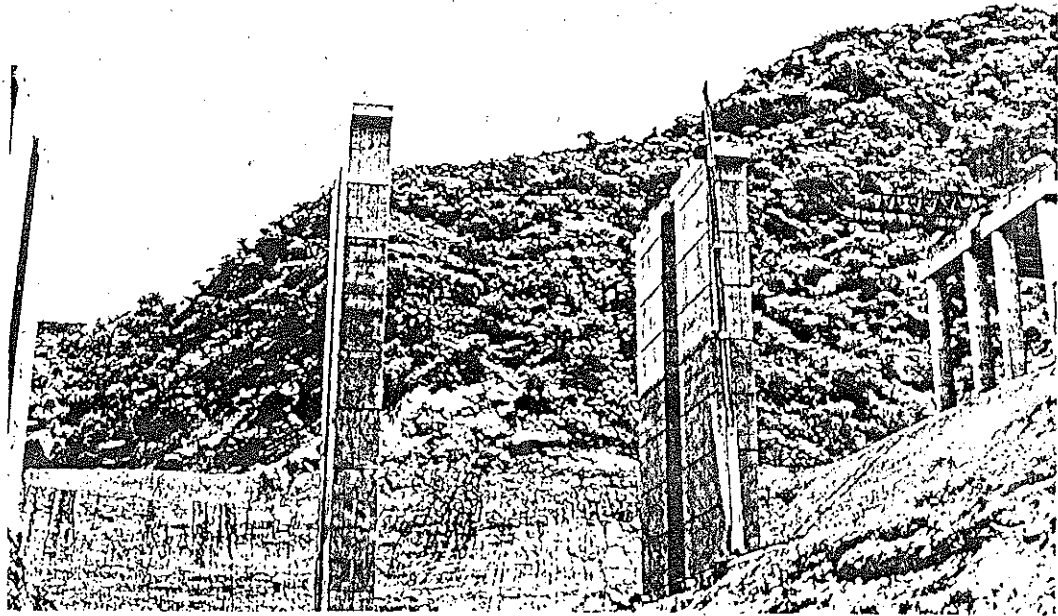
PLATE-18 : GANTREY CRANE AND LAUNCHING PLATFORM SEEN IN THE PHOTOGRAPH

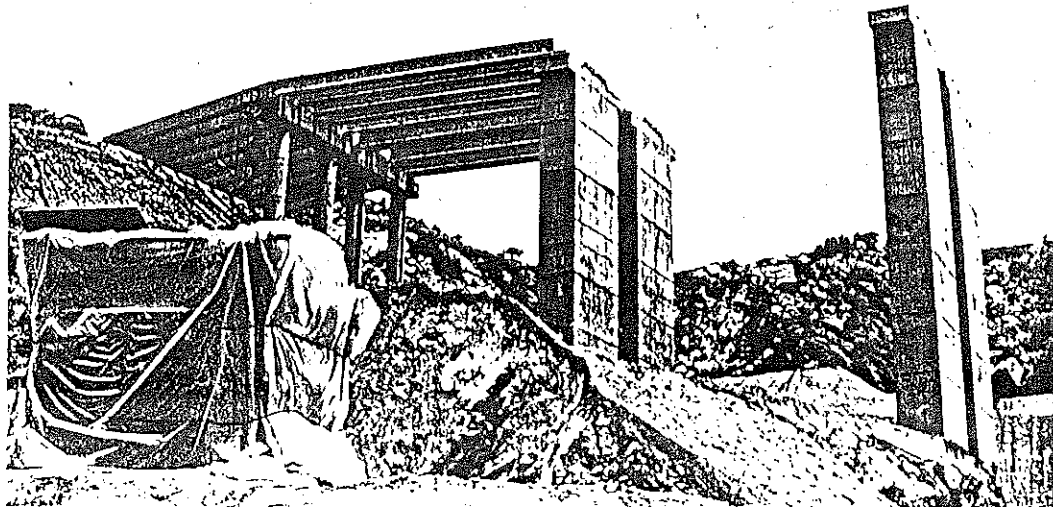
PLATE-19 : GIRDERS ARE HOISTED ON THE PIERS

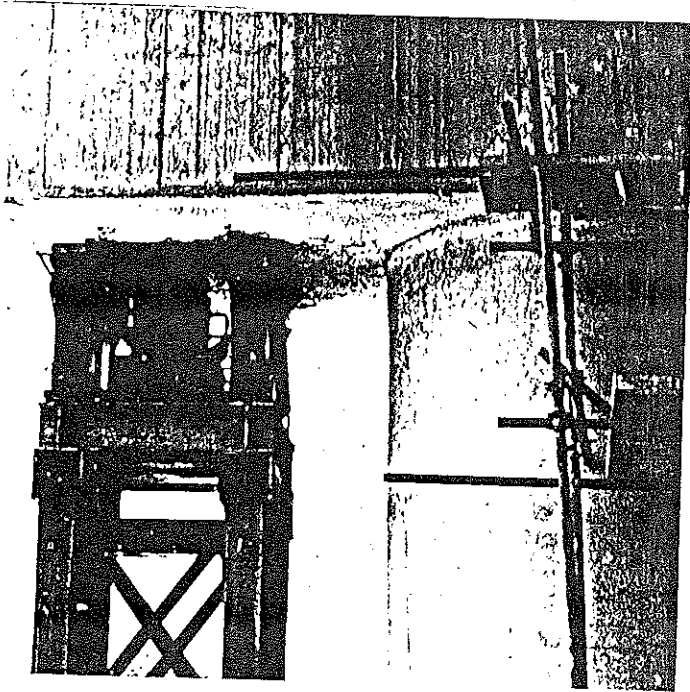
**4.6 Observations at C-5 Bridge:** The problem at C-5 bridge appeared in the form of cracks in the pier cap due to settling down of one pier of the C-5 bridge. This problem has been overcome by placing two RCC foundations adjacent to the problematic pier. On top of the RCC foundations, heavy steel columns have been put and after jacking up the pier cap to its original position using high pressure pneumatic jacks, steel plates have been pushed under the pier cap to fill the gap. After bringing the pier cap into the original position, the jacks have been released. The cracks in the pier cap have been properly drilled out & filled up with proper epoxy material. Plates-20 to 21 show the treatment made to C-5 bridge.

PLATE-20 : PIER CAP JACKED UP AND STEEL COLUMN PLACED UNDER THE CAP

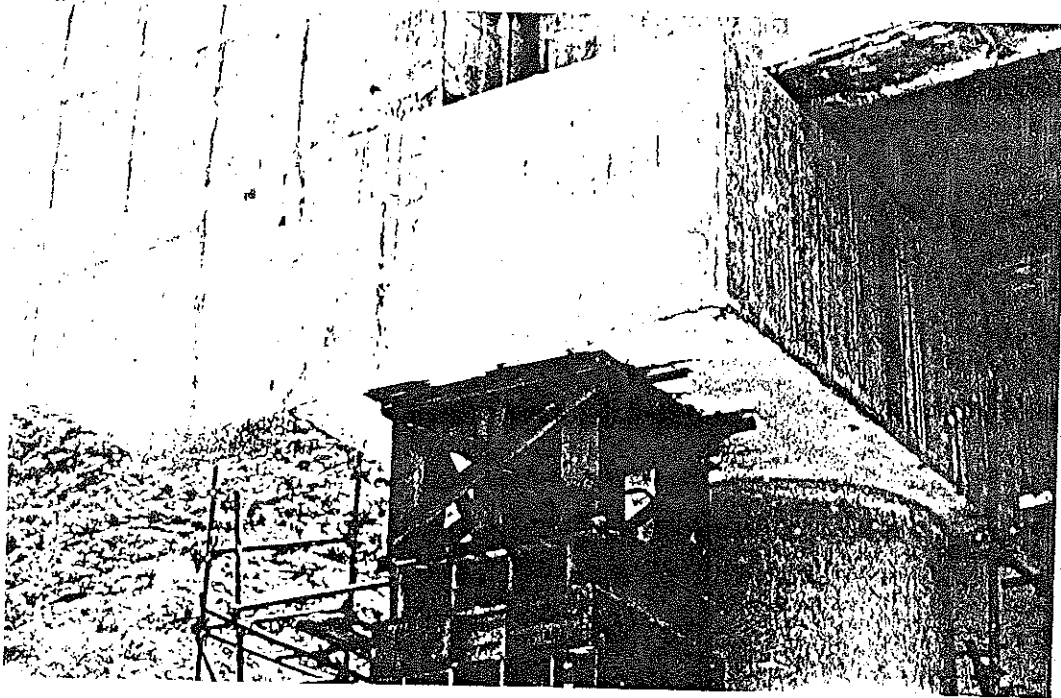
PLATE-21 : ANOTHER VIEW OF STEEL COLUMN UNDER THE PIER CAP

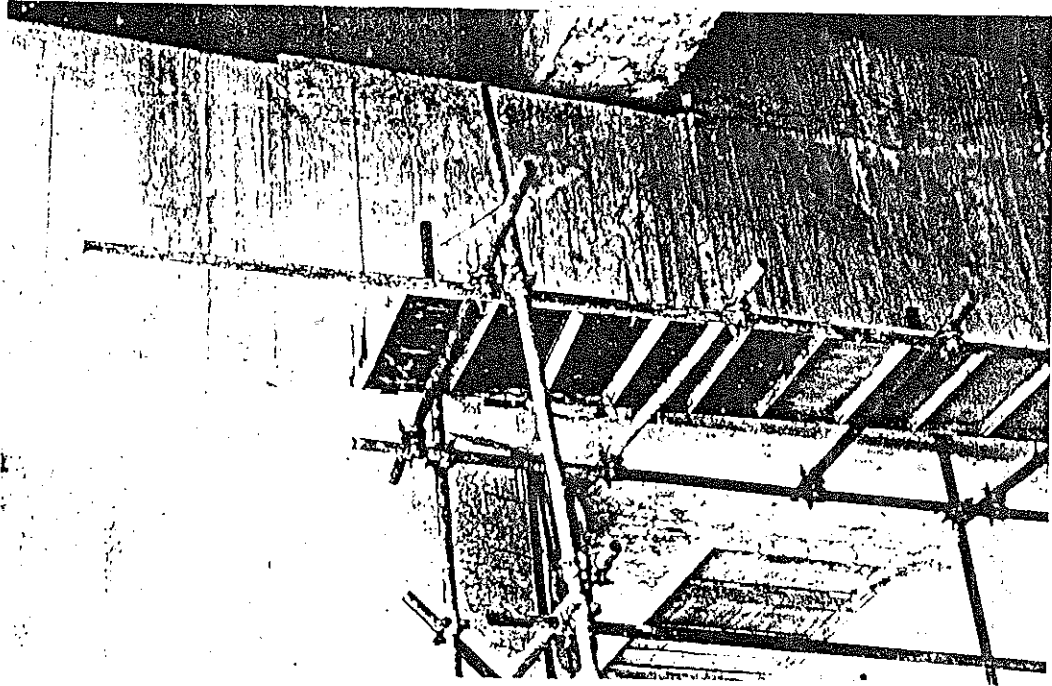
PLATE-22 : THE CRACKS IN THE PIER CAP DRILLED OUT AND FILLED WITH EPOXY MATERIAL

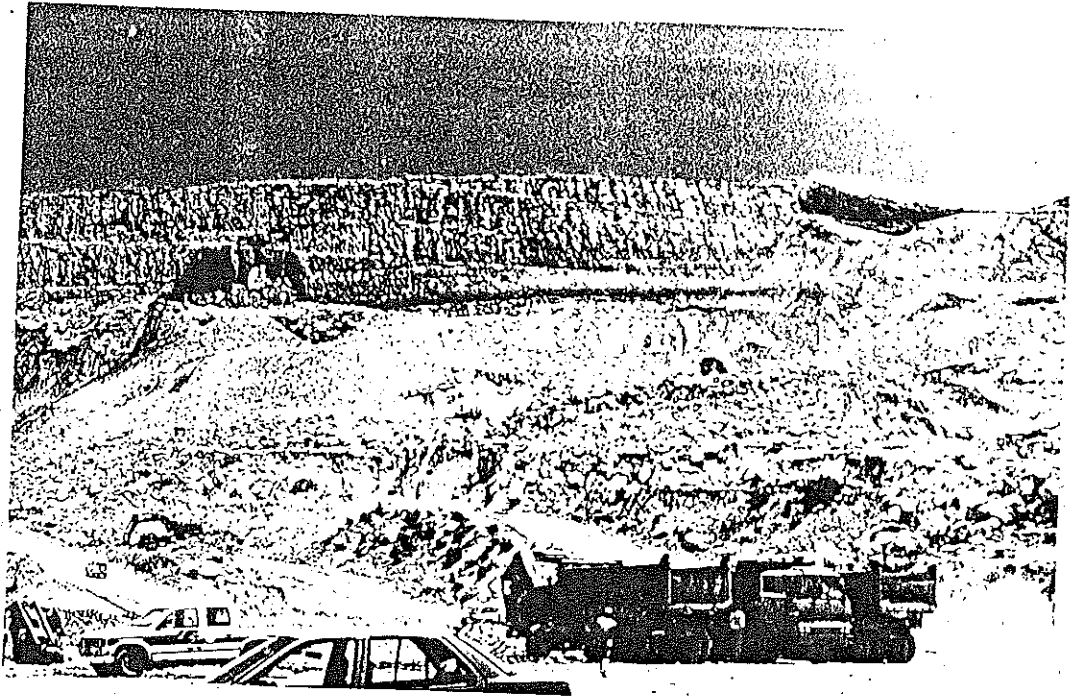
5.5 Sample No. SS-I: This was the material sample obtained from the salt range area. The sample was obtained from the material falling down the landslide. Plates-26 & 27 show the location of the landslide area from where the sample was obtained.

PLATE-26 : LOCATION SHOWING FROM WHERE SAMPLE OF LANDSLIDES MATERIAL

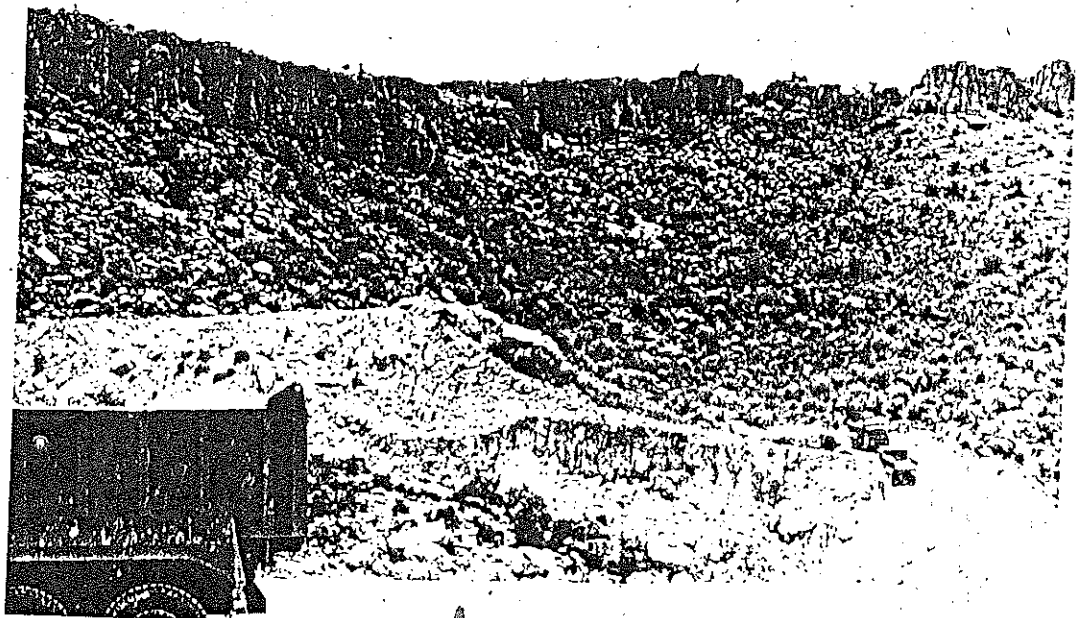
PLATE-27 : ANOTHER VIEW OF LANDSLIDES MATERIAL
