MINISTRY OF COMMUNICATIONS

REPORT
ON
RAIN / FLOOD DAMAGES TO
MEKRAN COASTAL HIGHWAY

February, 2005

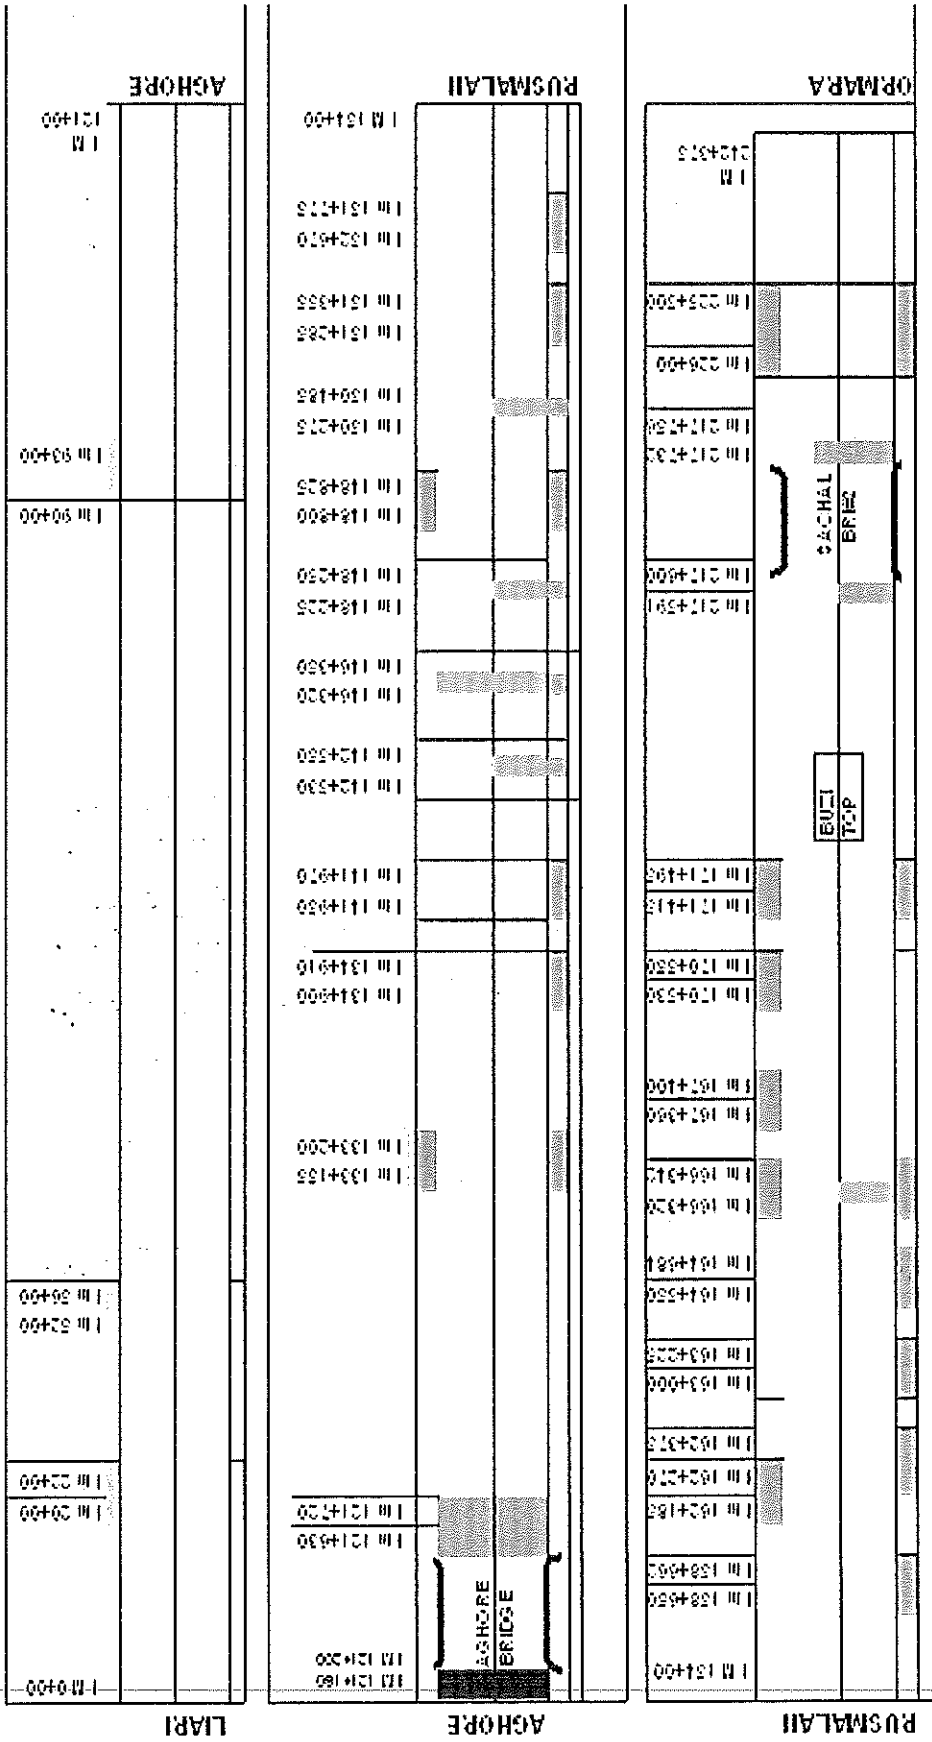
POST FLOOD STATUS (LIARI-ORMARA SECTION)

Breach on Bridge Approaches = 01 Nos
 Breach on oververts Nil
 Pavement = 401 M
 Shoulders = 6406 Km
 Embankment = 90 M
 Guard Rails = 483 M
 Side Drain = 4.661 Km
 Water Overtopped = 12 Locations

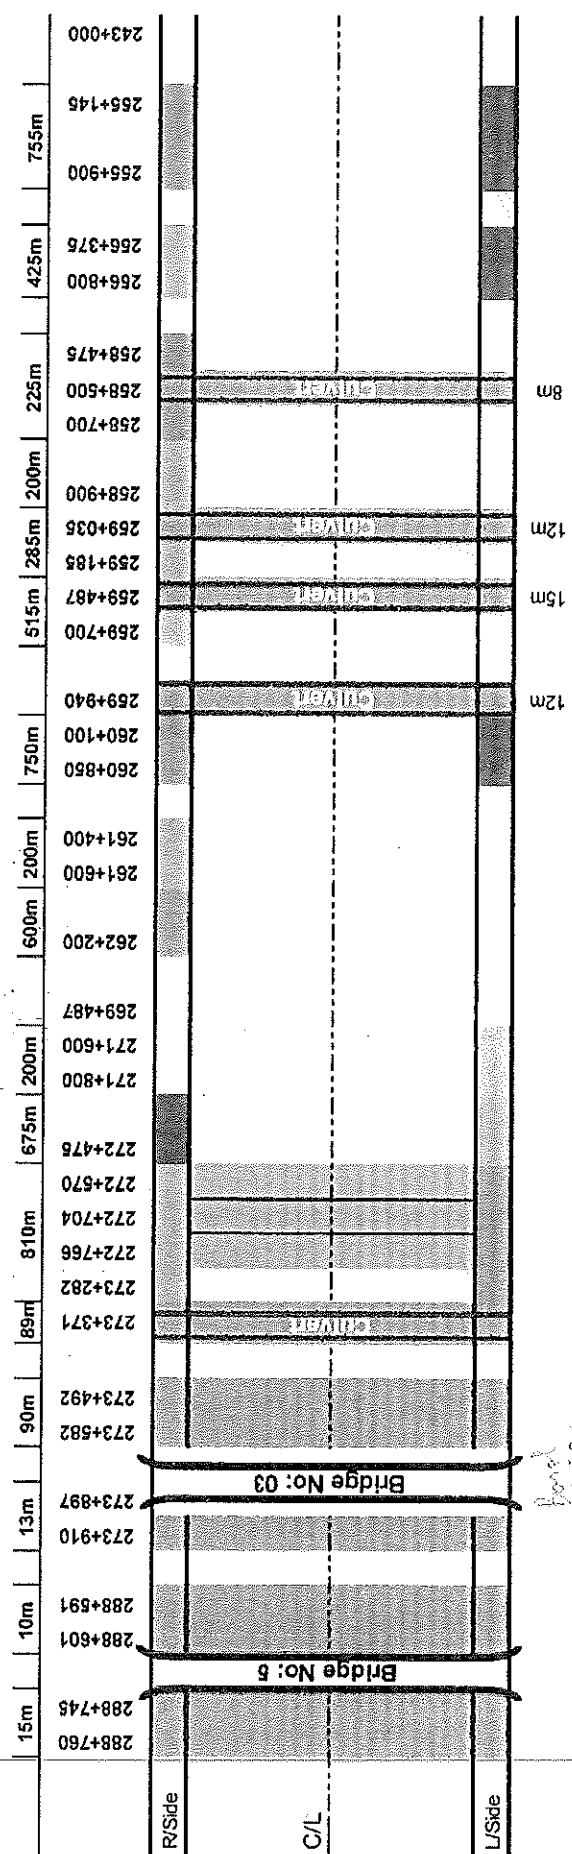
POST FLOOD STATUS(ORMARA -PASNI SUB SECTION - I)

Breach on Bridge Approaches = 04 Nos
 Breach on culverts = 05 Nos
 Pavement = 400 M
 Shoulders (L 2.46 + R 5.06) = 7.5 Km
 Embankment = 260 M

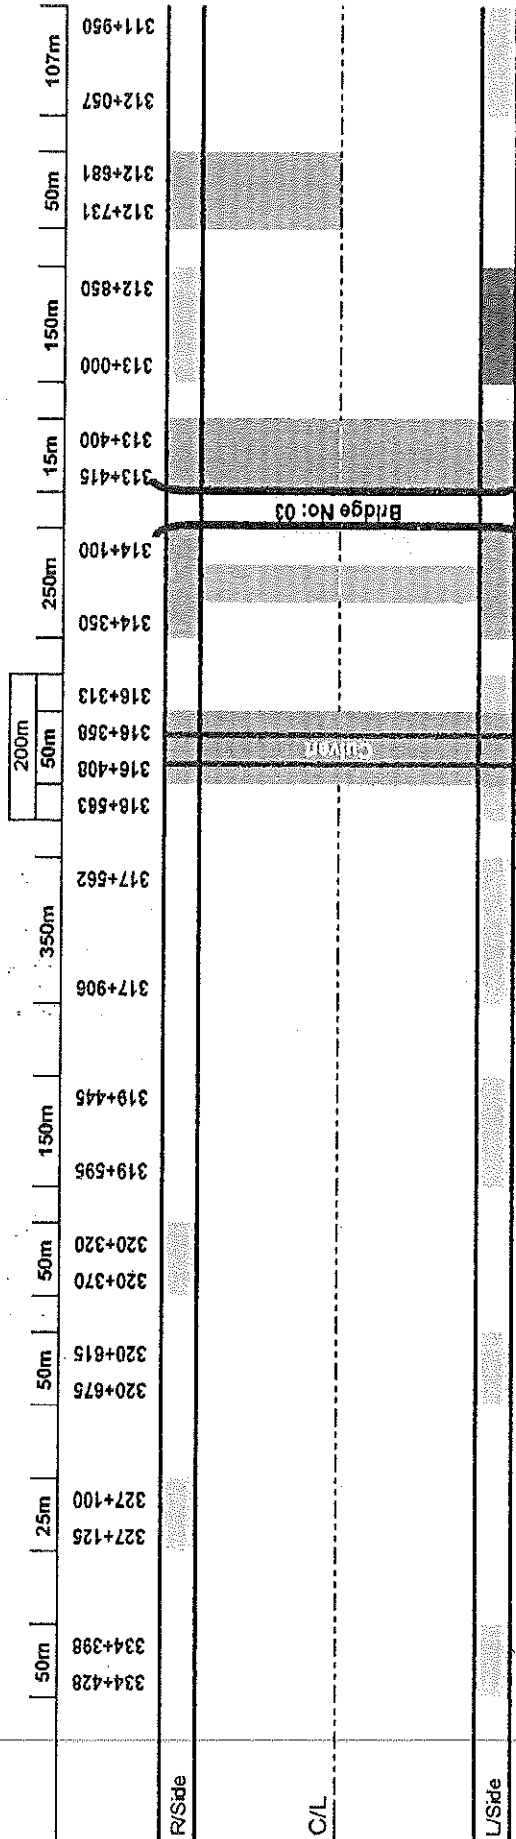
POST FLOOD STATUS(ORMARA -PASNI SUB SECTION - II)

Breach on Bridge Approaches = 01 Nos
 Breach on culverts = 01 Nos
 Pavement = 130 M
 Shoulders (L 0.315 + R 0.365) = 680 M

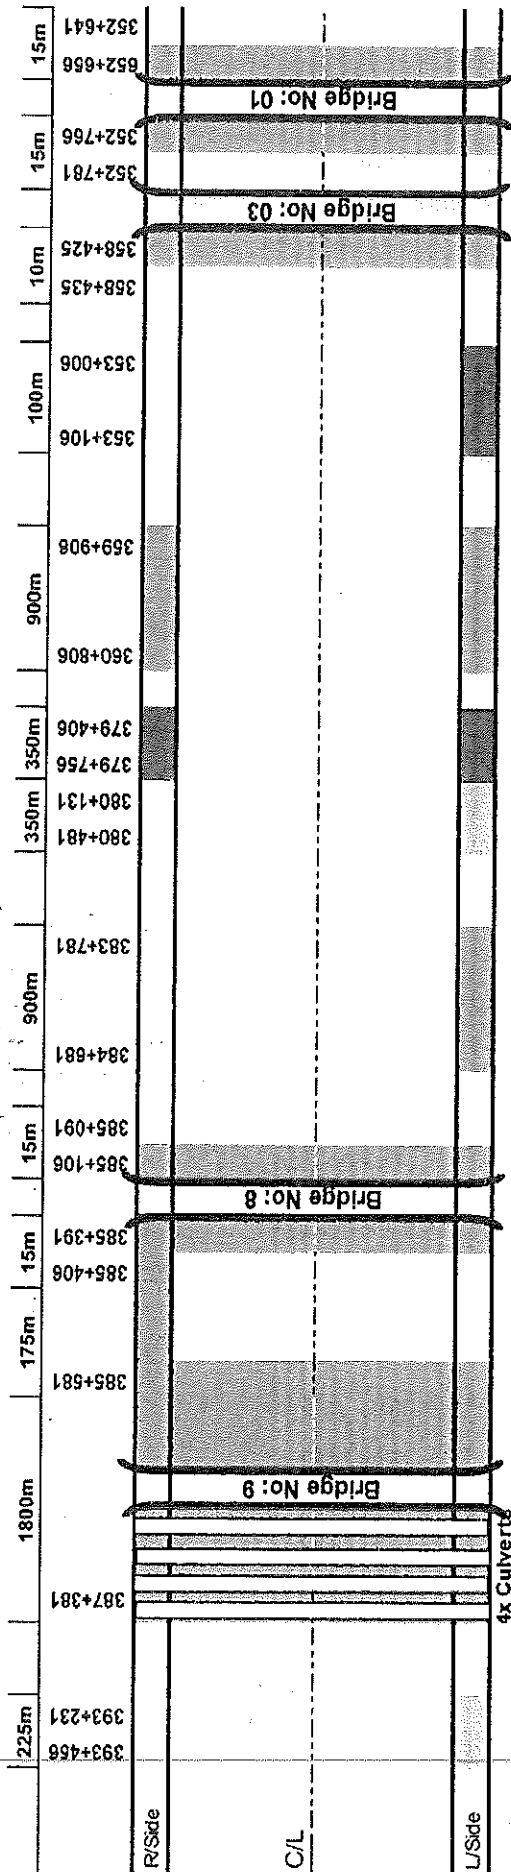
POST FLOOD STATUS(ORMARA -PASNI SUB SECTION - III)

Breach on Bridge Approaches	= 07 Nos
Breach on Culverts	= 04 Nos
Pavement	= 1870 M
Embankment	= 1870 M
Shoulders (L 2600 + R 1425)	= 4025 M
Grouted Riprap	= 200 M

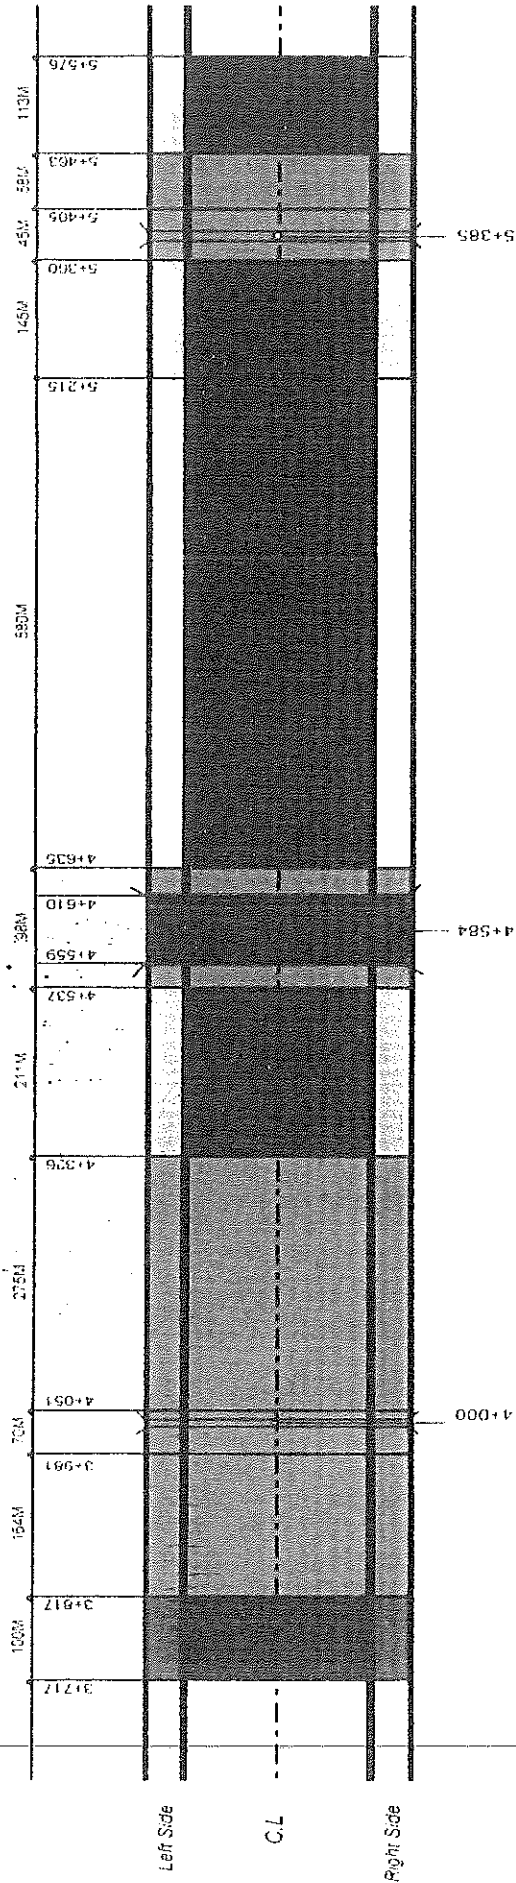
POST FLOOD STATUS (PASNI -GAWADAR SECTION)

- Breach on Bridge Approaches = 02 Nos
- Breach on culverts = 02 Nos
- Pavement = 659 M
- Embankment = 162 M
- Shoulders = 469 M
- DST = 1228 M
