GOVERNMENT OF PAKISTAN
MINISTRY OF COMMUNICATIONS

**CAUSES OF PRE-MATURE FAILURE
OF
SECTIONS OF N-20
CHOWK MARI TO MUREED SHAKH**

February, 2009

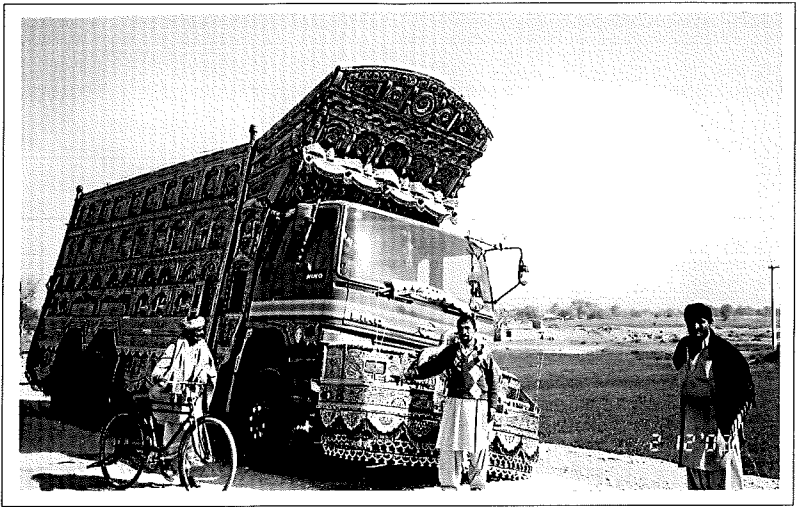
Photograph - 9 A truck stuck up in 'soft' shoulder in the damaged section of N-20

14. Many trucks were found damaged in the 16 kilometer section as compared to none in the remaining section of the highway as shown in the photograph 9.

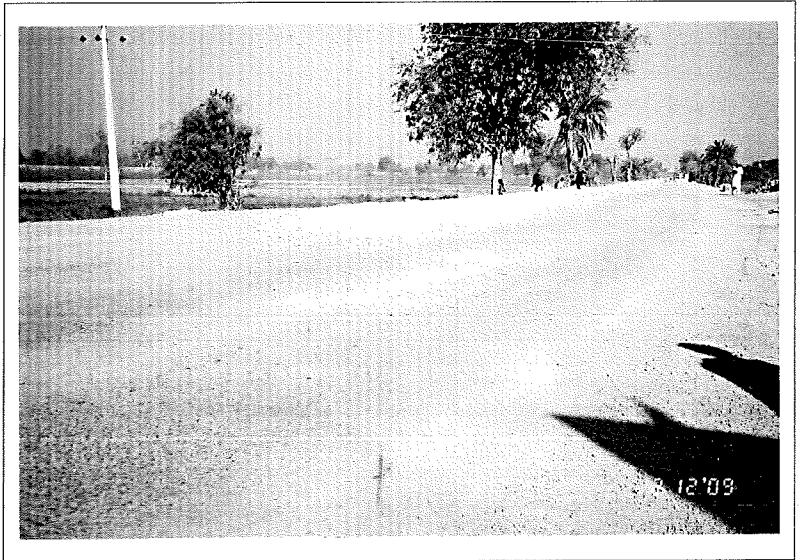
Photograph - 12 A newly repaired section of N-20

Since the substantial completion certificates were not issued by NHA as yet, therefore, the contractors were carrying out some repair work when the team visited the site as shown in photographs 12-14.

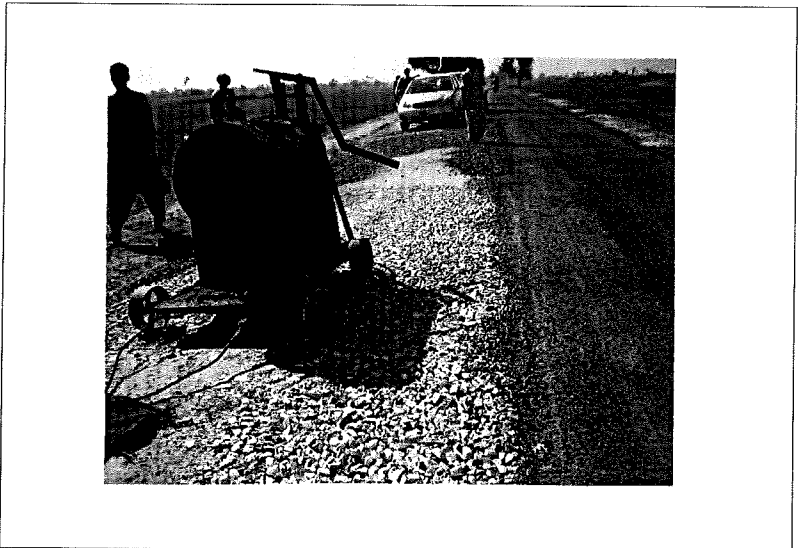
Photograph - 14 Repair work at the failed section is in progress (Aggregates are being spread to fill the depressions in the WBM layer, later TST will be carried out)

12. Repair work was carried out by using same type of aggregate as required for WBM, in fact the choice of aggregates must conform the type & severity of damage as shown in photographs 14 & 22.

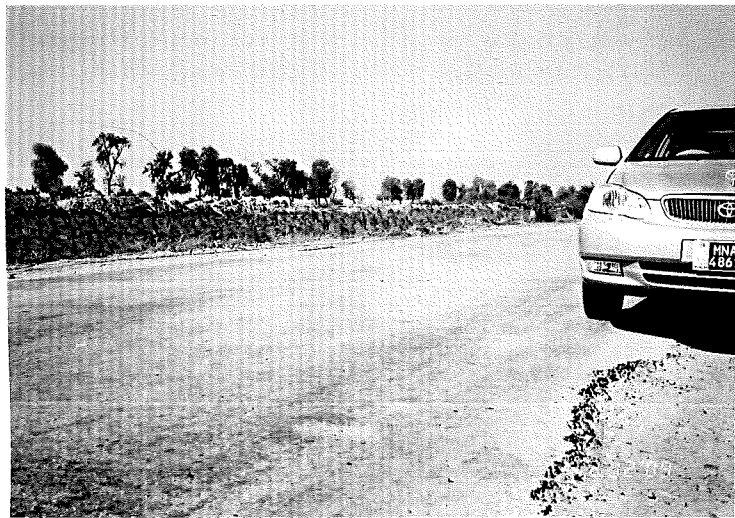
Photograph- 20 A relatively good section of old highway however broken edge requires immediate repairs

8. Difference in elevation between traffic lane and shoulder was seen at few locations due to cracking / breaking of the edge both on old and new highway sections; photograph 20.

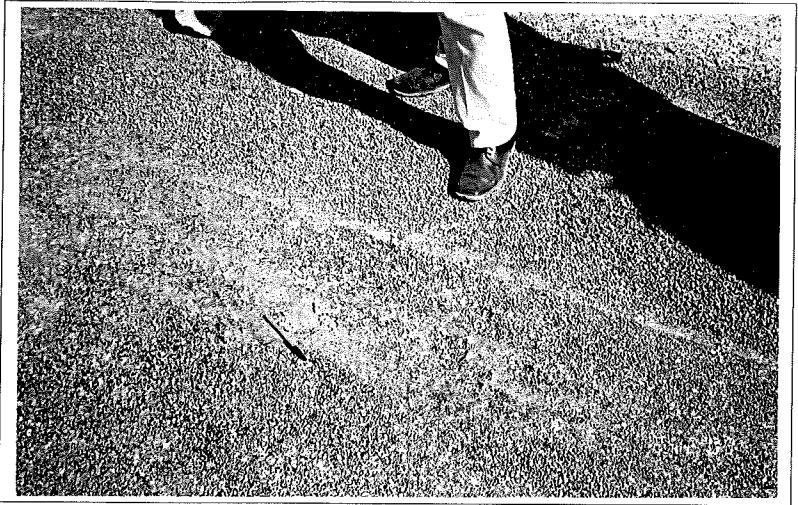
Photograph - 21 Repair work in progress but still proper bonding & embedment is not achieved

10. Chippings larger than 19 mm were on higher side and caused problem of adhesion and embedment into WBM layer.
11. It was also observed in the field survey that during the course of repair work many 'dry spots' on the surface were preventing proper bonding and embedment of TST layer (Photograph - 21).
