NATIONAL TRANSPORT RESEARCH CENTRE

MONITORING
OF
H-8, H-9 SERVICE ROAD, ISLAMABAD

NTRC-228

March, 2001

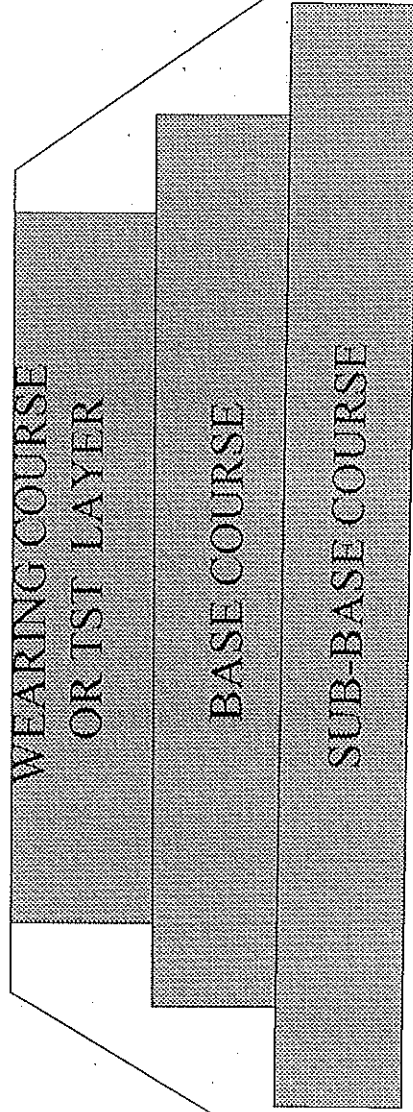
Figure - 1

A flexible pavement may consist of one or more layers of material classified as the surface course, base course, sub-base course and sub-grade. The terms used to describe the various highway component are shown diagrammatically in figure-I.

FLEXIBLE PAVEMENT COMPONENTS

TYPICAL X-SECTION

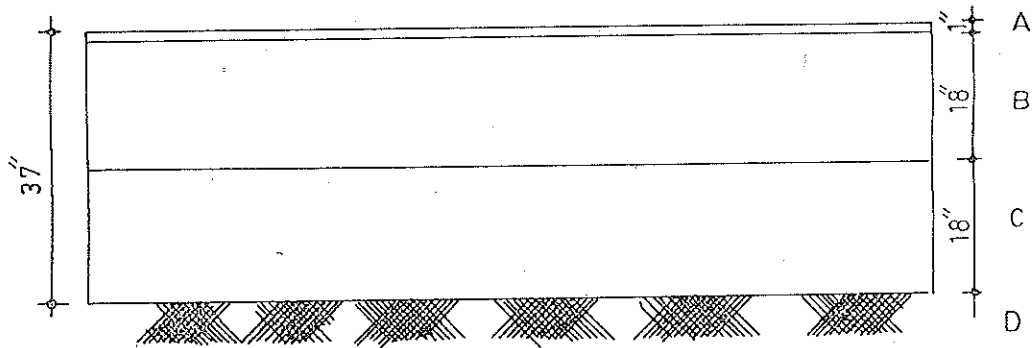
Figure - 2

CDA has used 18" gara as a sub-base and 18" crush aggregate as a base course with triple surface treatment (TST). The typical X-section may be seen at Fig. No. 2)

TYPICAL CROSS - SECTION OF THE ROAD

- A = 1" TRIPLE SURFACE TREATMENT (TST)
- B = 18" AGGREGATE BASE COURSE
- C = 18" GARA SUB-BASE COURSE
- D = SUB - GRADE

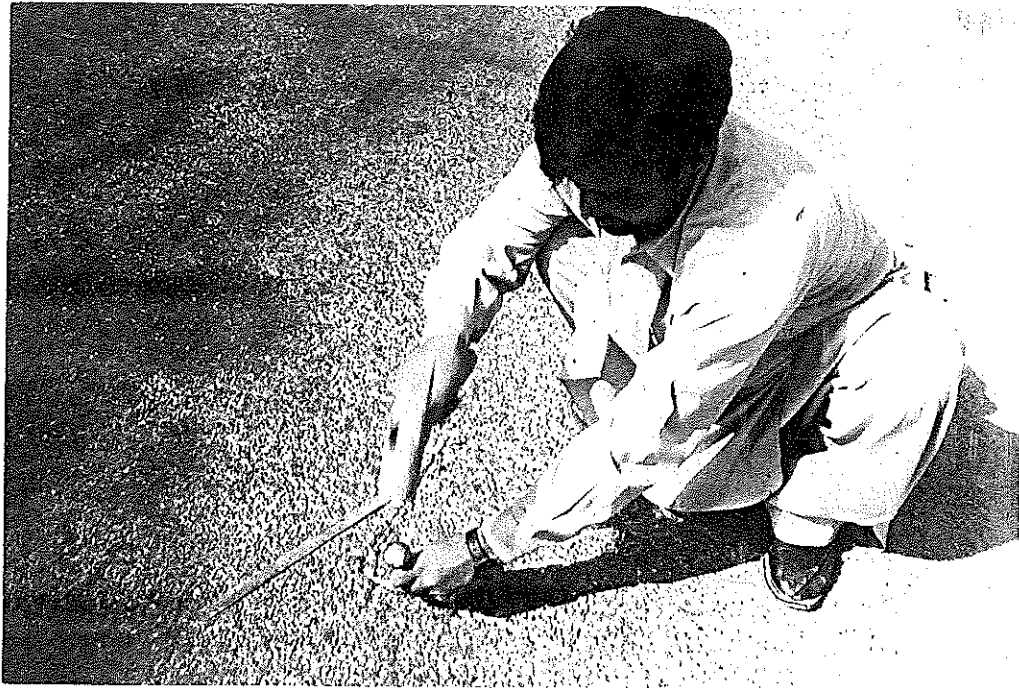
The samples were collected randomly and were free from bias. The samples were of adequate size, number and represented the true nature and condition (Plate No. 1).

Plate 1 : COLLECTION OF SAMPLES

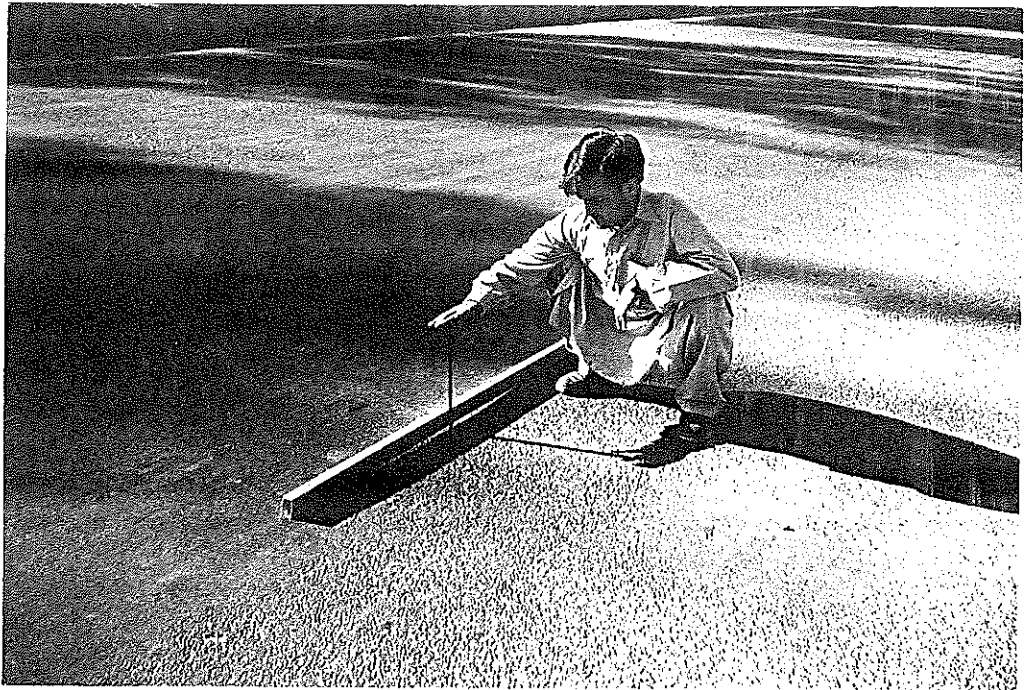
Roughness is pavements surface's irregularity that affect riding quality. The general condition of the newly constructed service road is not to the standard. The surface was observed to be uneven and a six feet straight edge revealed difference 6 to 18 mm when placed perpendicular and 2 to 8 mm when placed to parallel to central line of the road causes vibration during travelling (Plate No 2 & 3).

Plate 2 : SURFACE ROUGHNESS IS BEING CHECKED WITH STRAIGHT EDGE

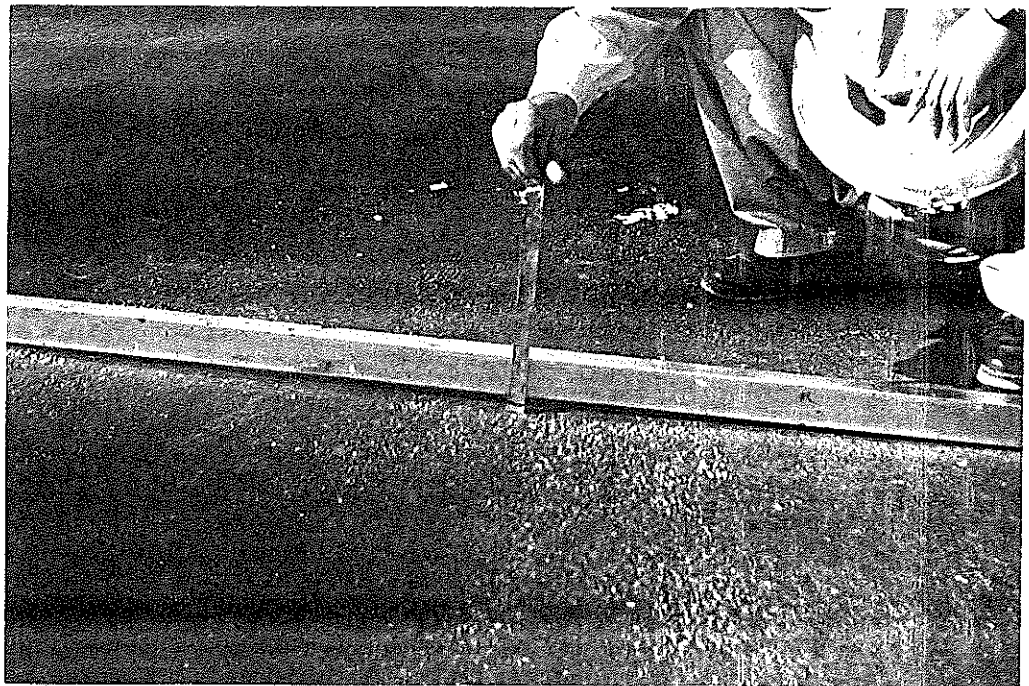
Plate 3 : CHECKING OF SURFACE UNDULATION WITH STRAIGHT EDGE

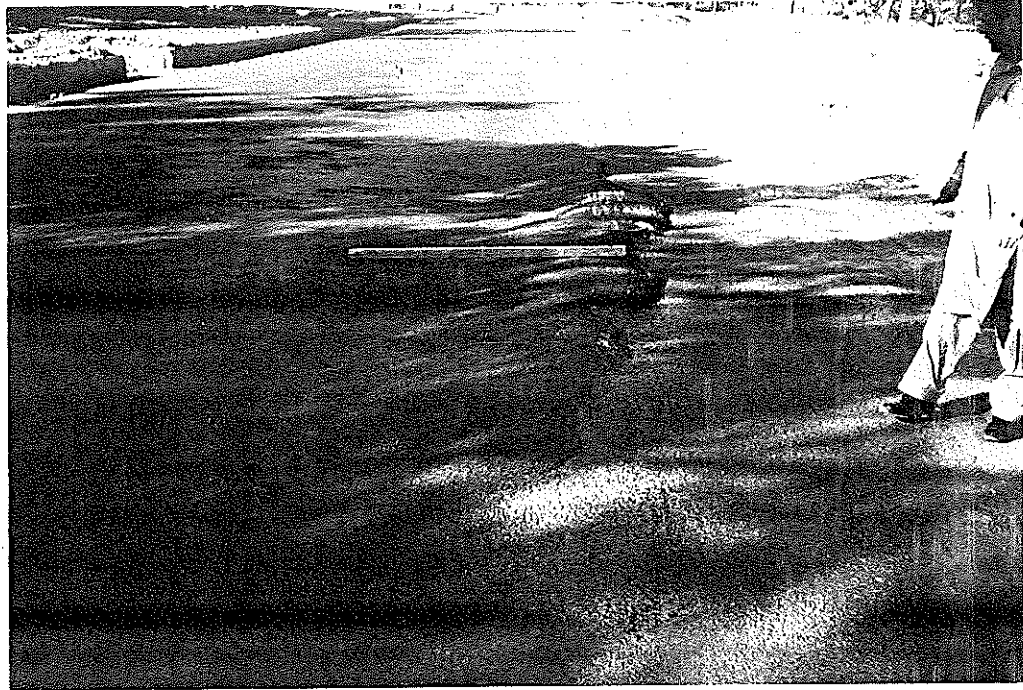
Shoving was observed in about 20m length shown in plate No.4.

Plate 4 : EXTENSIVE SHOIVING IS VISIBLE

- Shoving area must be rectified.
- Kerb stones may be fixed at the edge of open drain as a safety protection.
- Chip spreader may be used to spread the aggregates for TST to control the uniform spreading of aggregates.
- Poor control of the surface levels of road affect the riding quality which can be controlled by using mechanical paver.
- The liquid asphalt may be sprayed by mechanical distributor so that uniform quantity may be sprayed.
- Many distresses are closely interconnected and at later stage, it becomes difficult to identify the primary cause, therefore, pavement monitoring survey should be regularly carried out in order to apply timely remedial measures.

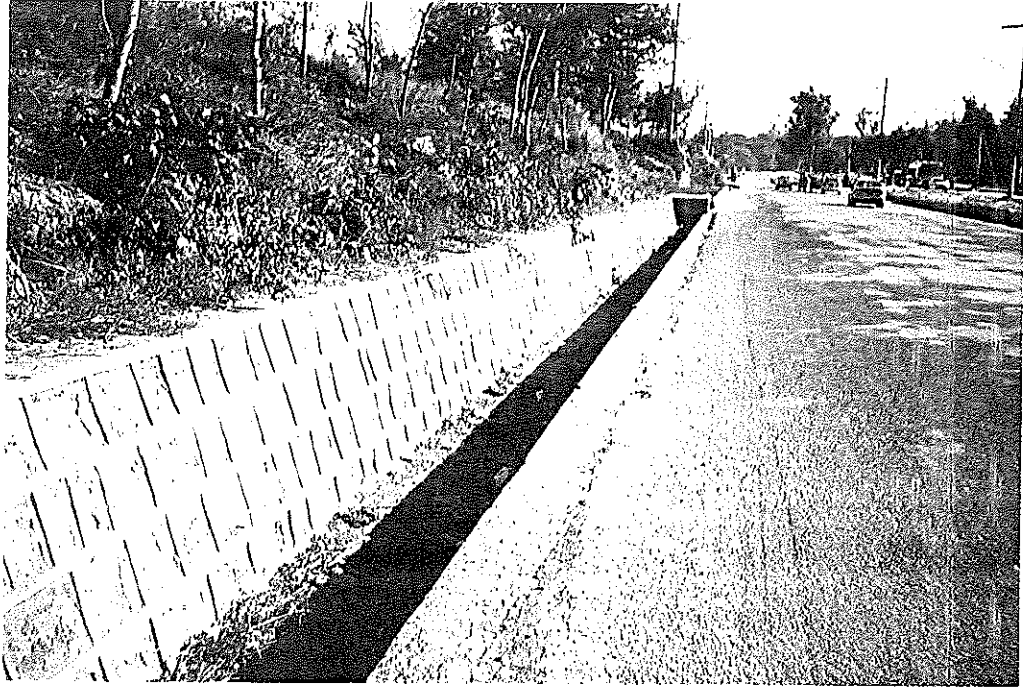
During visual inspection bleeding i.e. a film of bituminous material on the surface was observed on 40-50% area of the newly constructed road. This is due to the non-uniform spray of bitumen and

aggregates for TST layer. The quantity of aggregate as specified in NHA specification manual is 43 kg/sq.m for TST layer. The quantity of aggregates for the samples taken from the un-bled section was 22.7 kg/sq.m and 42.9 kg/sq.m. and in bled area, it was 37.62 kg/sq.m. and 36.16 kg/sq.m. The bitumen quantity in un-bled area was 2.8 ltr/sq.m and 1.76 ltr/sq.m and in bled area, it was 3.33 ltr/sq.m and 3.12 ltr/sq.m. It was found that the quantity of aggregate was less and bitumen quantity was more in the bled area which could be one cause of bleeding. Bleeding is a great safety hazard and reduces the skid resistance of the pavement surface. This is showed in plate No. 5 and results may be seen in Table No. 7.1.

Plate,5 : SIDE DRAIN WITHOUT SAFETY PROTECTION AND BLEEDING IS ALSO VISIBLE
