GOVERNMENT OF PAKISTAN
MINISTRY OF COMMUNICATIONS
NATIONAL TRANSPORT RESEARCH CENTRE

PEDESTRIAN SAFETY AT AN URBAN ROAD

NTRC - 240

JULY 2001

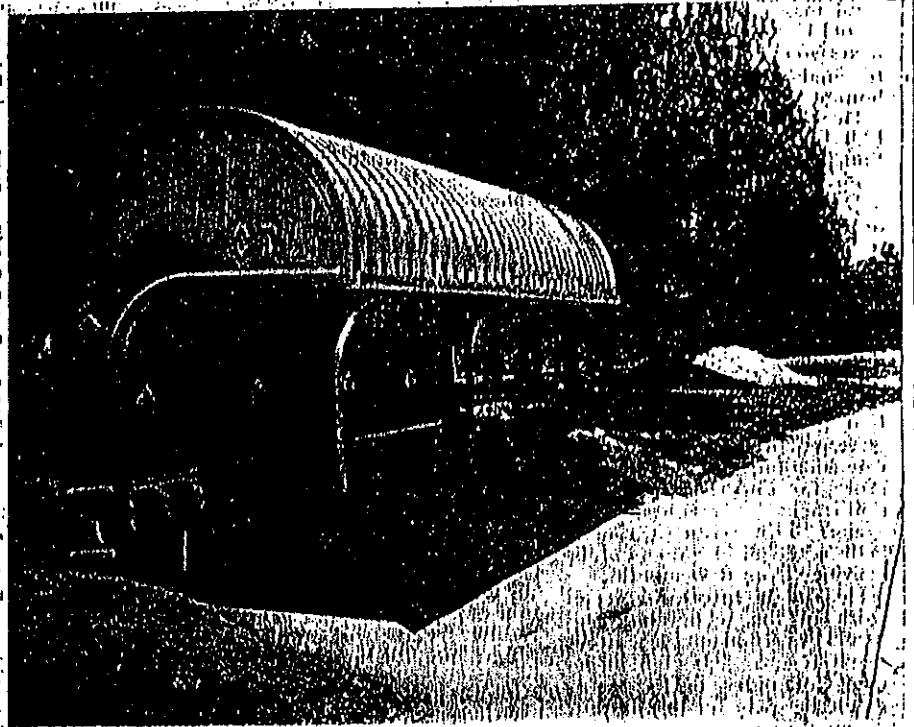
This time the CDA thought of improving this service and constructed fibre glass shelters. The bright coloured shelters designed by Design Wing of the CDA can be spotted easily and are more comfortable because of the heat resistant quality of the

material. It has a seating arrangement for 15 persons separate for ladies and gents.

But this time too the authority forgot to construct these shelters at the right place. The only shelter which has yet been constructed and shown in the picture is at Faisal Avenue crossing between G-7/1 and G-8/4. Now it seems quite ridiculous because not a single public vehicle passes by this spot and thus not a single passenger can ever be seen here.

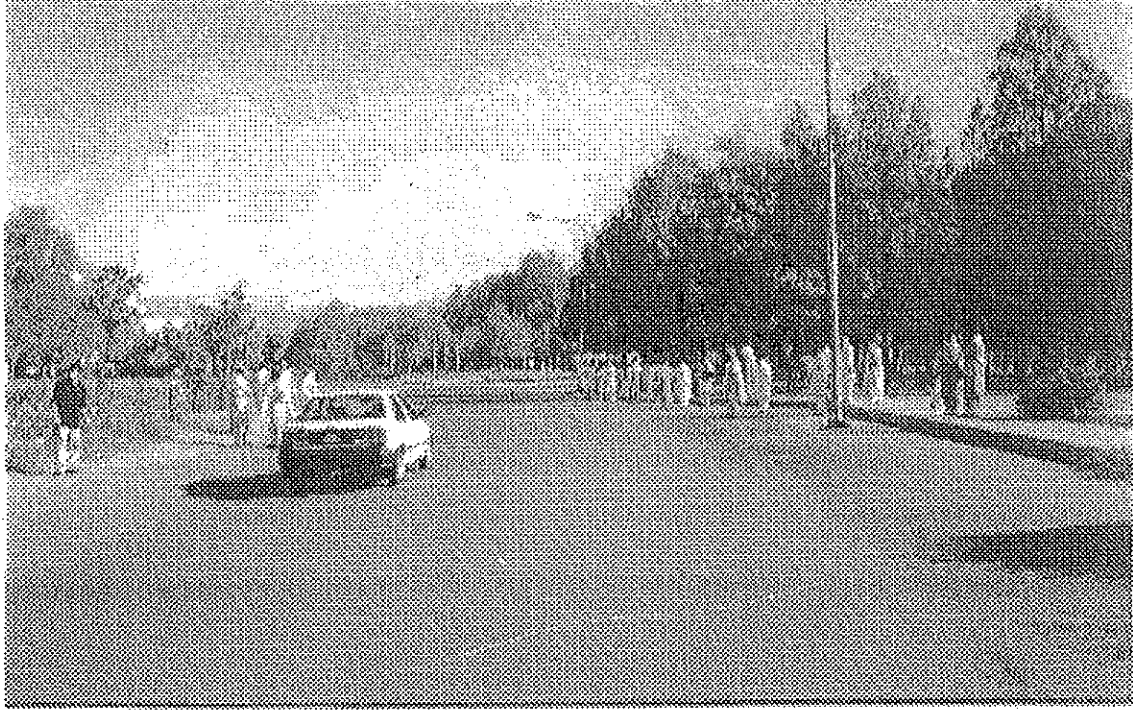
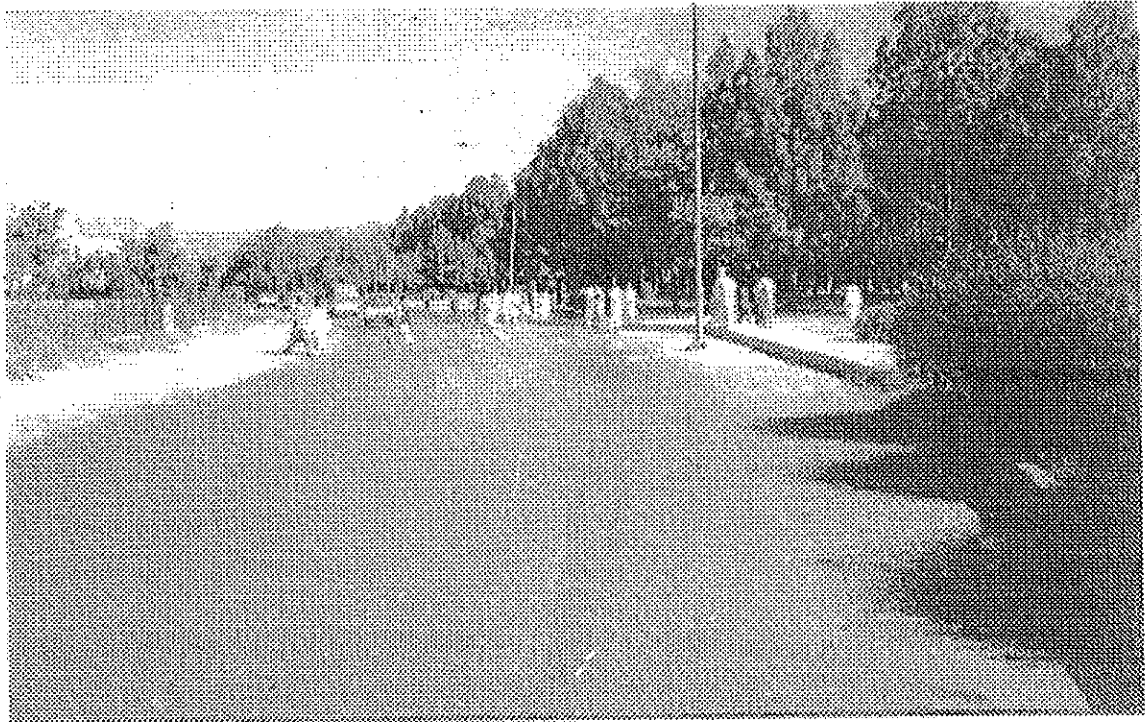
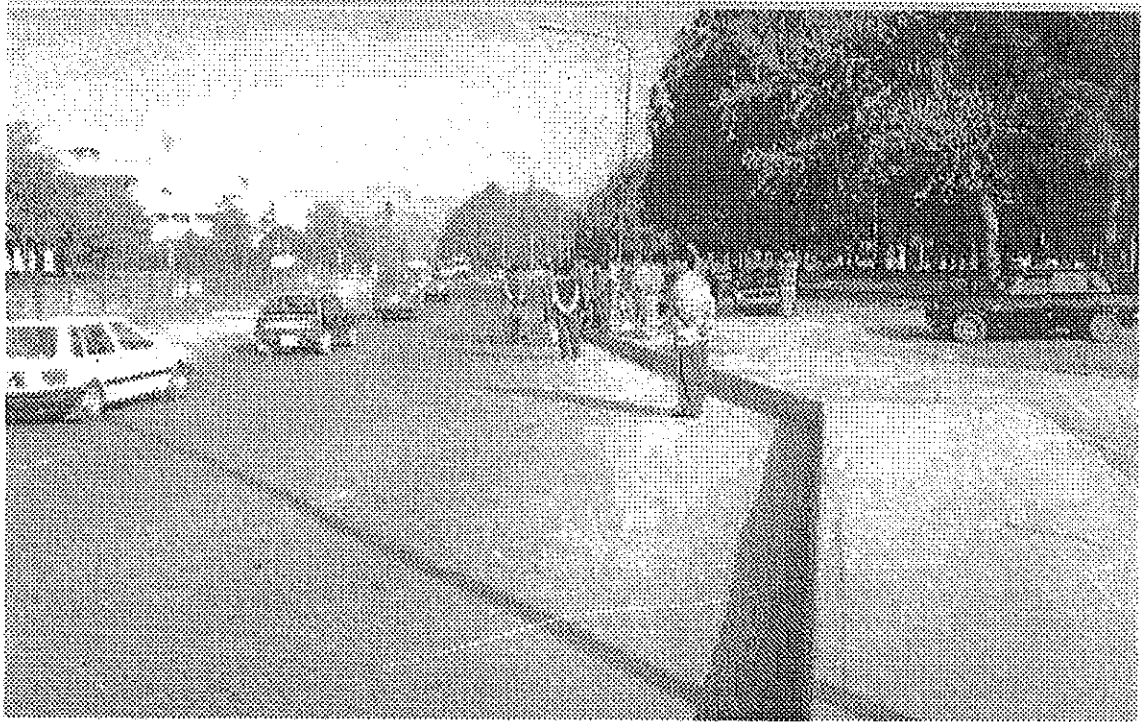
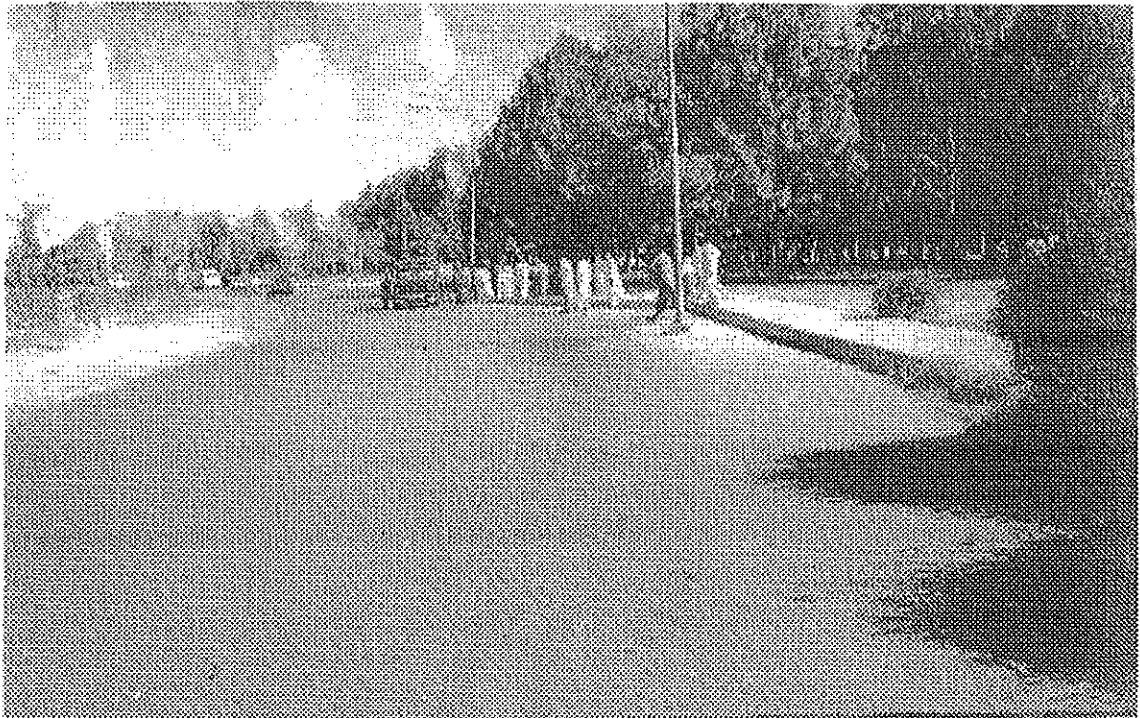
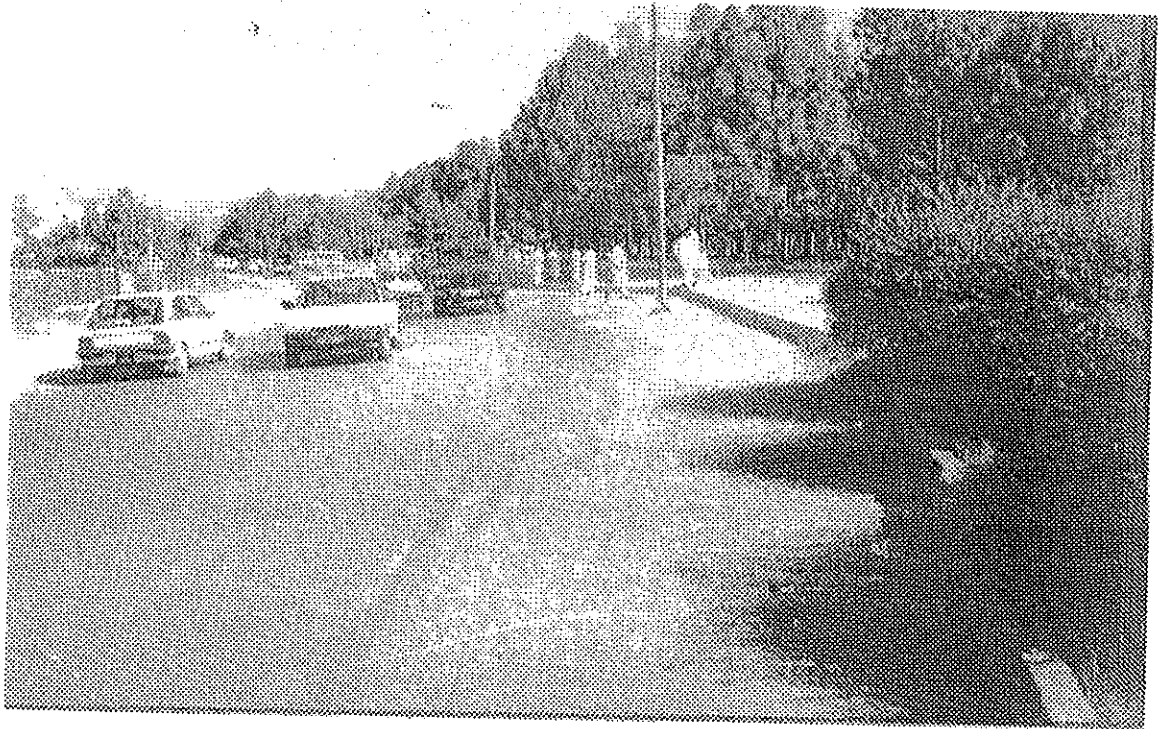
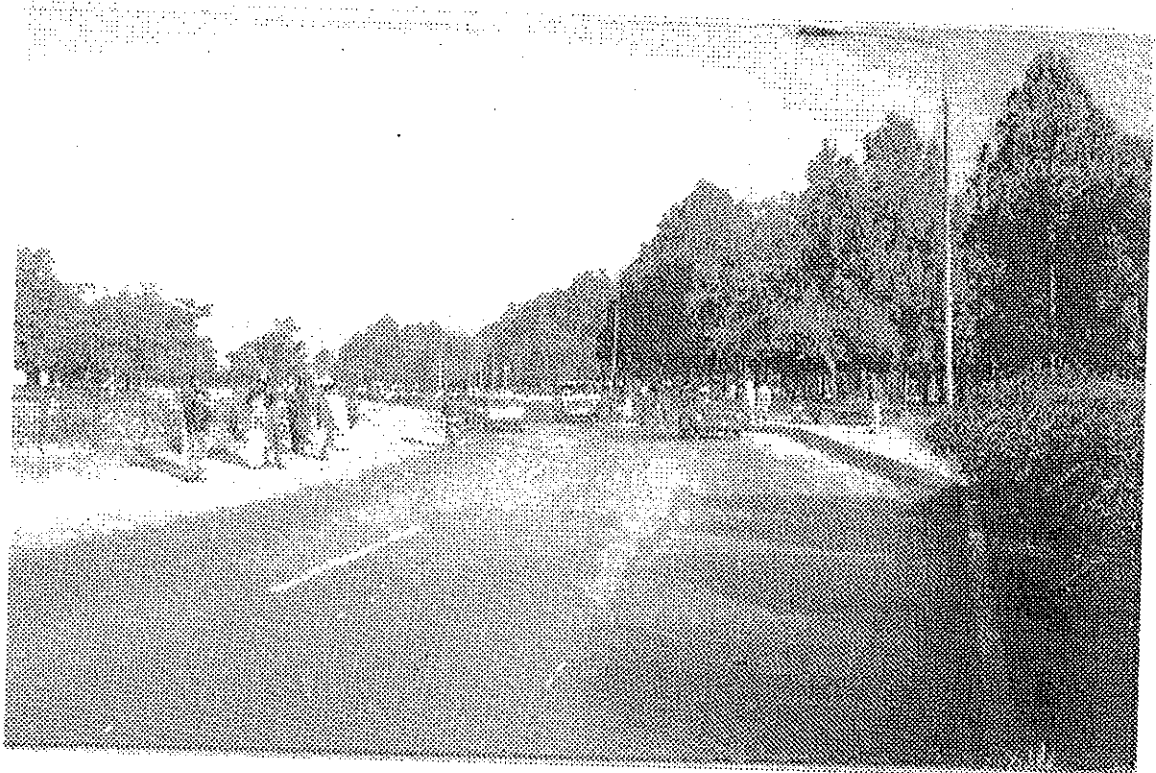
Before Situation Photographs

The wagon stop is situated on a curve as may be seen in Fig-1 (Annexure-V), which makes the visibility angle very poor and narrow. Often the Passengers disembarking from a wagon, crosses a road from anywhere and the incoming vehicle driver does not notice him, which causes accident.

There is a water drainage gutter on the westbound road below the road surface level such as a ditch, which not only reduces effective width of the road opposite to wagon stop but also causes a sudden jump to the vehicles, which happens to pass over it.

A single light pole was installed at the middle of the bus bay, which can be seen in the photographs in Annexure-V. It is observed that wagons are not being parked at proper place and picking / dropping of the passengers on the bus bay also causing the traffic hazards for passengers and vehicular traffic. On

These photographs of Annexure-V show that there is no facility for the pedestrians. There is no waiting shed for the passengers. The light pole fixed in the bus bay. Pedestrians cross the road in a haphazard manner. The PSV's do not use the stopping bay because the taxis are parked at the bay preventing PSV's from using the bay. The PSV's embark and dis-embark the passengers on the main road making them vulnerable to serve accidents. Further, the through traffic also get disturbed. The photograph No. 5 (Annexure-V) shows dangerous overloading by the bus in Peak hours.

the request of NTRC the pole was shifted behind the platform of the bus bay by the CDA.

Although the light pole at the bus stop on the road has been displaced on the proposed footpath, at least three more light poles should be installed at the bus stop up to the curve of Mini Zoo.

Road surface on T & T colony side should be made even and the level of drainage gutter should be raised upto the road level.
