NATIONAL TRANSPORT RESEARCH CENTRE

DISTRESS ANALYSIS
OF
KASHMIR HIGHWAY

NTRC-215

April, 2000

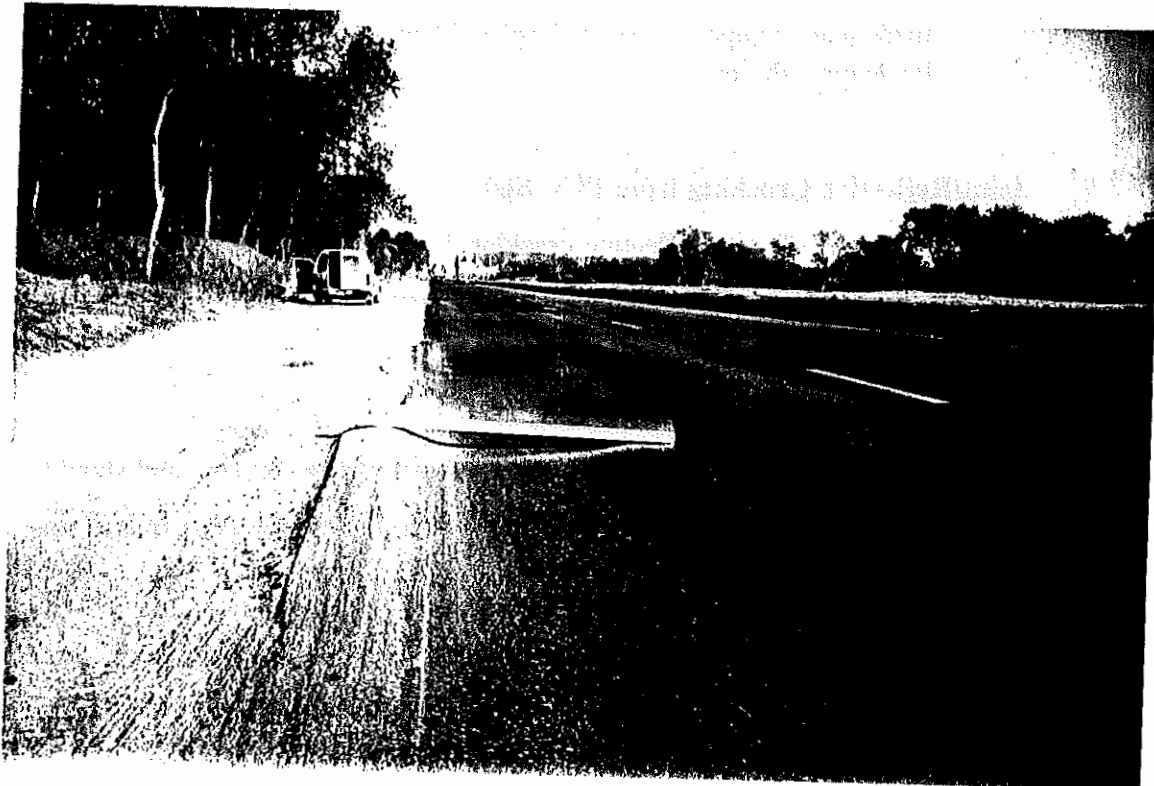
Plate 7.7-1

As corrugation usually occurs at a point where vehicles accelerate or decelerate, therefore, it was observed where trucks had to climb up the hill, take a sharp turn and had to stop. The severity was medium on the new carriageway while the old highway was severely effected at many places even at minor rises or decents, as shown in photograph 7.7-1 & 2.

High severity rutting. Material shoved along the both sides of the rutted wheel paths on Old Carriageway.

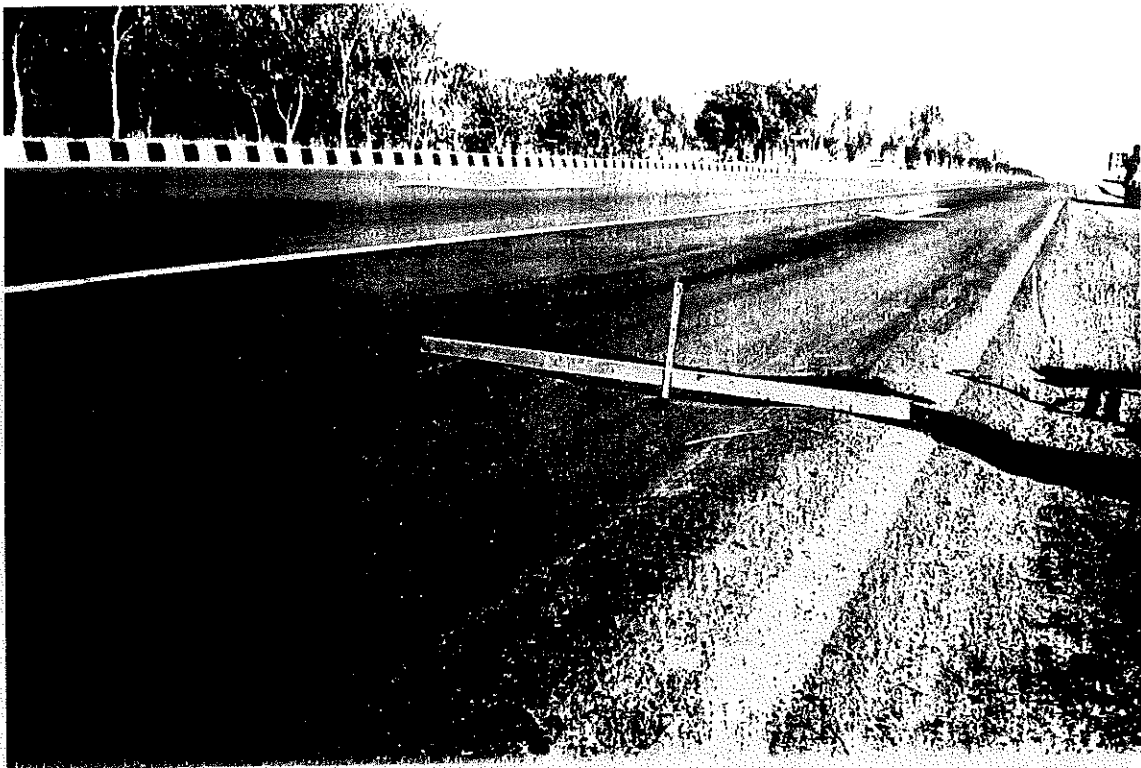
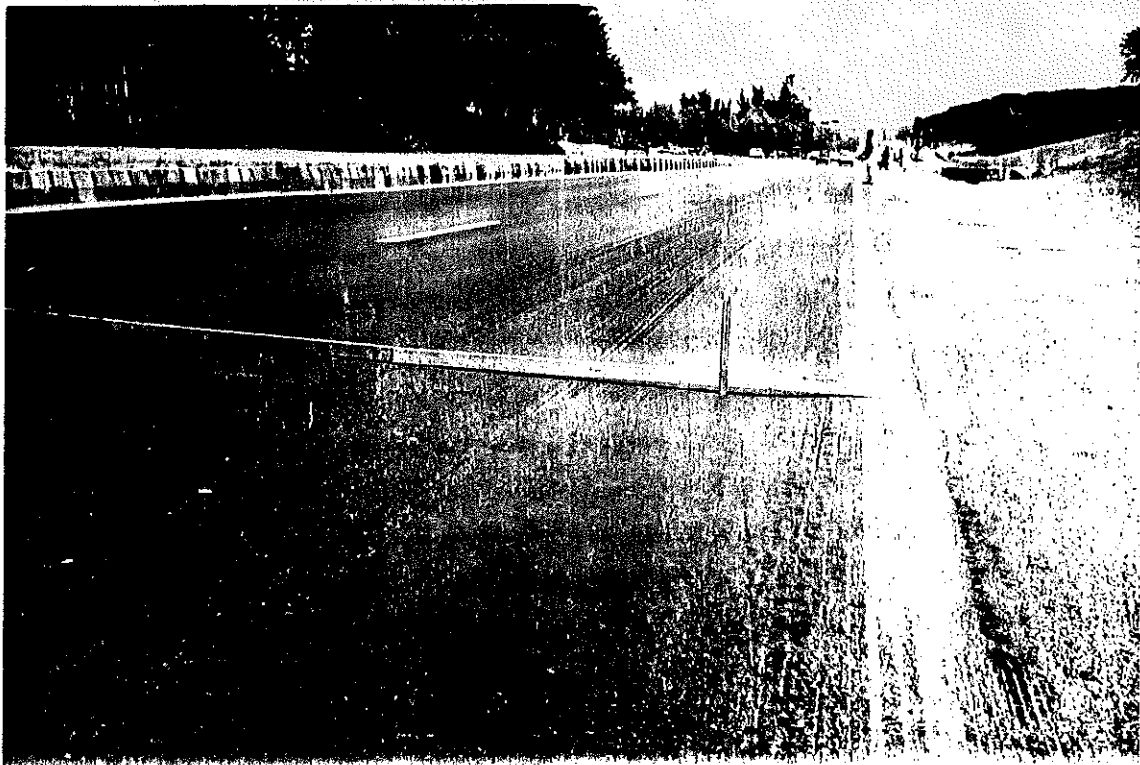
Plate 7.10

Signs of edge cracking were not observed in the new highway while the old highway had many. The probable cause was no lateral support and moisture difference between shoulder and pavements, as shown in photograph 7.10.

No difference of level in elevation between the traffic lane and shoulder were observed on the new highway. The shoulder of the new highway is treated one, while the old highway was through out its length had a difference of atleast 4" - 6" between the shoulder and the outer lane as shown in photograph 7.10. Repair work and construction of a paved shoulder was in progress.

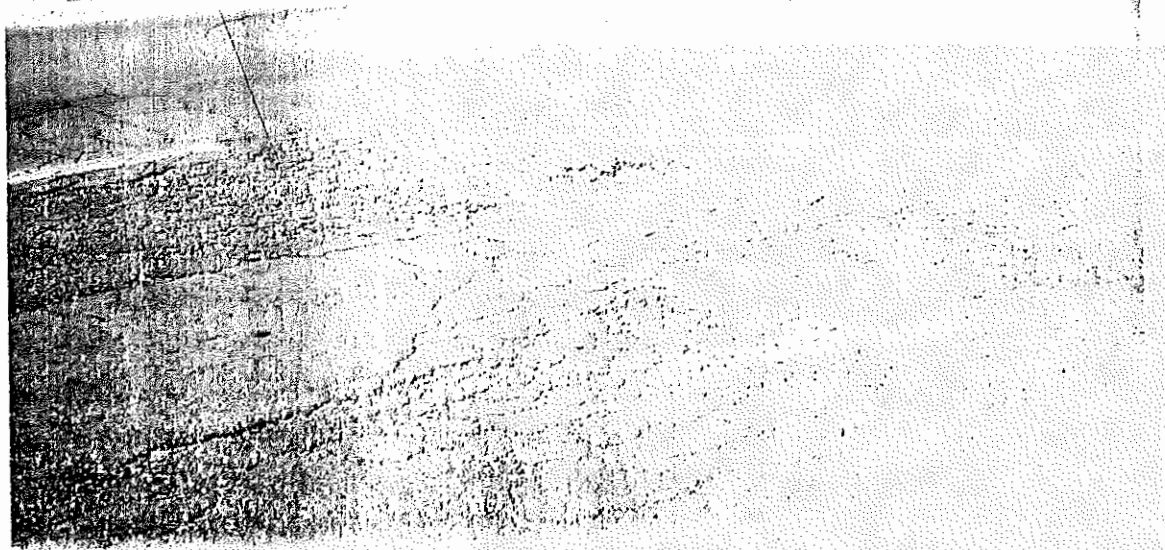
Significant signs of polishing of aggregates were observed at several locations and aggregates were found to be protruding above asphalt surface and were not rough at several locations on the new carriageway. Some polishing of aggregates on the right lane of the old carriageway was also observed. Nearly a quarter of the highway is patched and approximately half is milled, while a quarter is extremely rutted. These milled and rutted sections have very polished aggregates, which reduces skid resistance. The photographs 7.14-1 and 7.14-2 show the picture.

Plate 7.14-2 A view of polished aggregates on Old Carriageway.
