# Overhead Bridge – Railway Crossing at Taxila

On Sarai Kala & Haripur Road

Bridge Directorate, Highway Department

May 2003

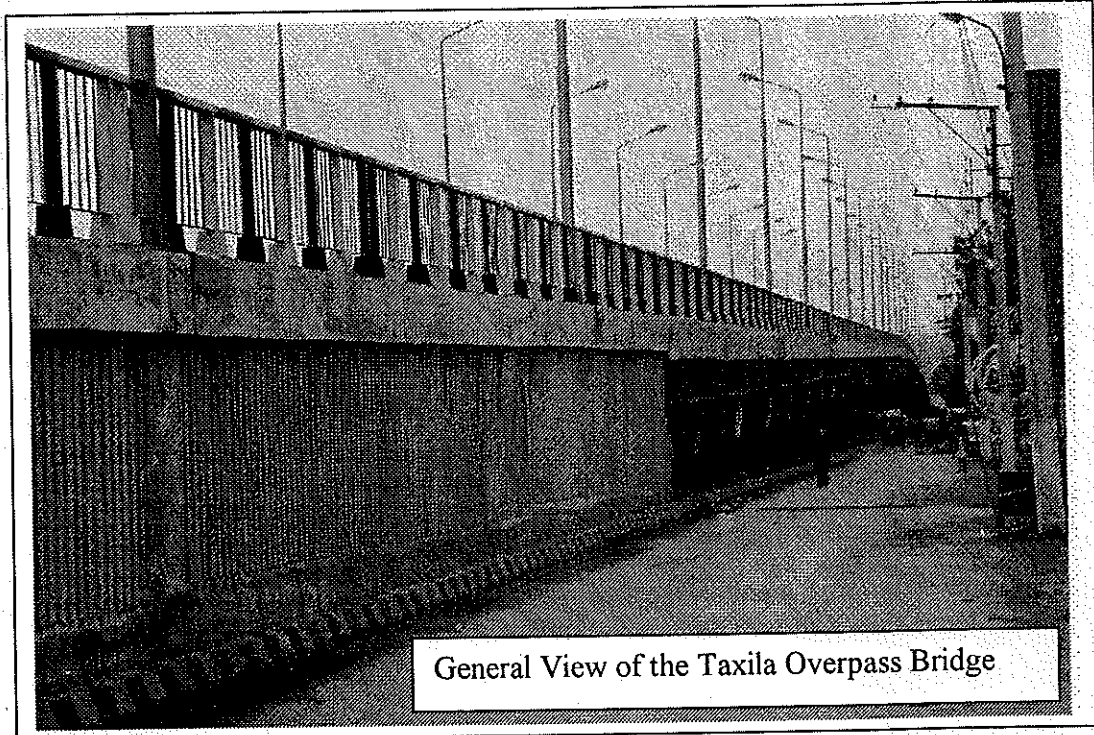
General View of the Taxila Overpass Bridge

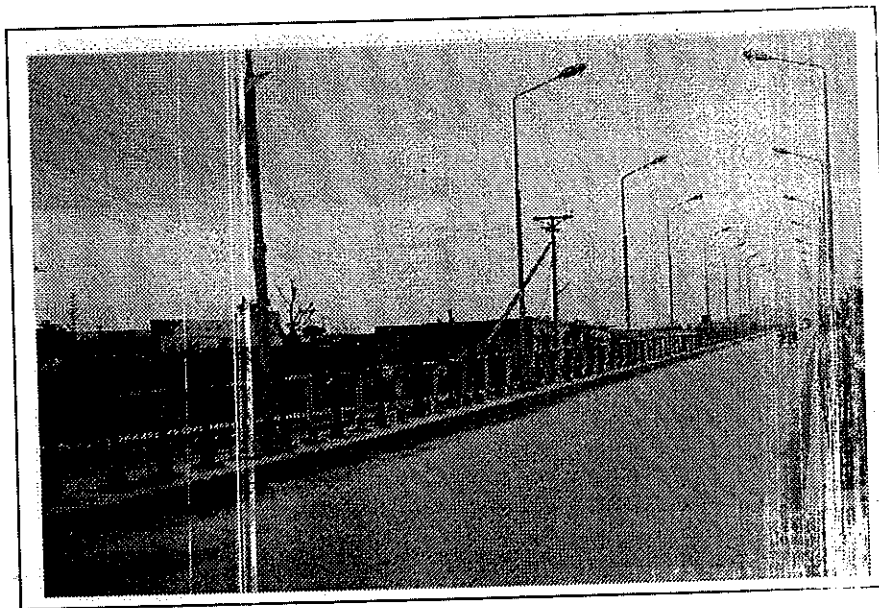
The front page shows a general view of the overpass bridge. Figure 1. - shows a general view of the bridge deck

Figure 1. - General view of the bridge deck
