NATIONAL TRANSPORT RESEARCH CENTRE

REPORT  
ON  
LAHORE - ISLAMABAD MOTORWAY

NTRC-201

June, 1997

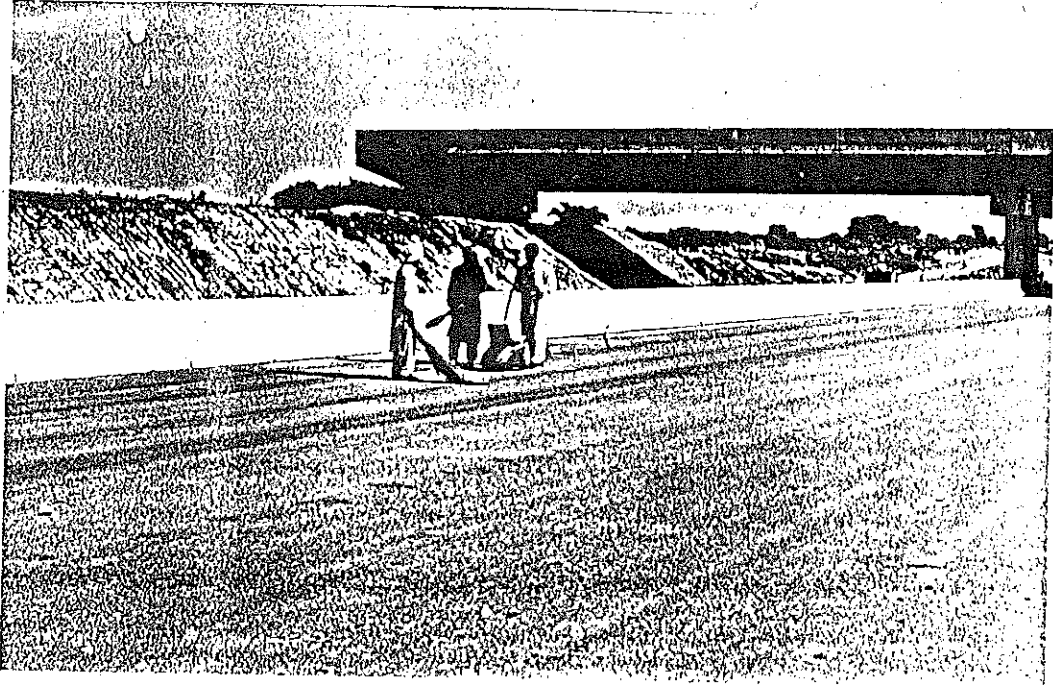
4.1 Surface Distress & Riding Quality: In order to check the surface distress such as cracking or rutting, thorough visual inspections were made along the whole length of section-III and section-IV and some locations randomly selected were thoroughly inspected. It was observed that riding surface was generally in good condition and there were no visible signs of any distress in the form of rutting or cracking. Plate-1 and Plate-2 exhibits close view of the surface showing no signs of any type of distress cracking or rutting. Similarly Plate-3 and Plate-4 show the longitudinal view of the pavement were no signs of distress in the form of rutting are observed. During the visual inspection of the surface, it was observed that road roughness was being checked using ARRB profilometer. The display of the profilometer showed the International Roughness Index (IRI) of 1.5 meter/kilometer. The IRI of 1.5 m/km is the roughness requirement for the Motorway at the time of its opening. Plates- 5 & 6 show the profilometer at work.

PLATE-5 : PROFILOMETER AT WORK

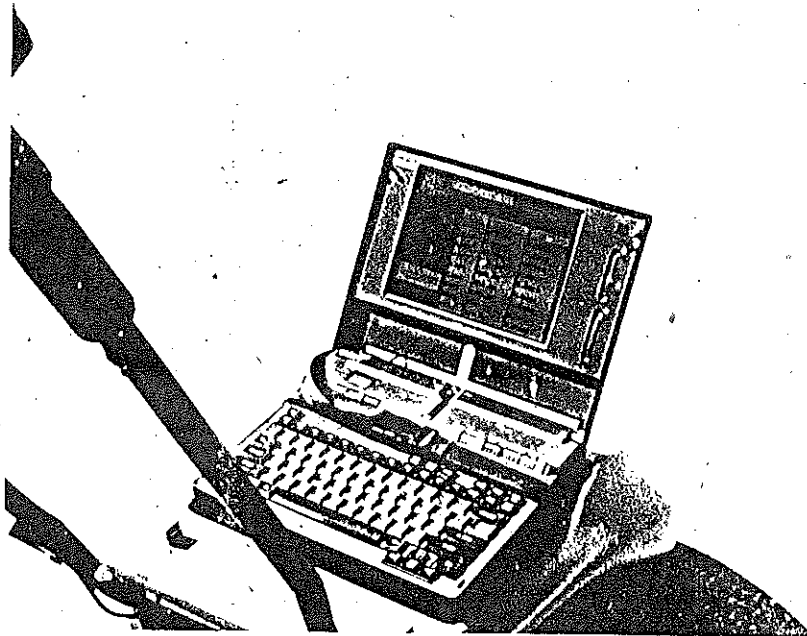
PLATE-6 : PROFILOMETER DISPLAY

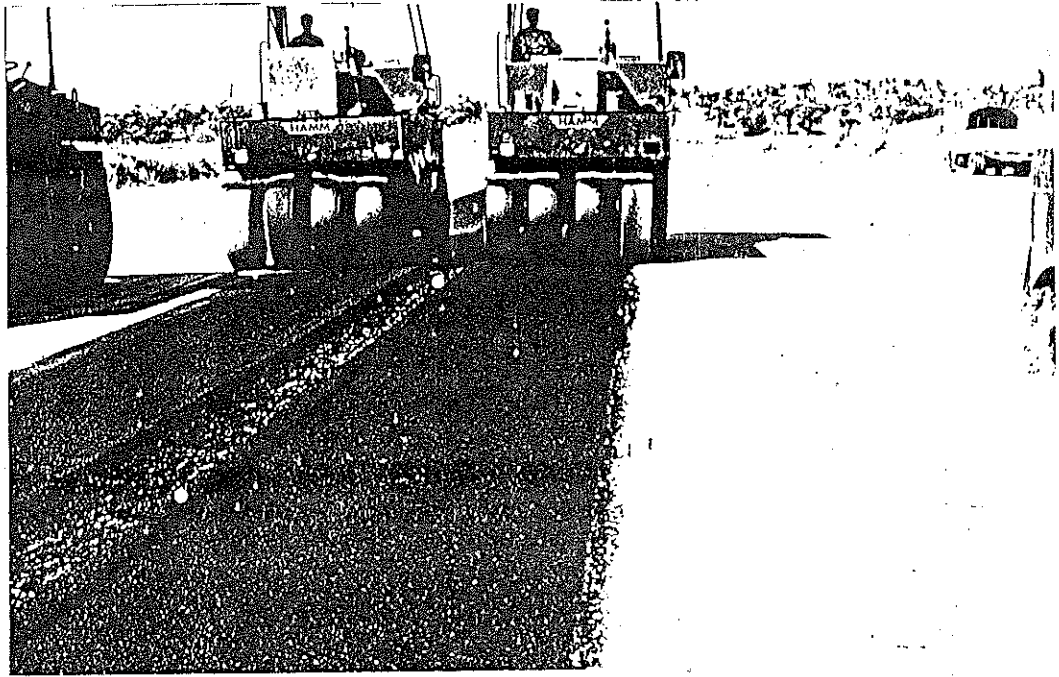
5.1 Sample No. AC-I: This sample was obtained from the freshly laid asphaltic concrete wearing course near Chakri from Section-III of Motorway where inner lane near New Jersey barrier was being paved. Paver was in operation and the sample No. AC-I was obtained from the freshly laid surface. Plate-24 and 25 show the location and execution of the work.

PLATE-24 : INNER LANE NEAR NEW JERSEY BARRIER BEING  
PAVED

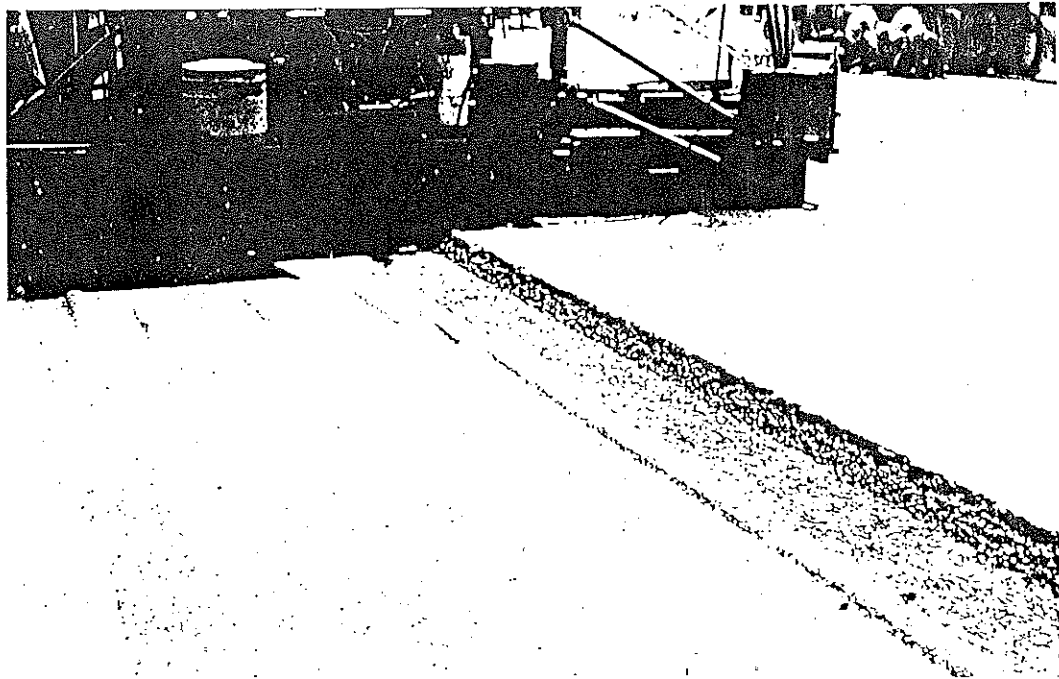
PLATE-25 : ANOTHER VIEW PAVES IN OPERATION
